**Restoration of the  
Barnstable County Superior  
Courthouse  
3195 Main Street  
Barnstable, MA 02630**

**Gale JN 843680  
May 9, 2025**

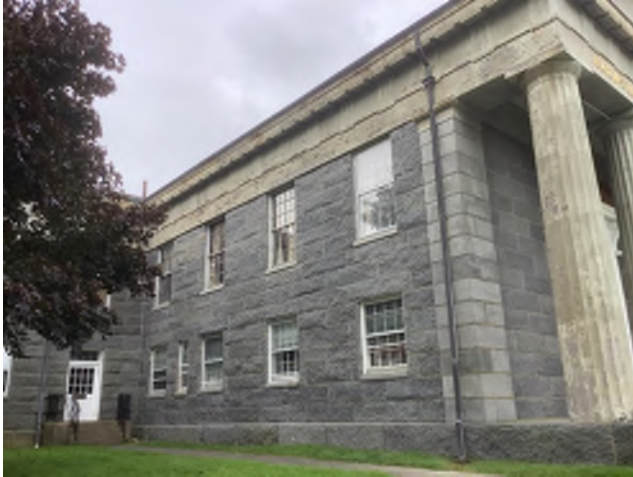
Image 1: Overall view of typical window openings at the Original building.

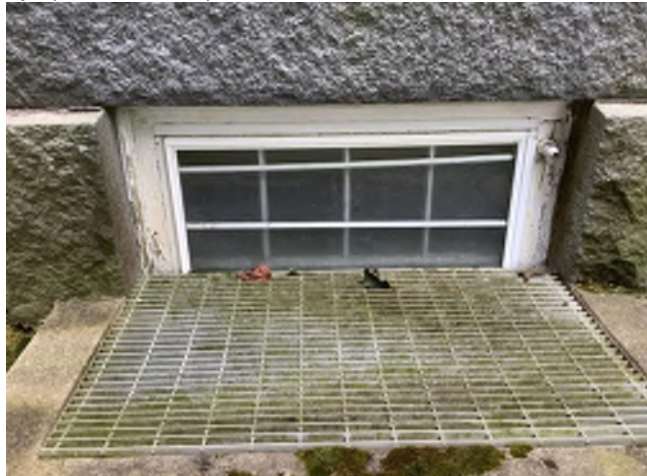
Image 4: Typical Basement window within the 1893 and 1903 wing additions.

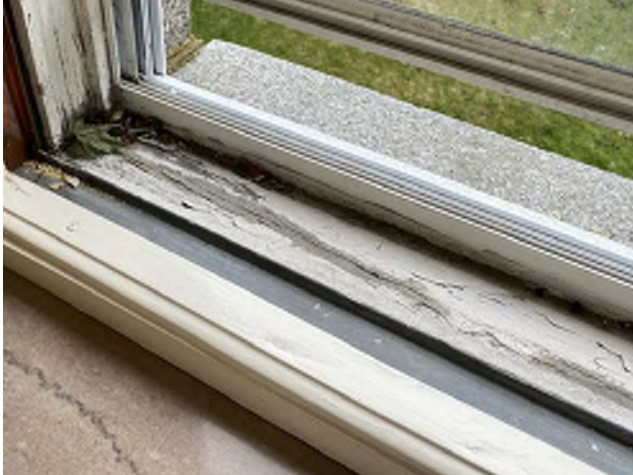
Image 5: Typical peeling paint and weatherchecking at wood sill.

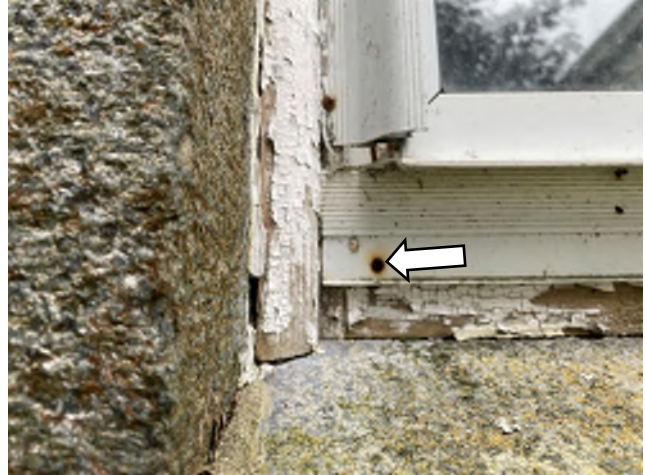
Image 6: Detail view of typical condition of exterior wood trim and sill. The arrow indicates a rusted fastener that secures the storm window to the wood sill.

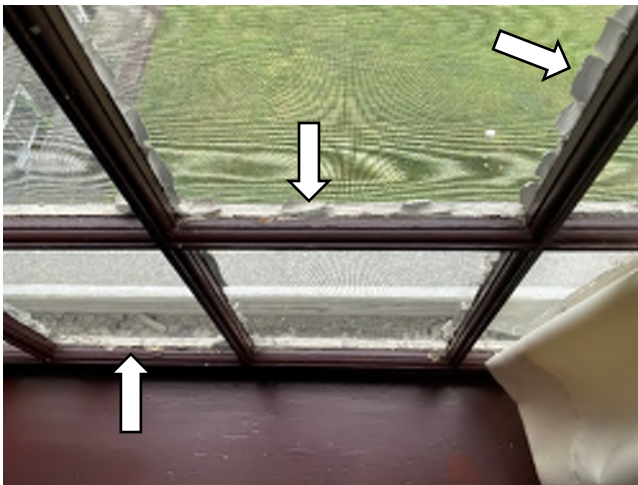
Image 7: The arrows indicate failed glazing putty present at the majority of wood windows.

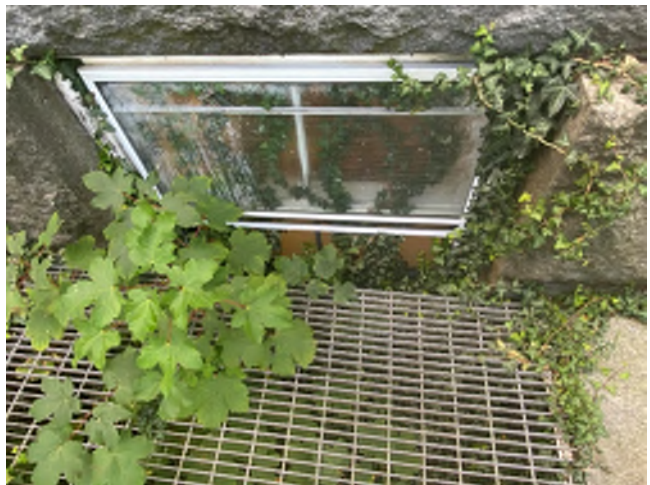
Image 8: Vegetation growth basement window. At this window location, vegetation growth was observed behind the storm window.

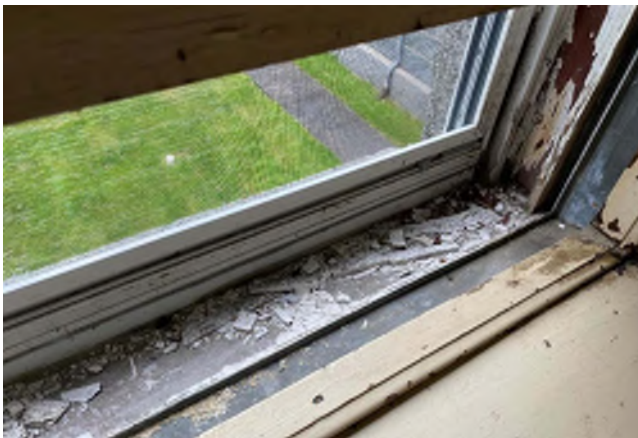
Image 9: Debris from falling glazing putty and paint has typically collected at each window sill.

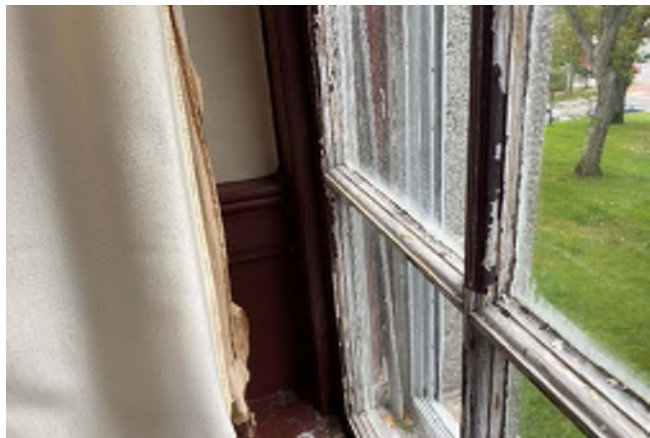
Image 10: Example of interior deteriorated painted wood surfaces.

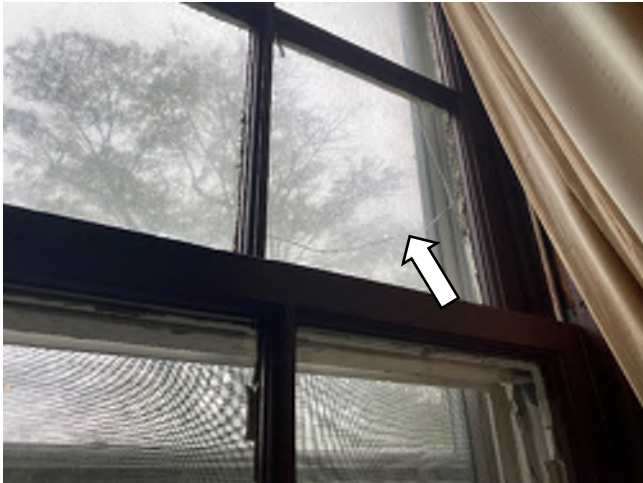
Image 11: The arrow indicates an example of a cracked glass pane.

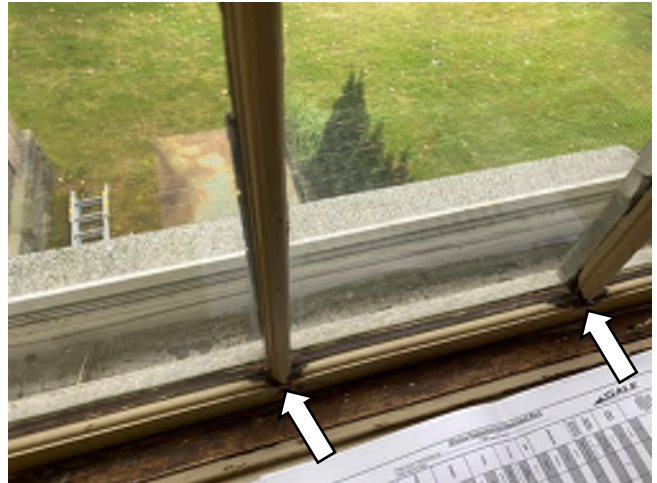
Image 12: At this window location, deterioration was observed where the muntins meet the sash bottom rail (arrows).

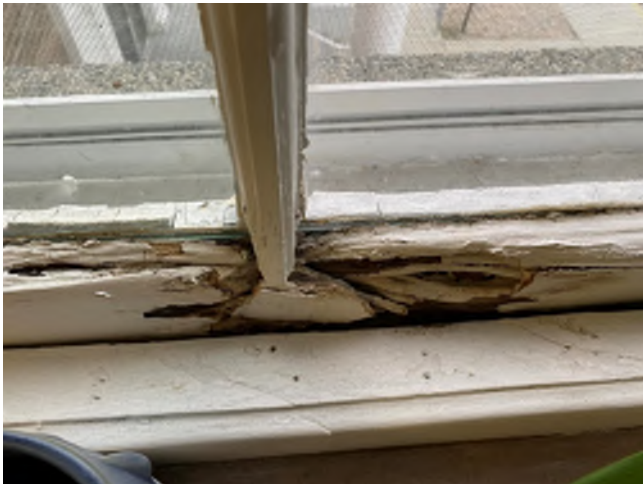
Image 13: A severe example of wood deterioration at a sash bottom rail.

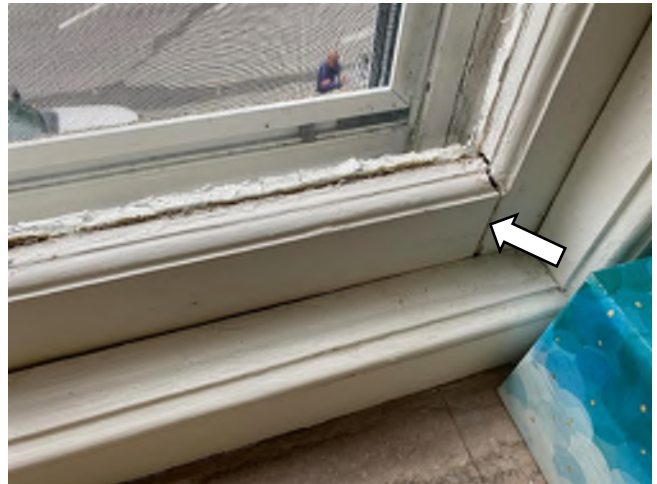
Image 14: The arrow indicates an example of gap opened up between the sash bottom rail and stile.

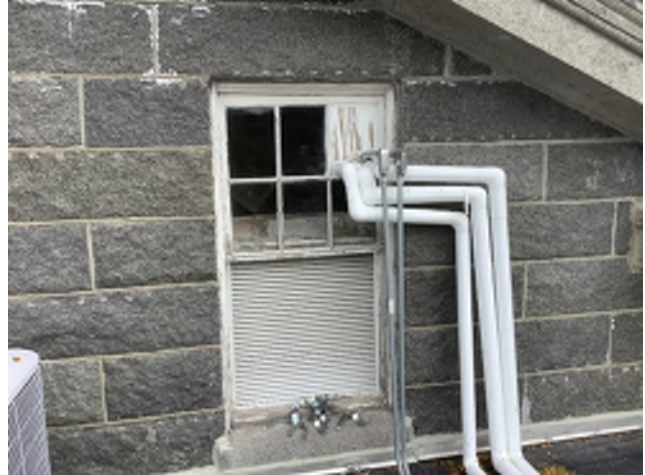
Image 18: View of a window located above the roof line on the South elevation with lower sashed replaced and conduit penetrations.

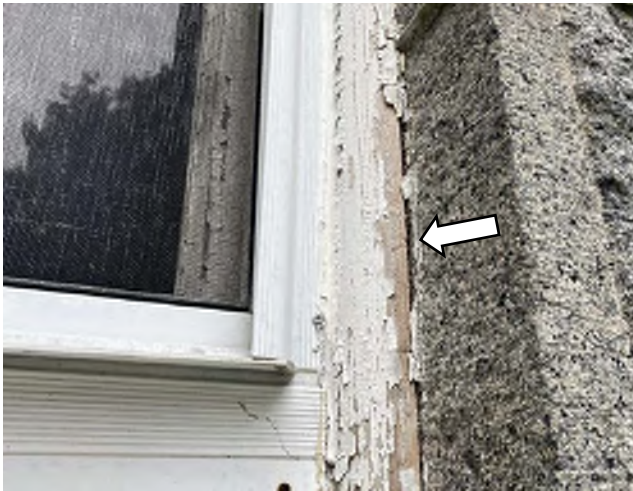
Image 19: Deteriorated cant sealant between wood trim and granite masonry.

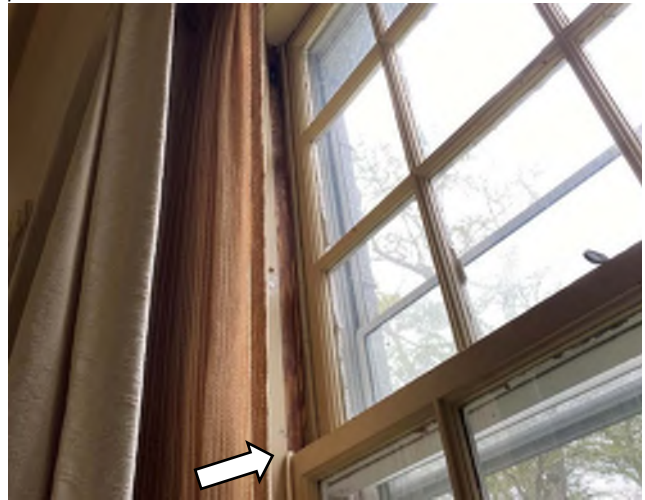
Image 20: View of disconnected upper sash balance.

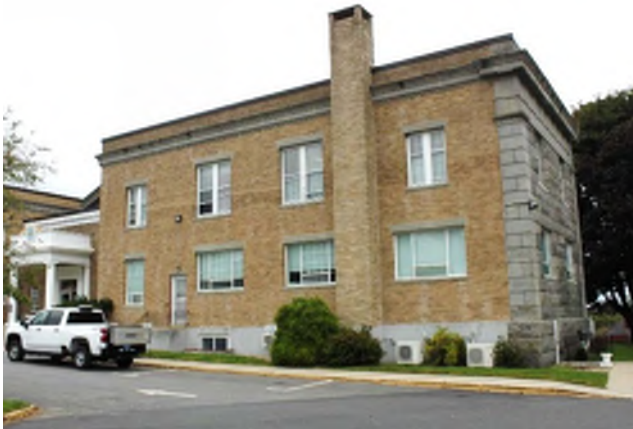
*Image 21: Overall view of the South Elevation of one of the 1925 Addition wings. Wood windows are typically installed on the second floor of these wings.*

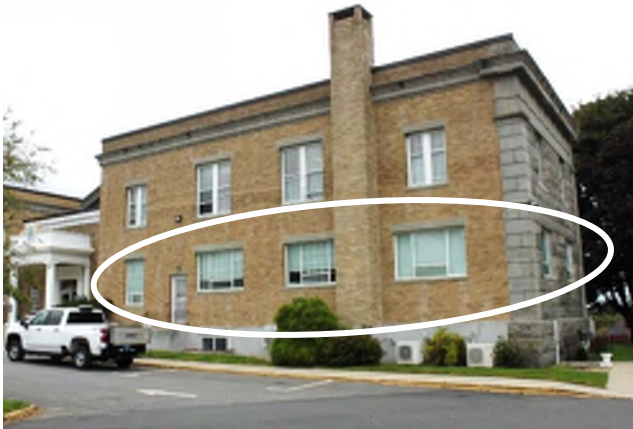
Image 25: Overall view of the South Elevation of one of the 1925 Addition wings. Steel windows are typically installed on the first floor of these wings (circle).

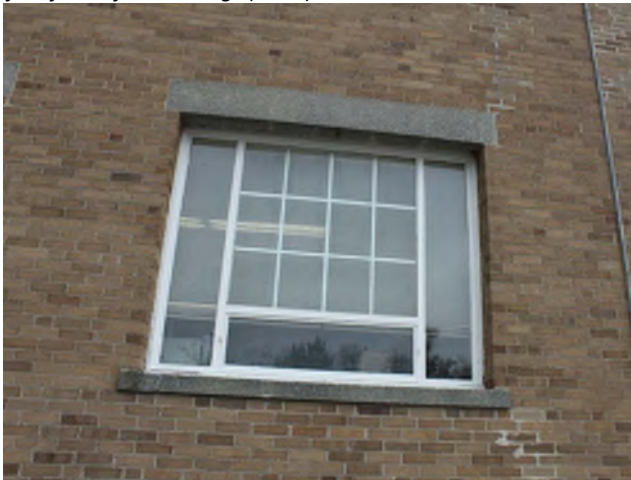
Image 27: Typical large steel window opening, with center hopper unit and fixed lites above and on either side of the hopper unit. Note that the muntins are only installed at the fixed lite above the hopper unit at this location. The insect screen is also missing from this window location.

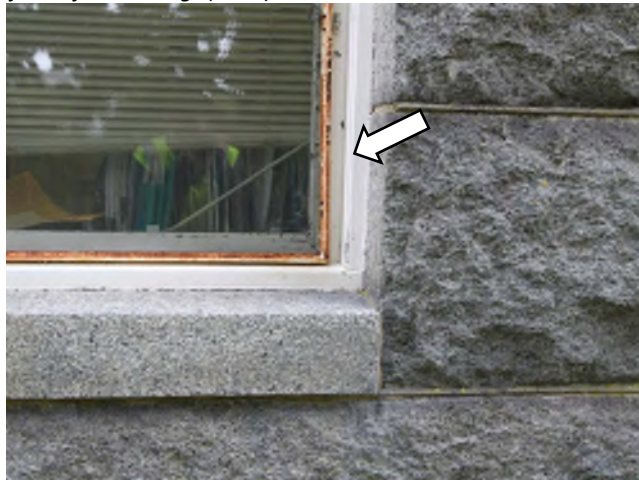
Image 28: The arrow indicates the wood frame within which the steel window frames are set. This wood was generally in fair condition. Also visible is the typical rust visible on the insect screen frames.

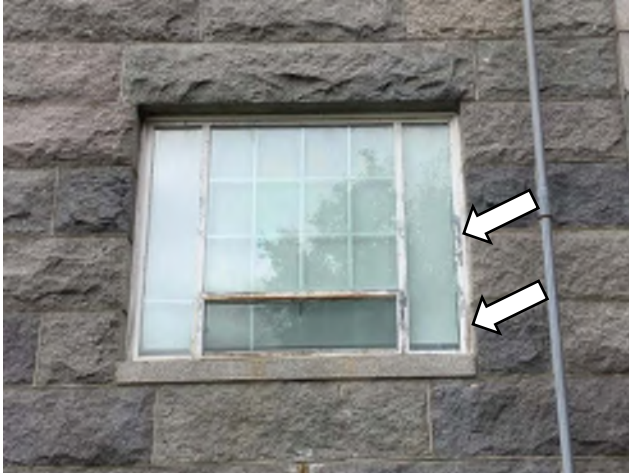
Image 29: Isolated windows exhibited heightened paint defects on the steel frame and wood components (arrows). Rust is also visible on the insect screen at the hopper unit. The hopper unit at this location has one (1) muntin installed, but others appear to be missing or not installed.

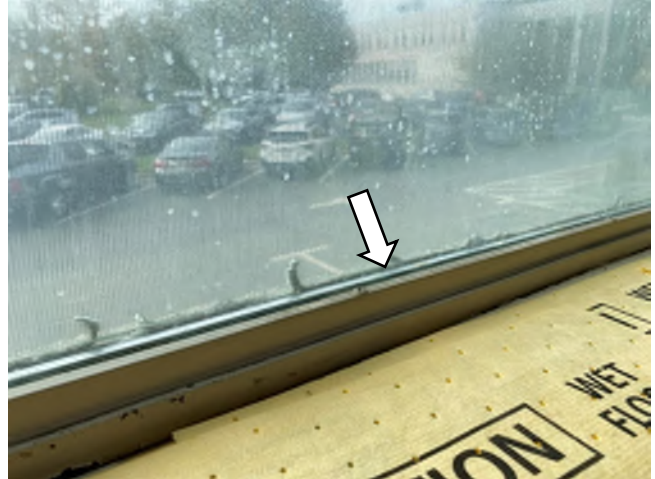
Image 30: The arrow indicates the glazing tape seal that was generally observed to be in poor condition. Also visible is the fogging and staining of IGUs common throughout the 1925 Addition.

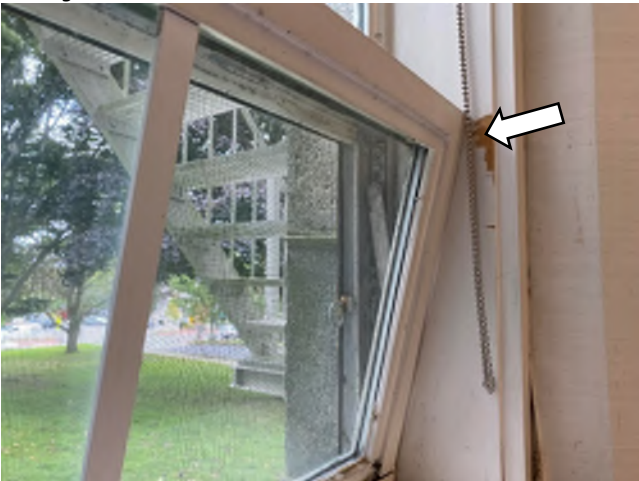
Image 31: The arrow indicates a location where the operable hopper unit sash is rubbing against the wood framing and is eroding the paint layer.

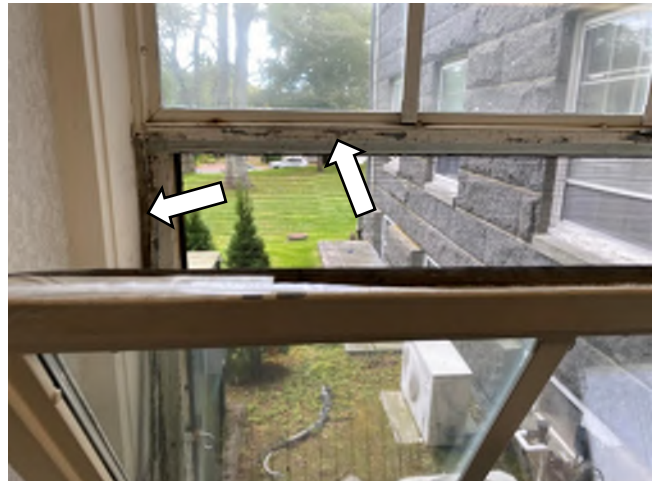
Image 32: The arrow indicates paint defects on the steel window frames common where the hopper sash unit meets the fixed frame.

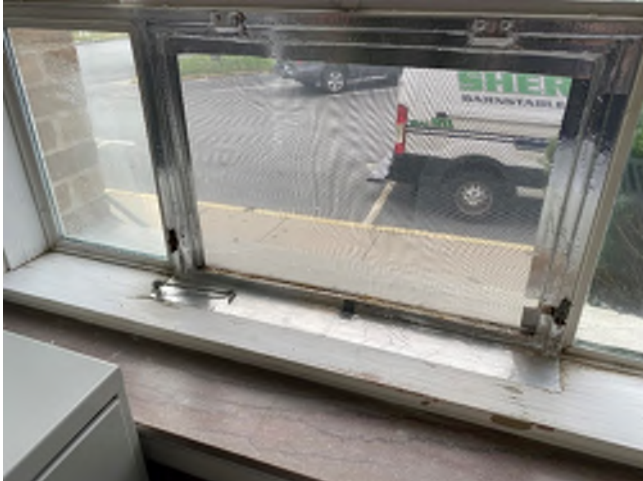
Image 33: At one (1) window location, the hopper unit was taped around its perimeter and the cam handles were missing.

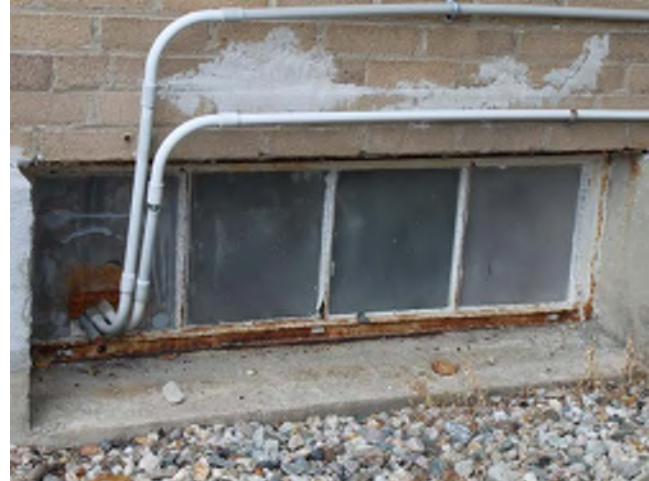
Image 34: The fixed steel window at basement level appears to be experiencing heightened rusting on the frame. This window appears to be of a different construction compared to the typical steel window at the 1925 Addition. Conduit penetrates through one of the glass panes at this location, typical for basement windows in general.

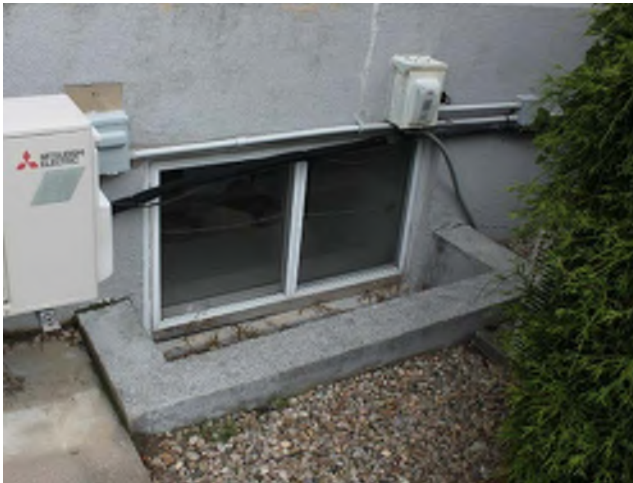
Image 35: Exterior view of a typical basement sliding window

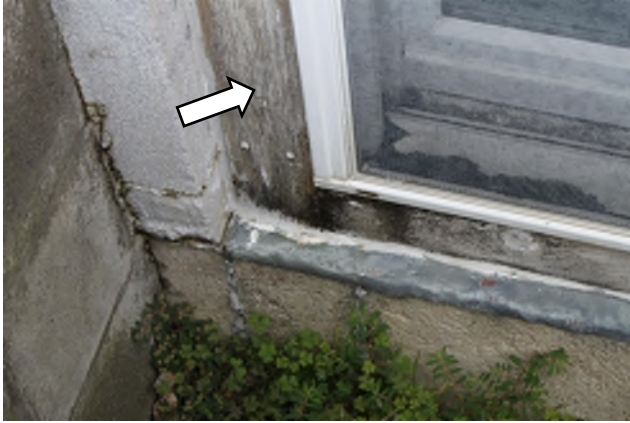
Image 37: The arrow indicates exposed wood blocking at the sliding window units that has lost most of its paint and is showing signs of deterioration.

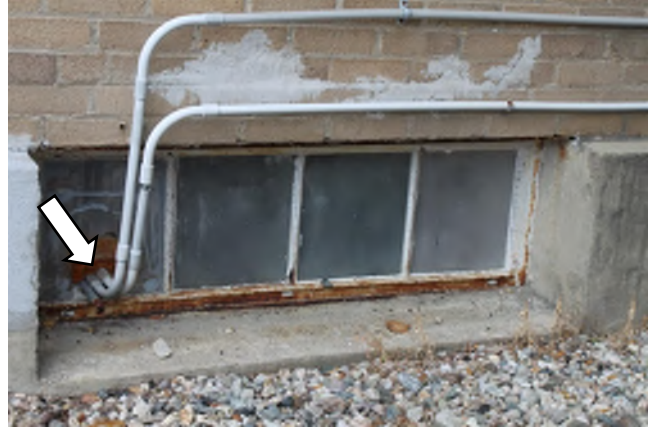
Image 38: Exterior view of the steel basement window. Rust is visible throughout the frame, and the glazing putty is deteriorated. The arrow indicates two (2) conduits installed through a broken pane of glass.

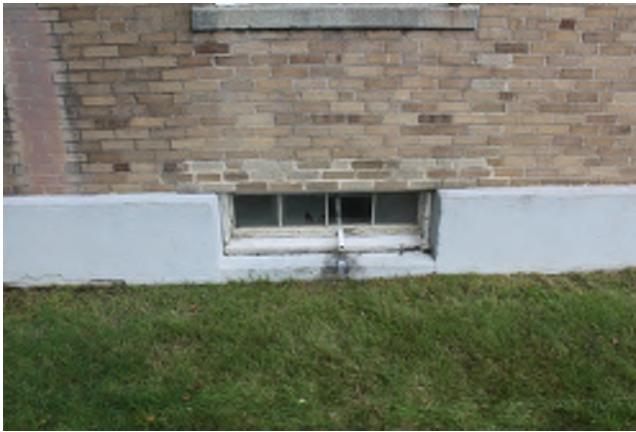
Image 39: Exterior view of one (1) of the wood basement windows.

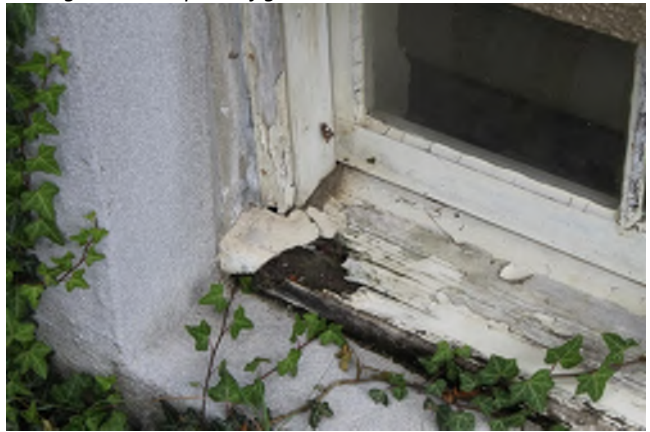
Image 40: The exterior wood components appear to be experiencing heightened deterioration compared to other wood windows on the building.

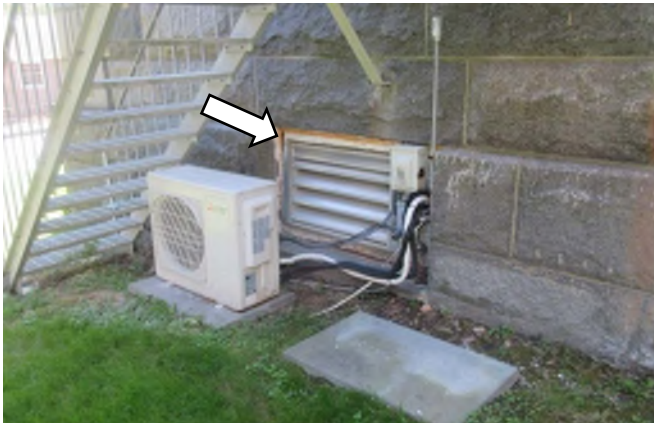
Image 41: Exterior view of the infill panel location on the North Elevation of the East Wing. The arrow indicates a gap that has developed around the displaced infill panel.

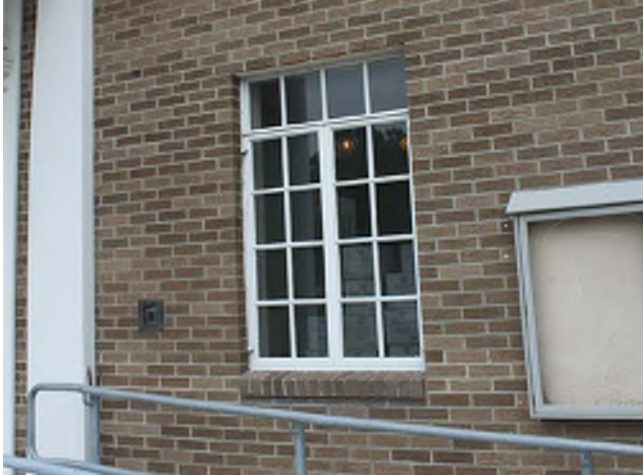
Image 45: Exterior view of a typical 1971 Addition steel window.

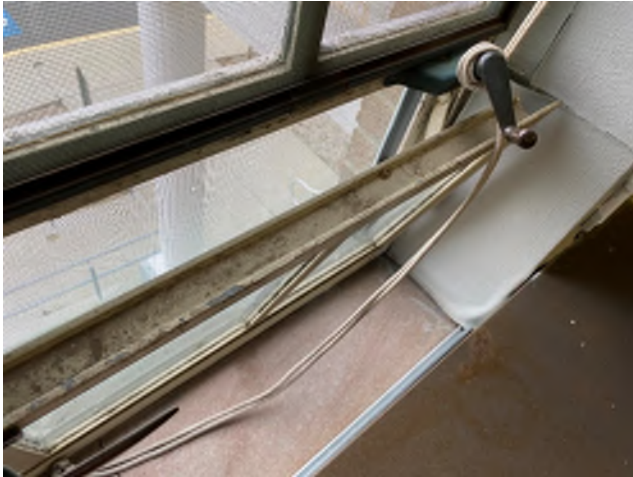
Image 47: Interior view of hopper opening at 1971 steel window. Gale noted a lack of weather stripping.

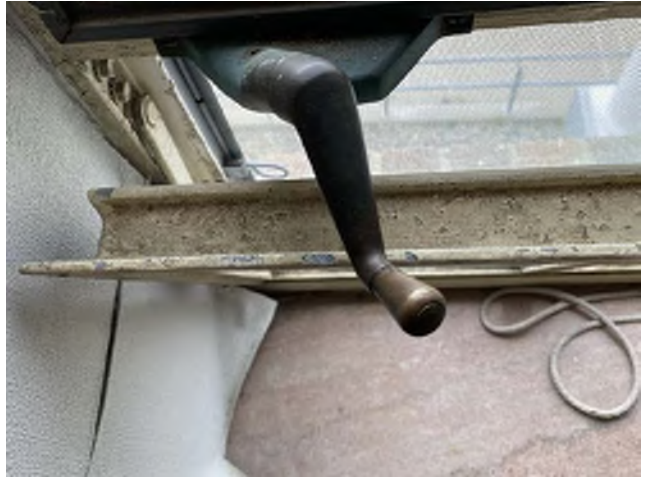
Image 48: Interior view of hopper opening at 1971 steel window. Gale observed peeling paint.

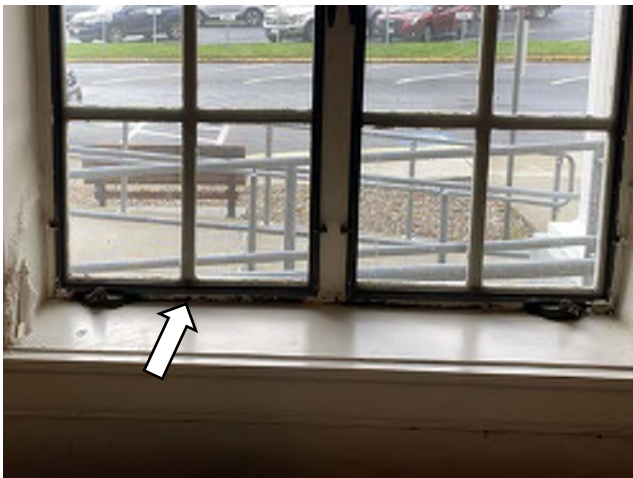
Image 49: Interior view of peeling paint below window.

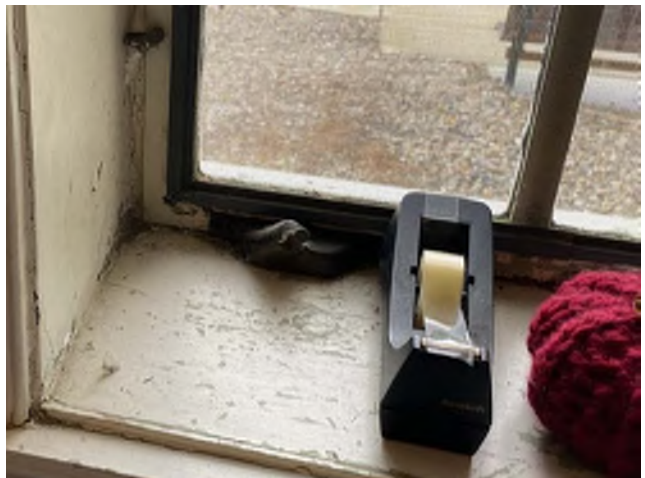
Image 50: View of broken crank at 1971 steel window.

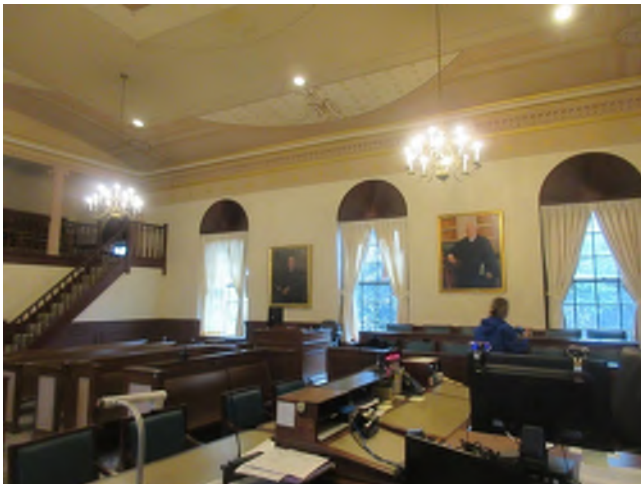
Image 51: Overall view of the 1832 Courtroom space.

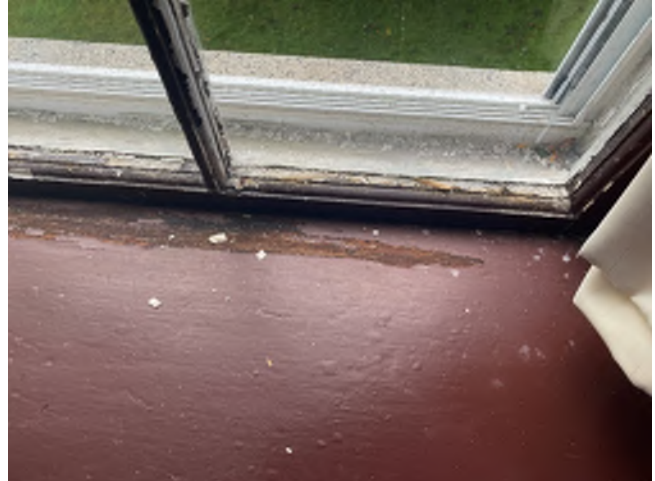
Image 54: Interior painted wood finishes within this space appear to be in worse condition compared to elsewhere on the building.

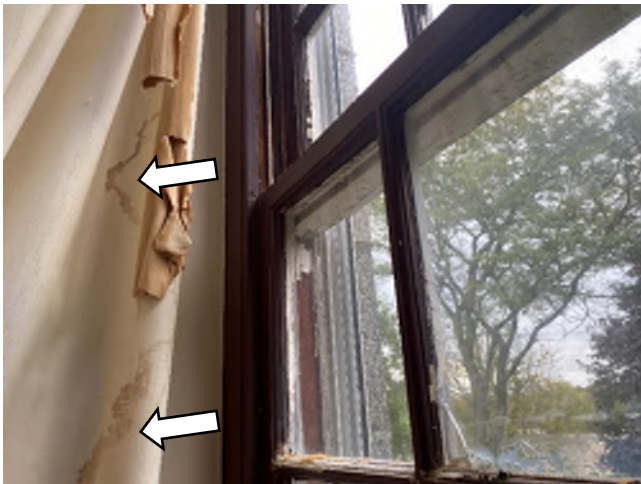
Image 55: The arrow indicates staining on the drapes observed at one (1) window location.

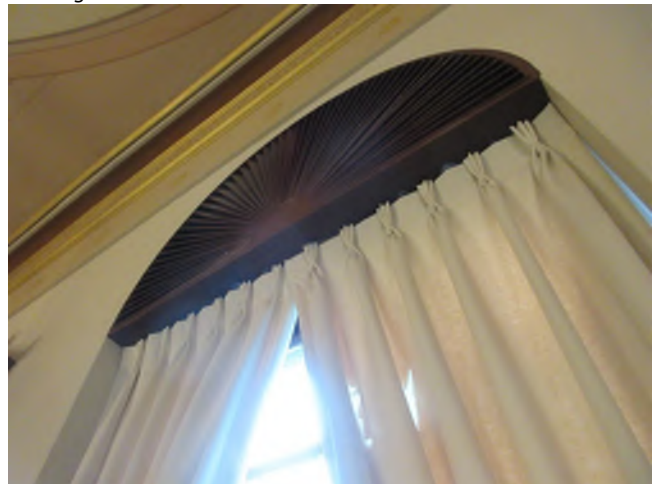
Image 56: View of the typical fan-like arched wood transom and drapes at each window within this space.

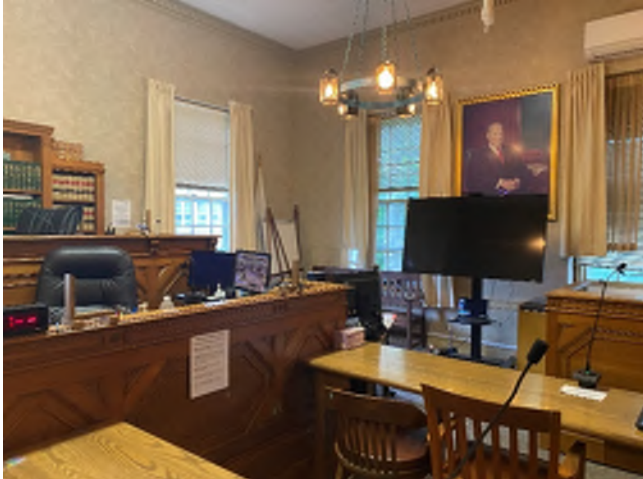
Image 57: View of the Second Session Courtroom space.

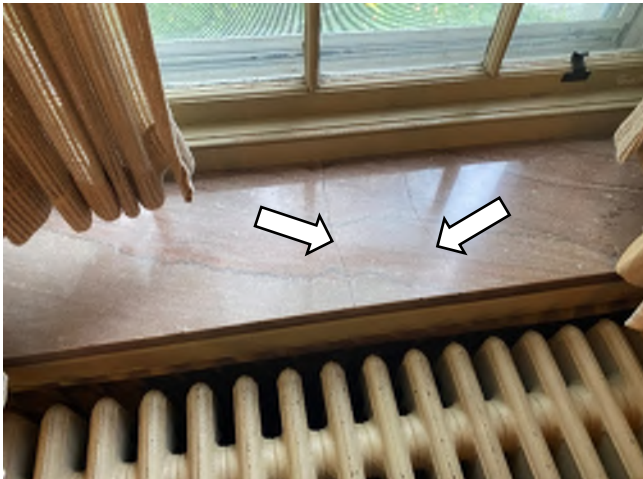
Image 59: The arrows indicate cracks observed in one (1) of the marble stools.

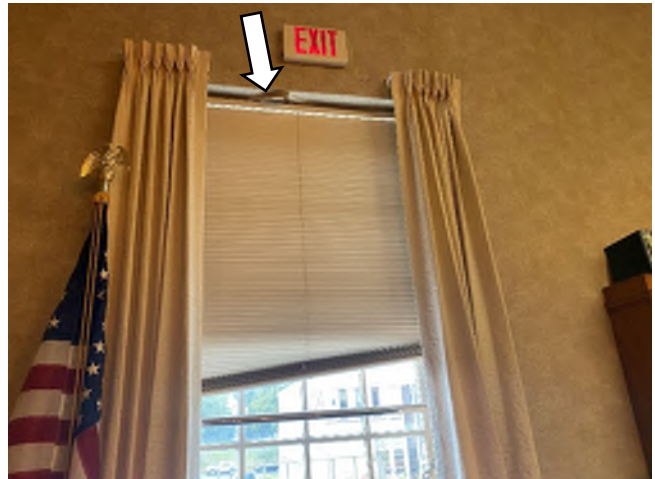
Image 60: The arrow indicates a location of peeling wallpaper.

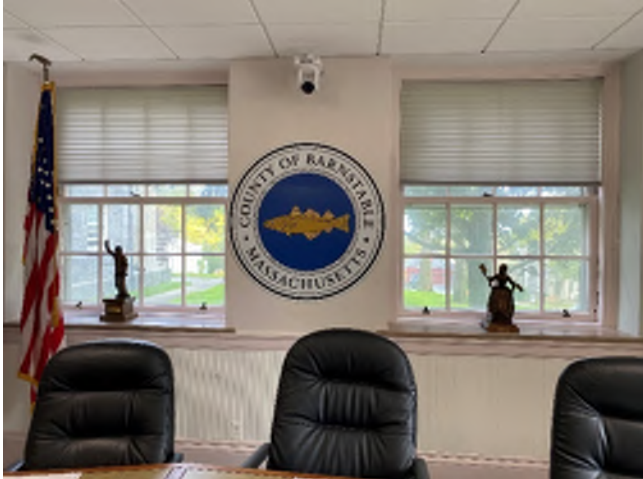
Image 61: View of interior finishes at the windows within the meeting room.

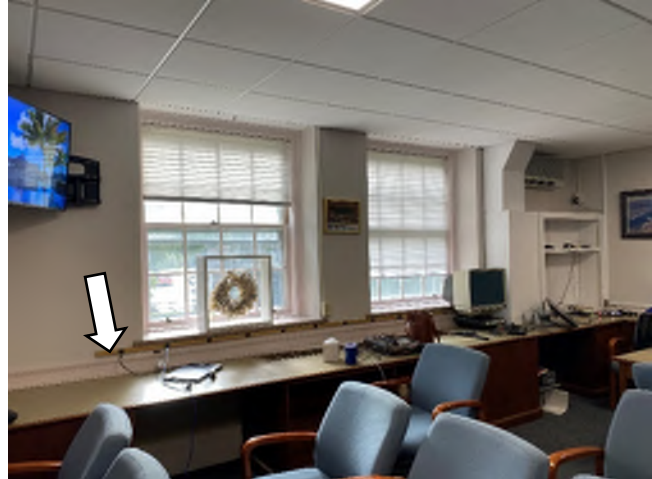
Image 62: View of the built-in desk/countertop installed in front of the windows. The arrow indicates a power strip installed immediately below the windows.

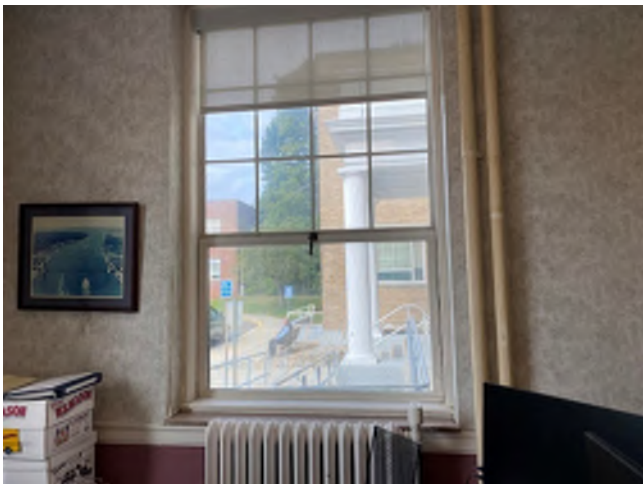
Image 63: View of a typical window opening within this space.

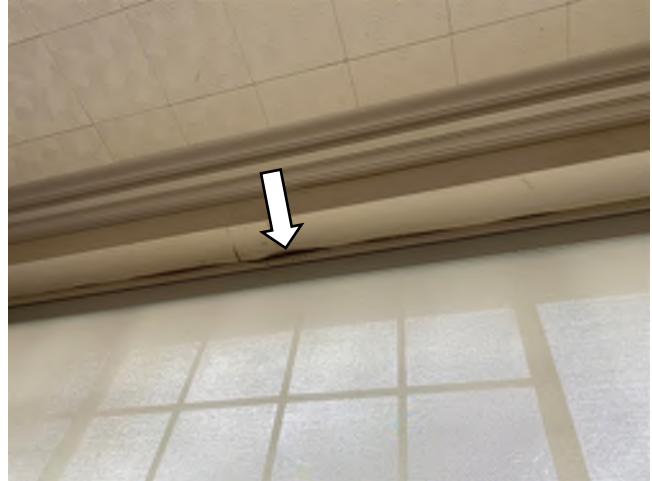
Image 66: The arrow indicates peeling wallpaper observed adjacent to a window head.

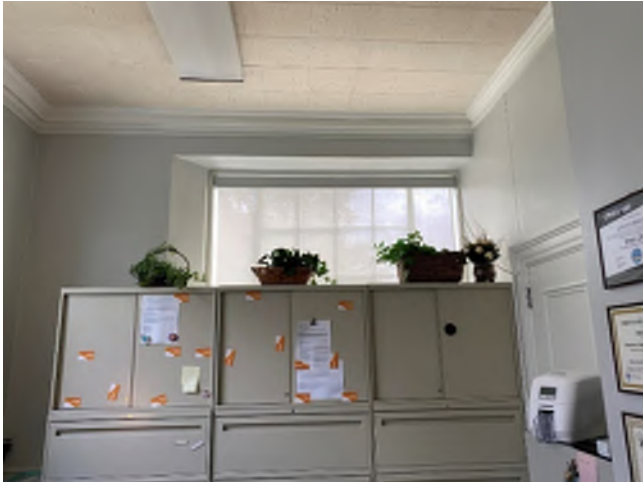
Image 67: Within one (1) of the offices, large filing cabinets block access to the window.

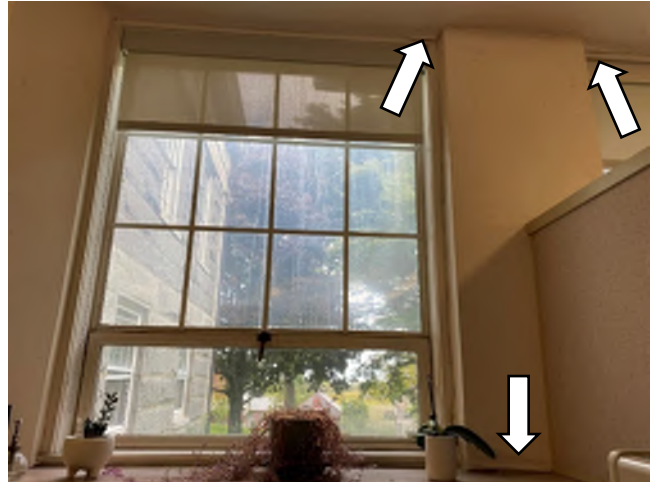
Image 68: The arrows indicate additional examples of peeling wallpaper adjacent to the windows.

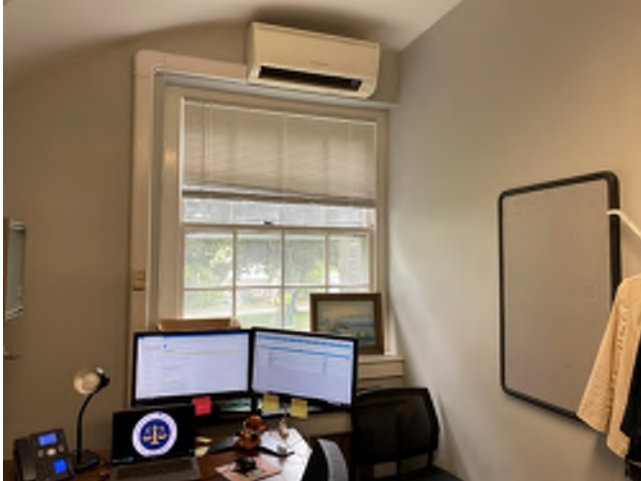
Image 69: An example of window opening within the 1832 first floor offices. A mini-split distributor unit and condenser lines are installed immediately above and next to the window opening. Non-fixed desk furniture is installed immediately in front of the opening.

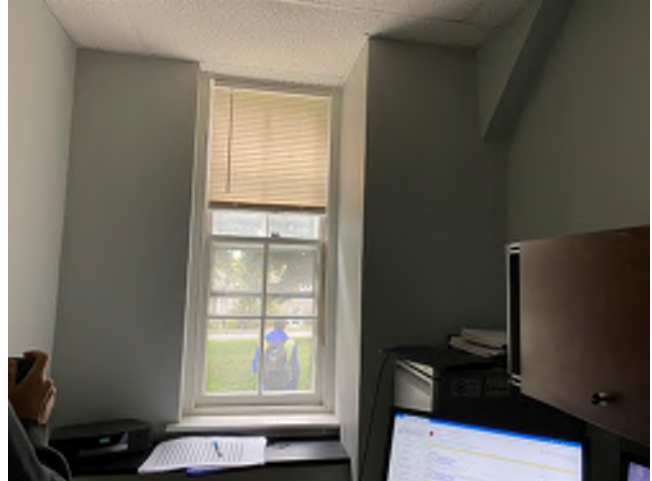
Image 70: An additional example of a window opening within the 1832 first floor offices.

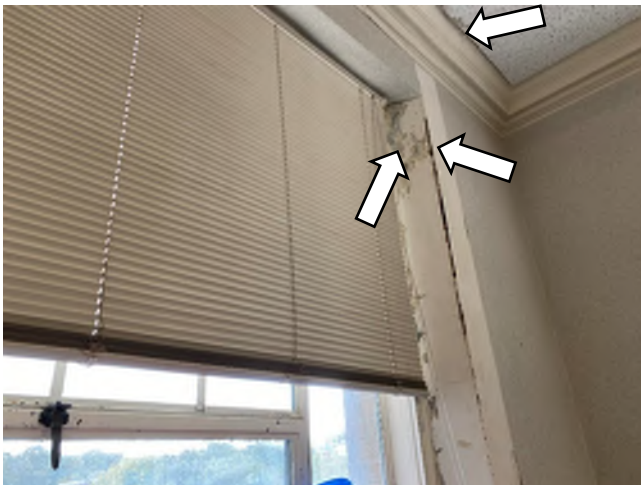
Image 71: One (1) window location exhibited potential previous water infiltration with apparent staining on the ceiling and window jamb, as well as previous wood repairs (arrows).

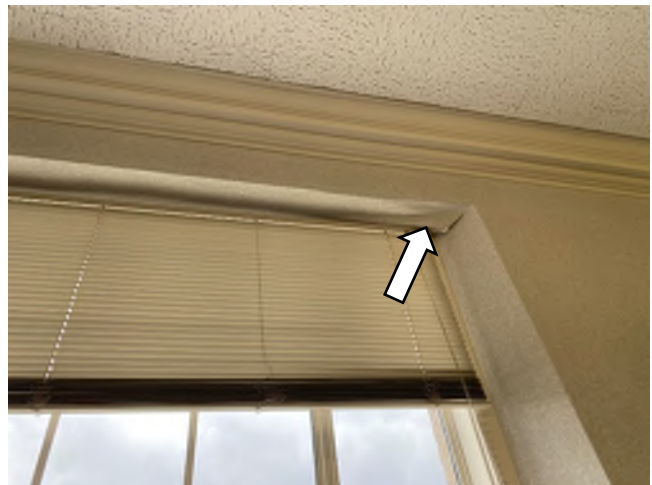
Image 72: An example of peeling wallpaper at a window head.

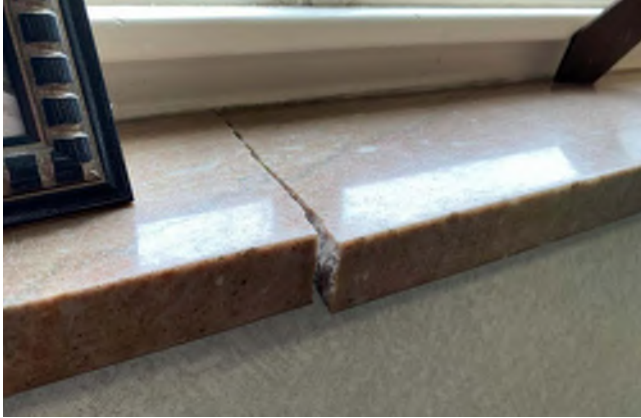
Image 73: An example of a cracked marble stool.

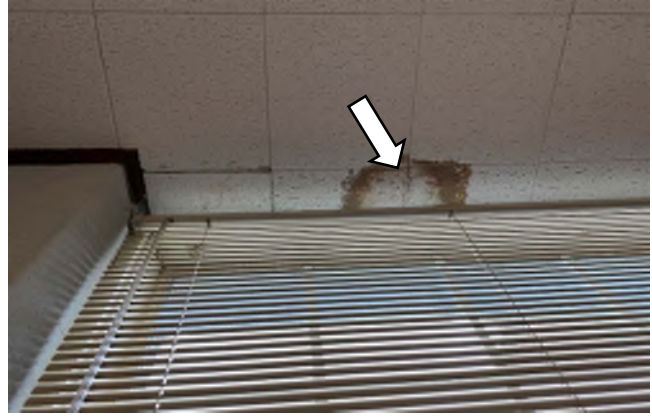
Image 74: Staining was observed on the ceiling at one (1) location in this area. The spline ceiling is installed into the window opening at this location.

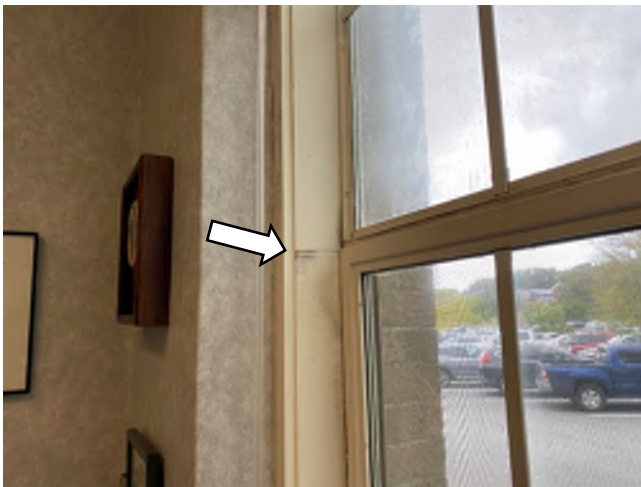
Image 75: An example of paint abrasion due to the hopper window sash rubbing against the jambs.

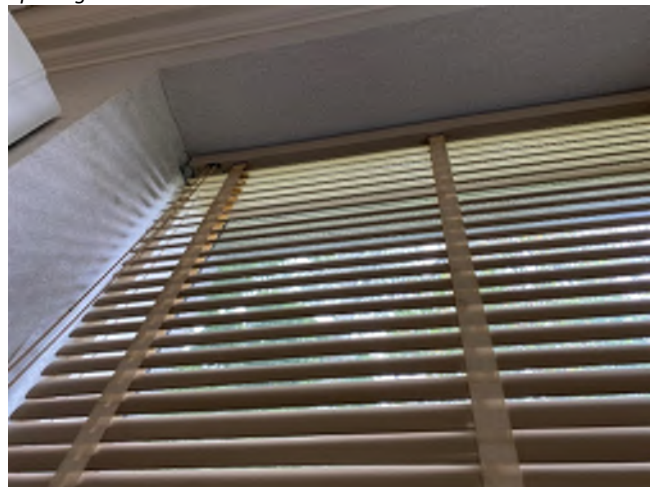
Image 76: The windows within this space utilize blinds with larger slats compared to other spaces. These blinds were difficult to operate.

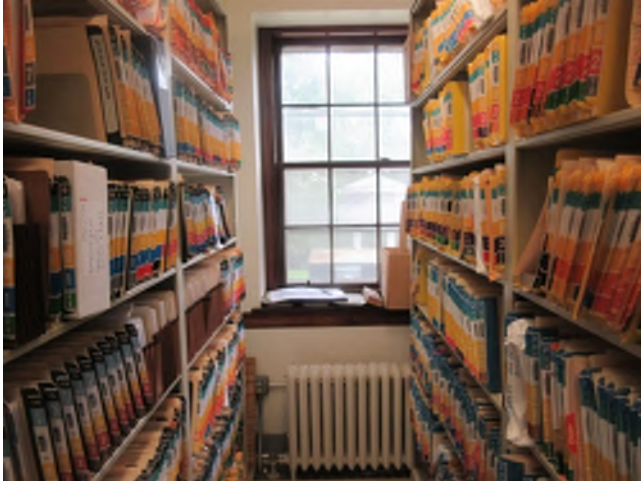
Image 77: View of the window within the stacks room.

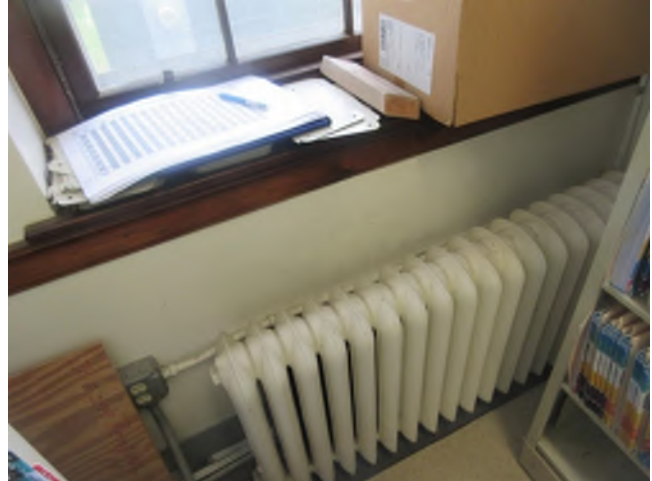
Image 78: View of the window sill within the stacks room.

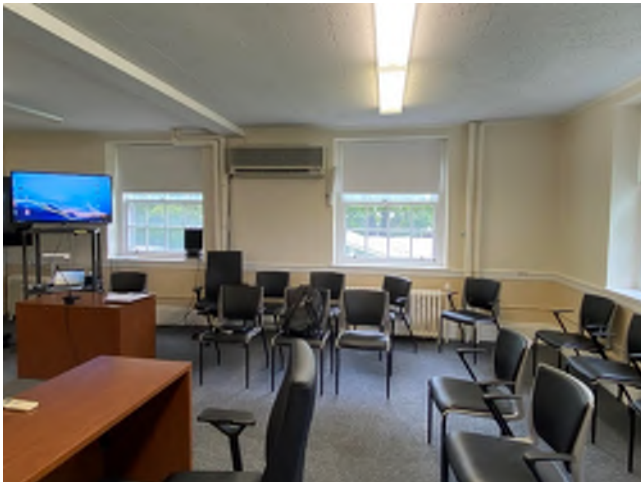
Image 79: Overall view of the Third Session Courtroom.

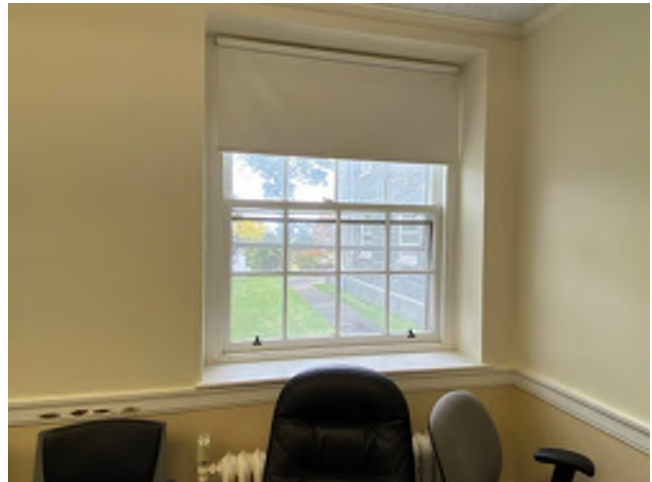
Image 80: View of a typical window within the Third Session Courtroom.

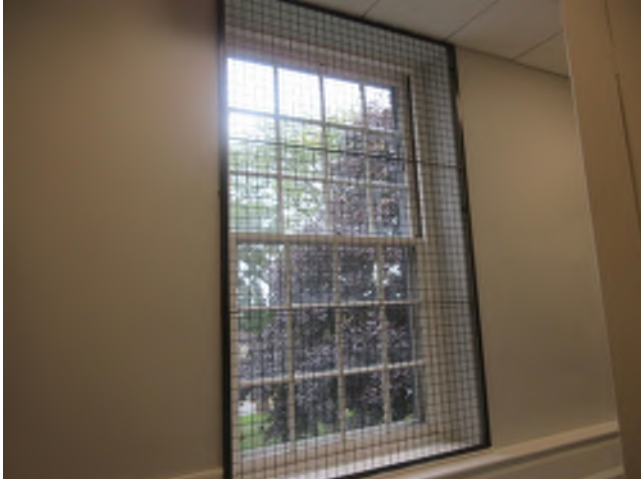
Image 81: View of a typical window within the lock-up area. Interior security screens are installed at the windows within this space.

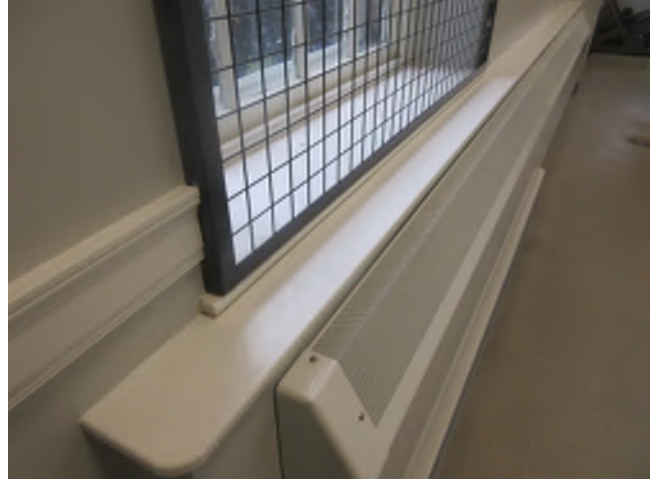
Image 82: Newer radiation equipment and wall build-out has been installed below the windows in this space.

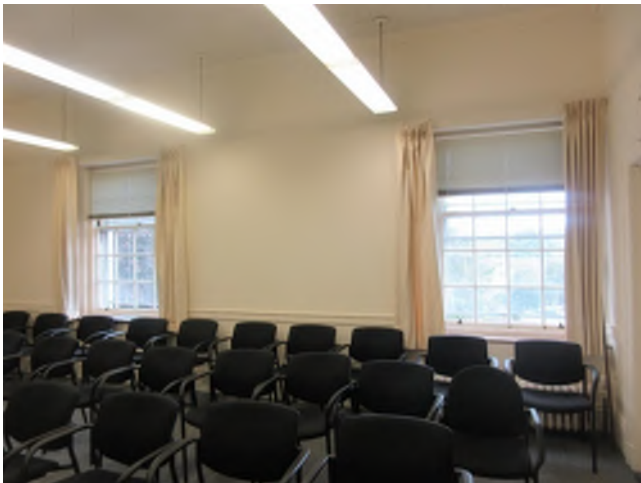
Image 83: View of the jury selection room.

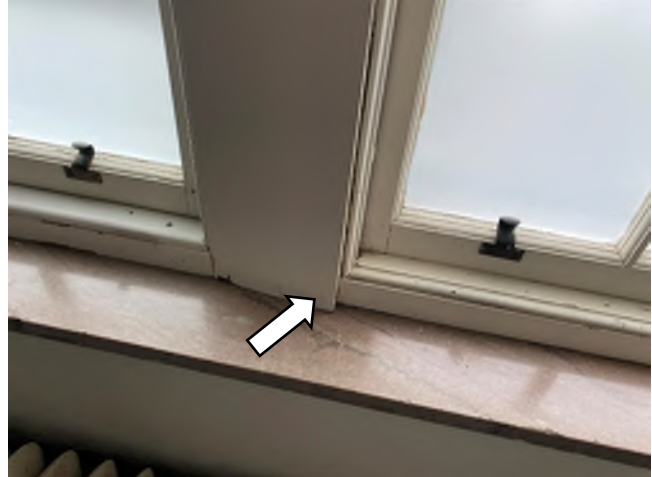
Image 86: The arrow indicates wood trim at the vertical mullion that is warped and displaced.

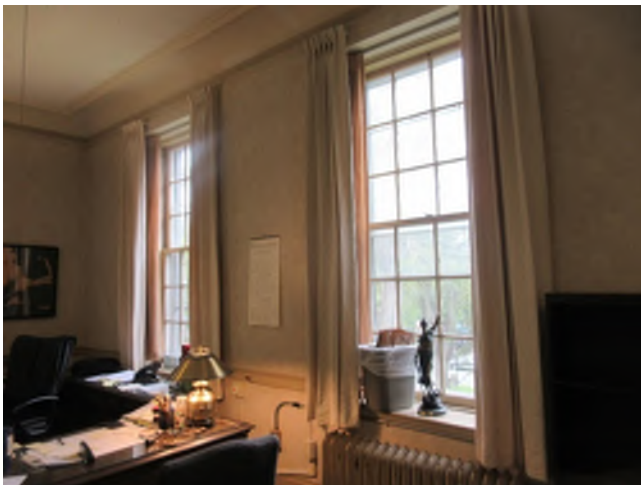
Image 87: View within the Judge's Chamber for the 1832 Courtroom.

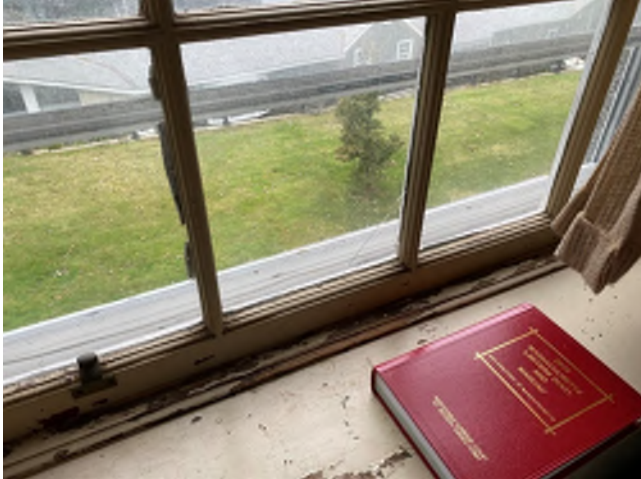
Image 89: Deterioration of interior painted surfaces was noted at multiple openings within this space.

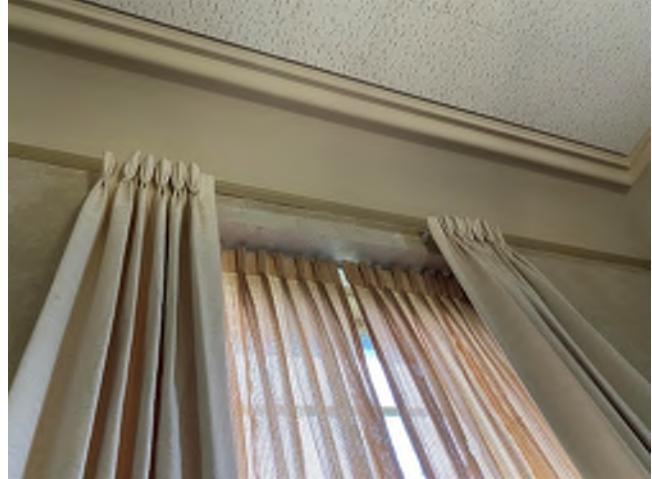
Image 90: Peeling wallpaper was generally noted at the top of the wall around the perimeter of the room.

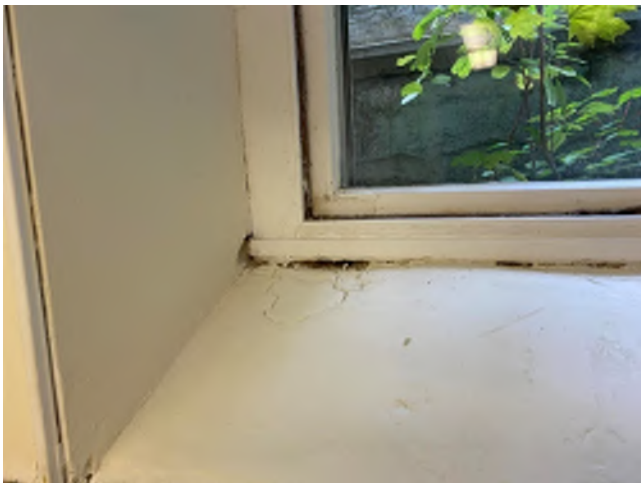
Image 91: Example of damaged plaster at the sloped window sill in basement.
