**Restoration of the  
Barnstable County Superior  
Courthouse  
3195 Main Street  
Barnstable, MA 02630**

**Gale JN 843680  
May 9, 2025**

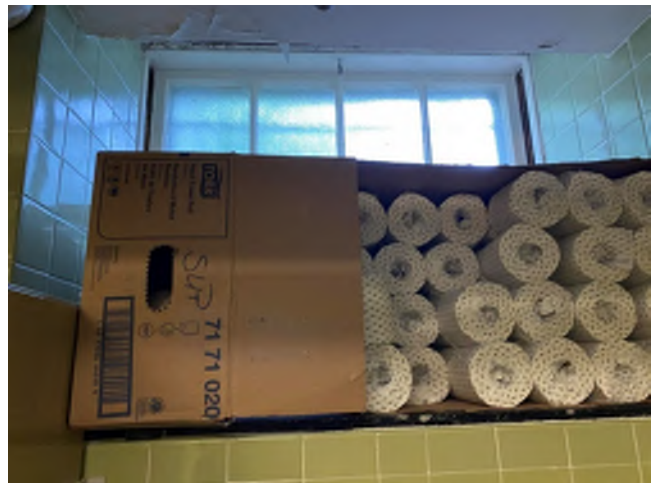
Image 92: View of one (1) of the basement bathroom windows with items stored in front of it.

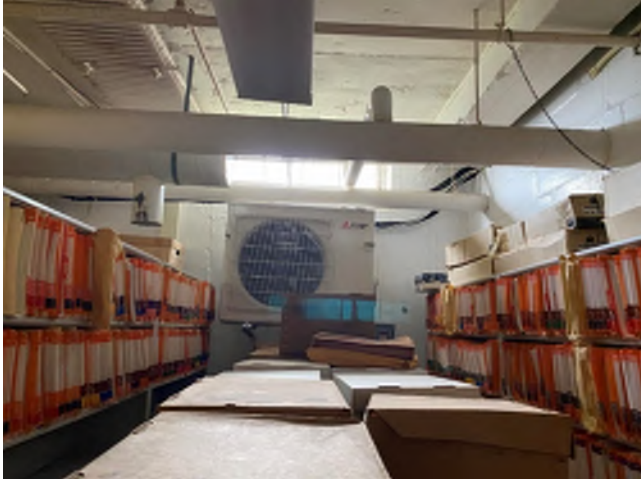
Image 93: View of the storage area in the basement. A split system and multiple shelving units were observed to be installed below one (1) window in this space.

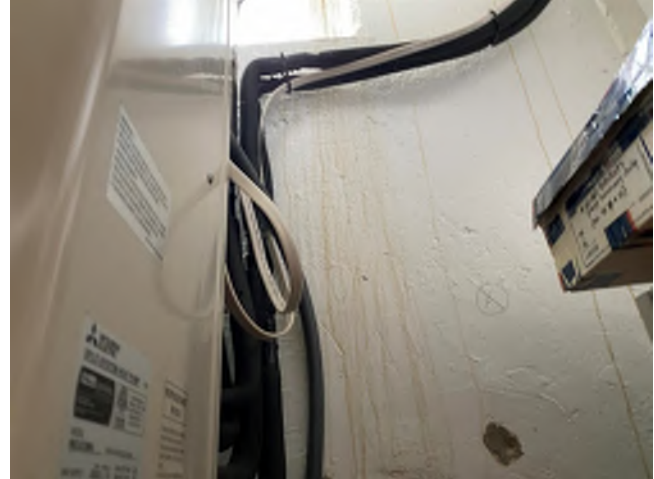
Image 94: Water streaking was evident below isolated window locations in the basement.

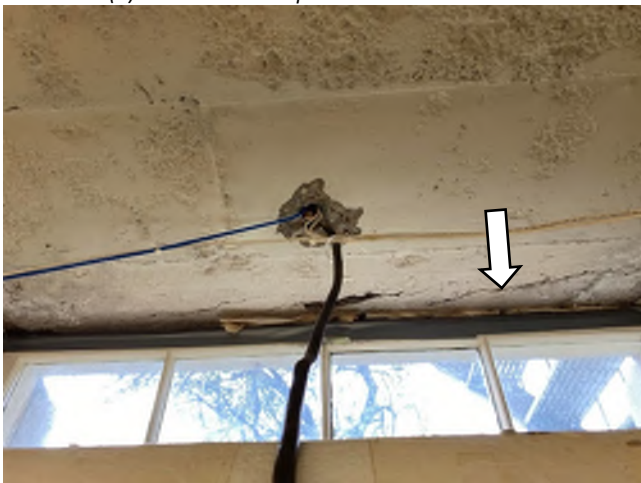
Image 95: The arrow indicates cracking was observed in the concrete floor slab at one (1) of the basement window locations.

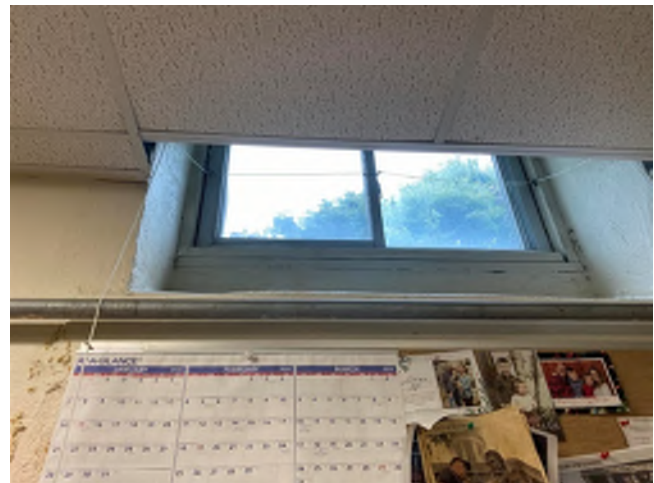
Image 96: Newer aluminum sliding windows within the facilities office are installed above the suspended ceiling level.

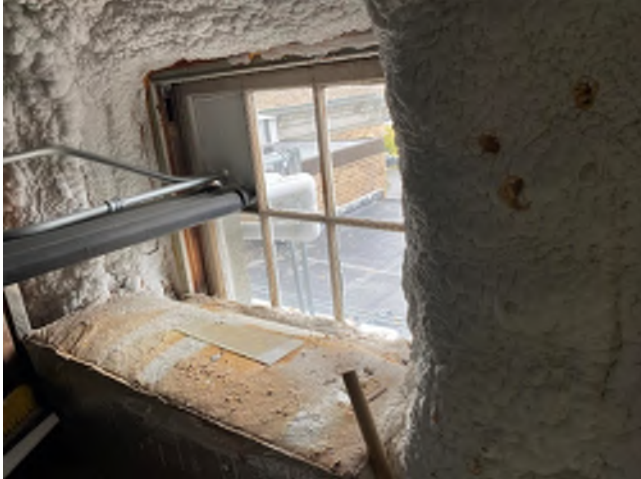
Image 97: Interior view of one (1) of the attic windows, with spray foam installed into the window opening returns.

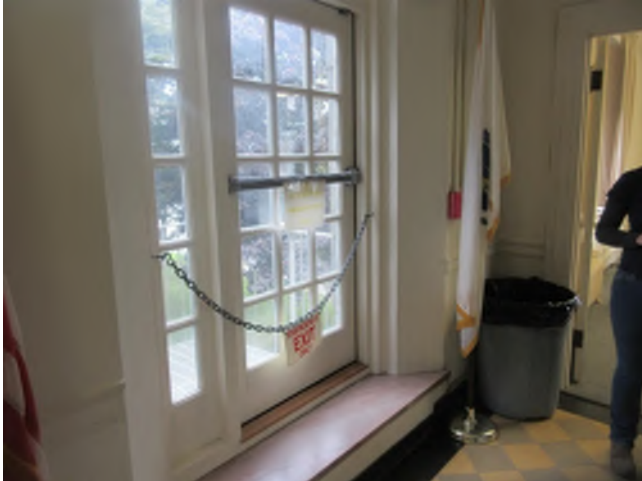
Image 99: Interior view of Door 1.

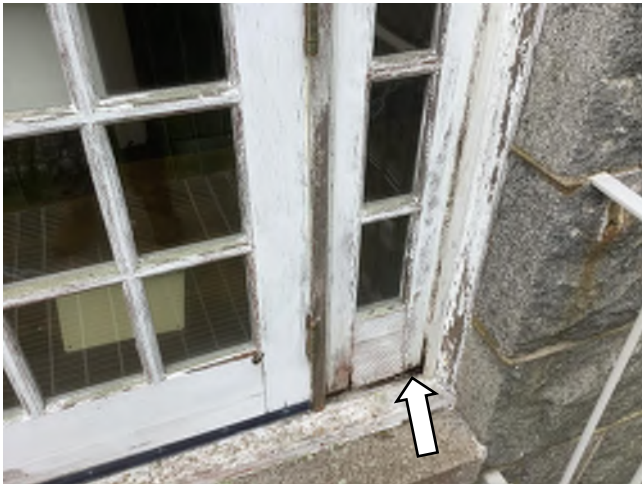
Image 101: Exterior surfaces of the door are experiencing widespread paint deterioration. The arrow indicates visibly warped and decayed wood at the side lite panel.

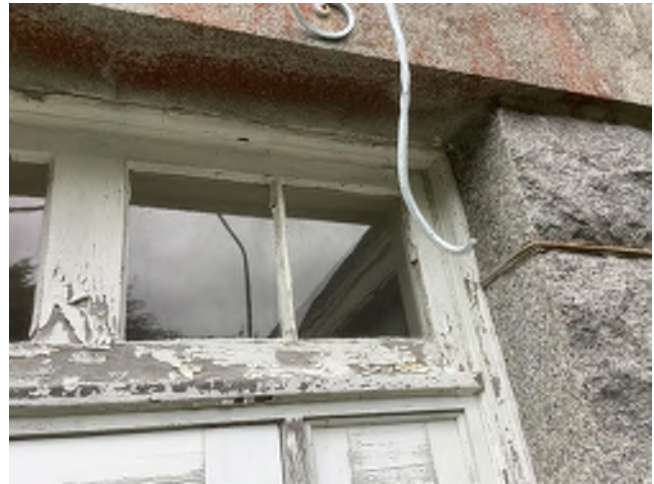
Image 102: The transom utilizes glazing putty to seal the glass and is generally poor condition.

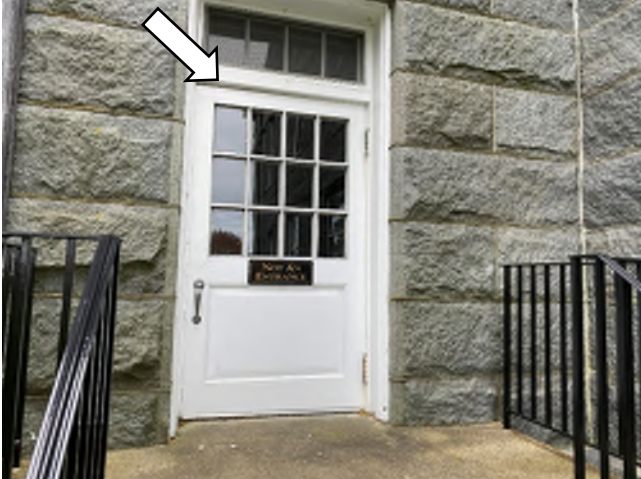
Image 103: Exterior view of Door 2. The arrow indicates a gap observed between the door and frame when the door is in the closed position.

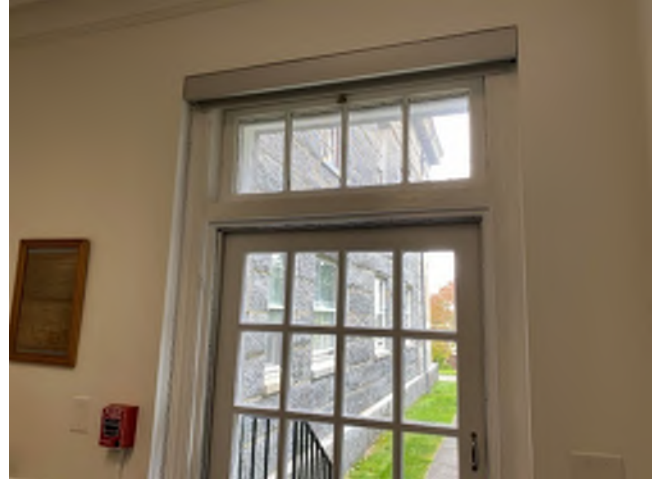
Image 104: Interior view of Door 2 and transom.

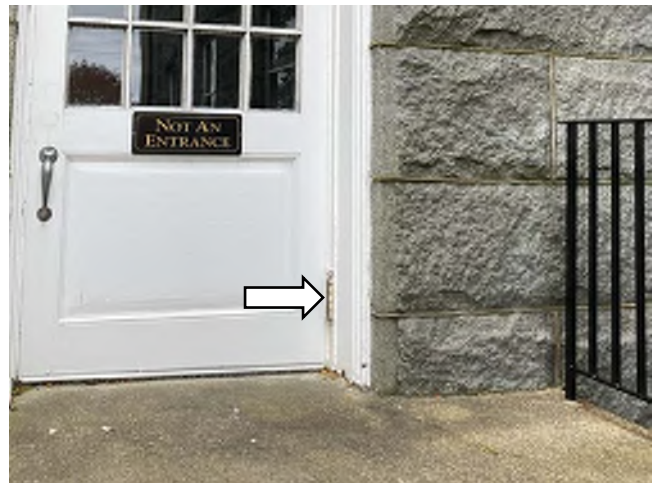
Image 106: The arrow indicates a rusted hinge.

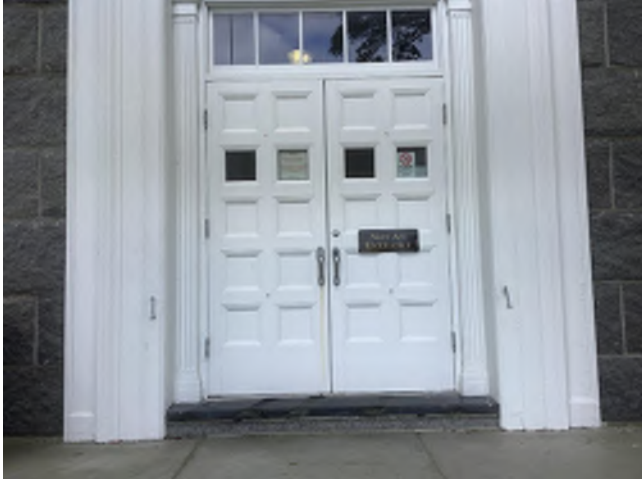
Image 107: Exterior view of Door 3. The arrow indicates a gap observed between the door and frame when the door is in the closed position.

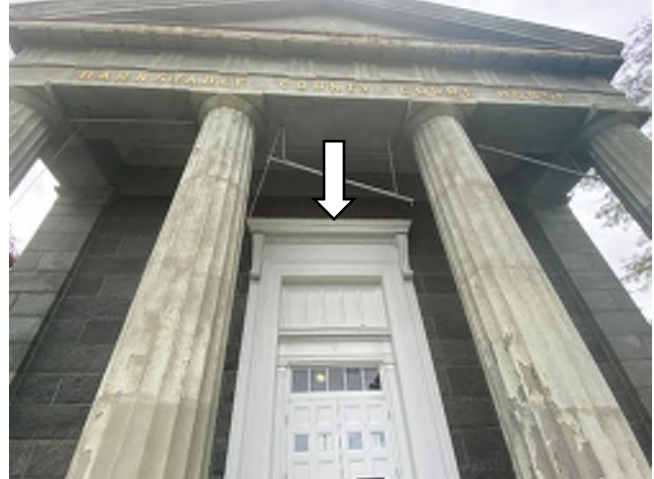
Image 108: Exterior view of ornamentation above the door. The arrow indicates rust staining emanating from the bird screen above the door.

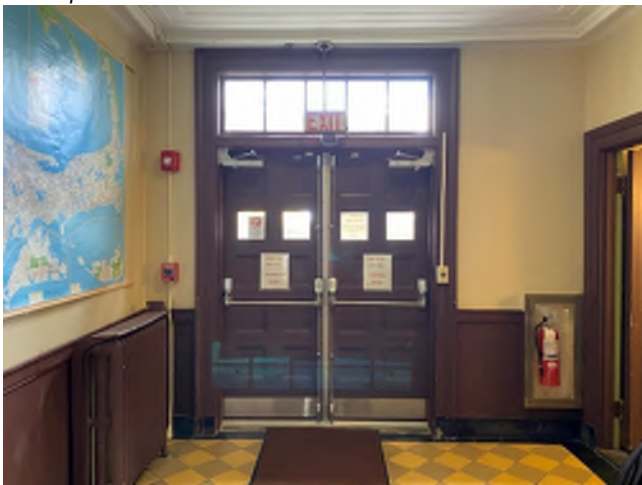
Image 109: Interior view of the Door 2 threshold.

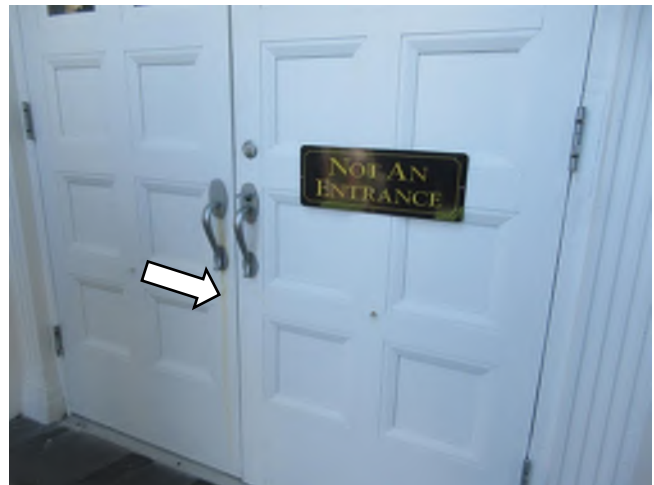
Image 110: The arrow staining emanating from the exterior door hardware.

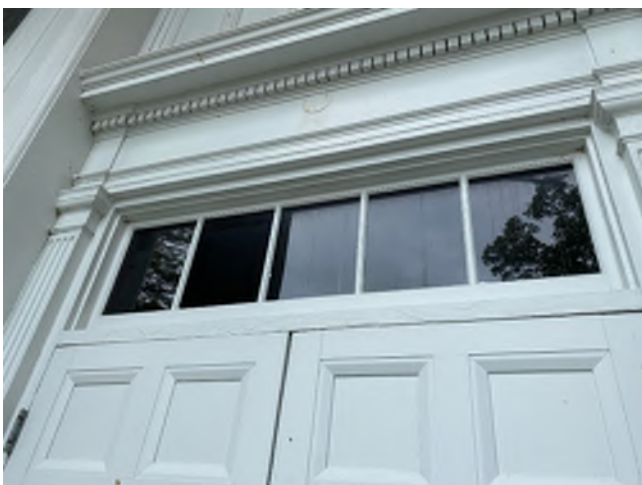
Image 111: Detail view of the door transom.

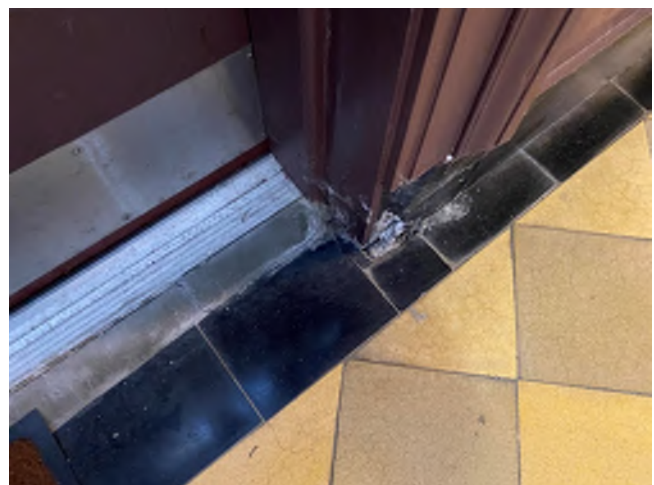
Image 112: The arrow staining emanating from the exterior door hardware.

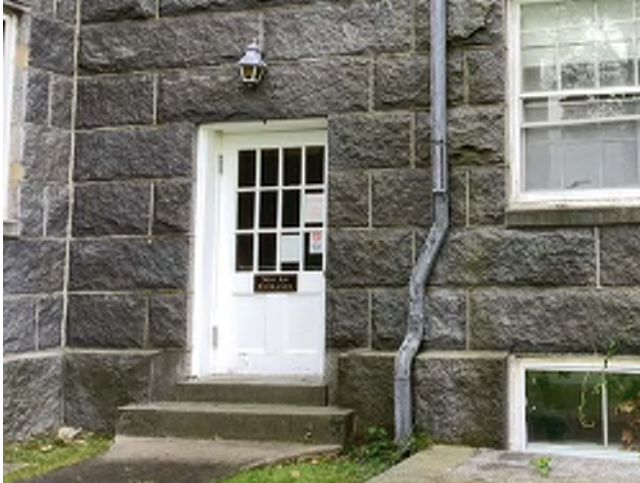
Image 113: Exterior view of Door 4.

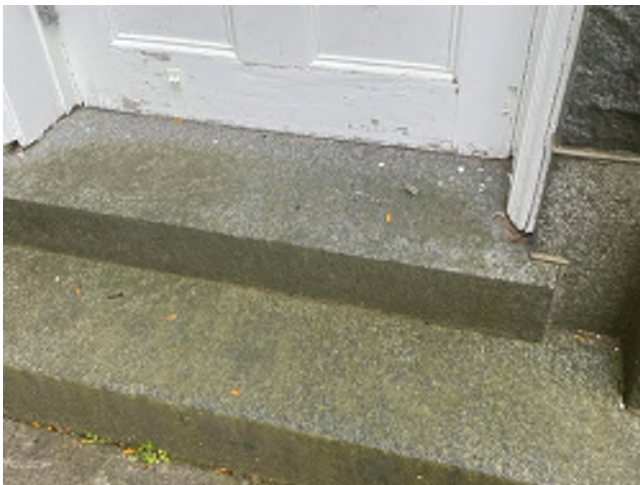
Image 115: Interior view of the Door 2 threshold. No door sweeps or raised threshold are installed. Painted surfaces near the threshold level were observed to be weathered.

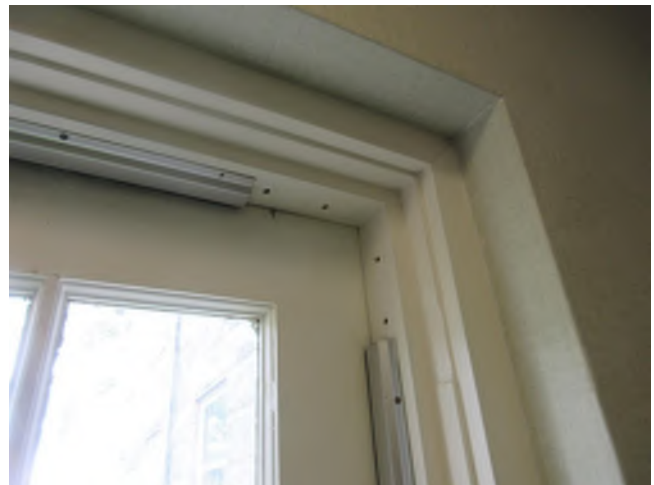
Image 116: Weatherstripping is discontinuous at the head and jamb.

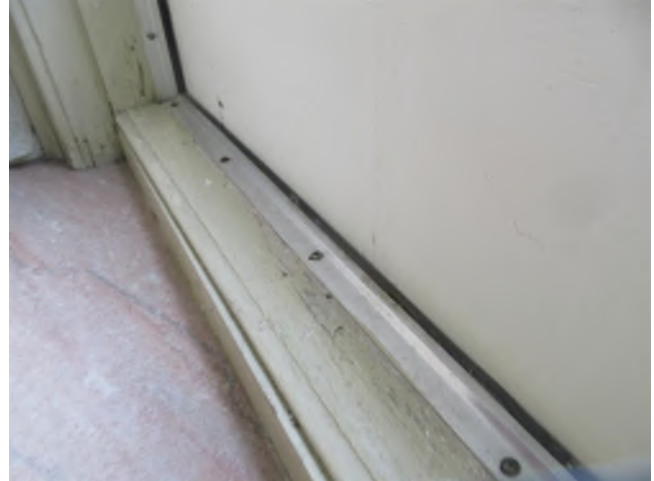
Image 122: Weathered paint was observed on the interior wood surfaces near the threshold level.

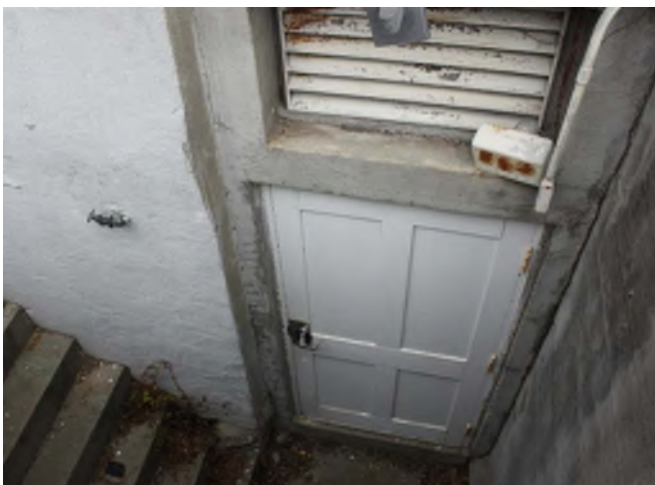
Image 123: Exterior view of Door 7 with louver above.

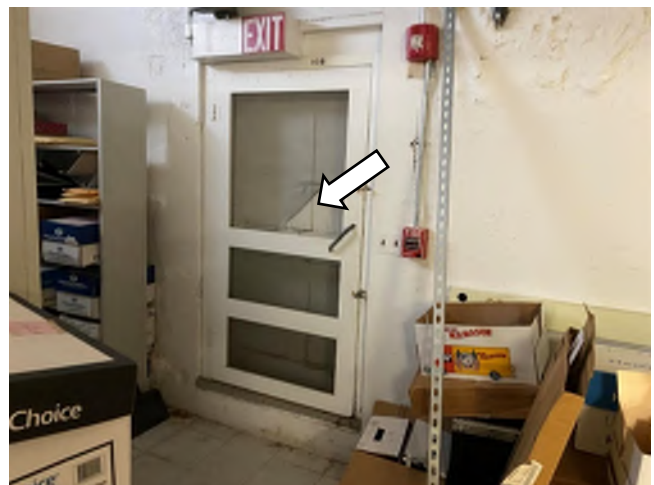
Image 124: Interior view of Door 7 and interior screen door. The arrow indicates damage to the screen.

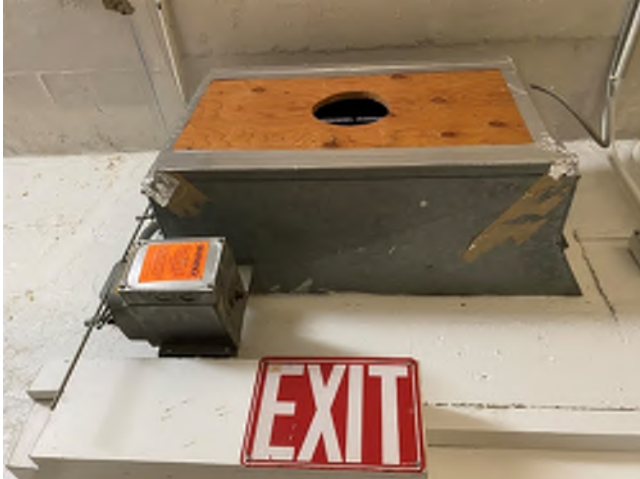
Image 125: The louver above the door appears to be connected to abandoned ductwork.

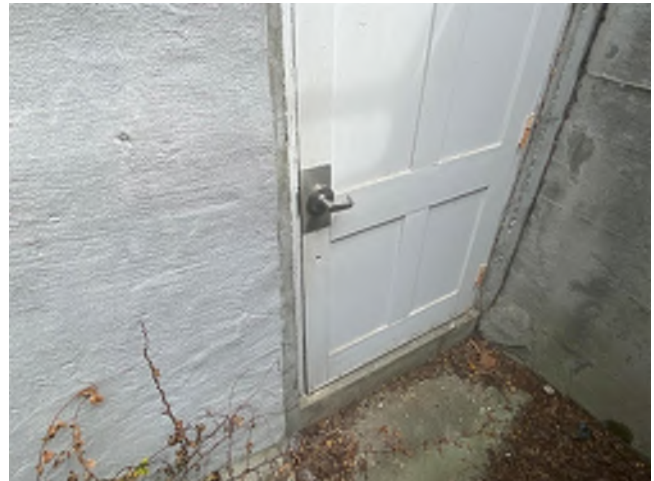
Image 128: Exterior view of Door 7 and threshold. The door threshold is raised above the interior floor and exterior landing levels.

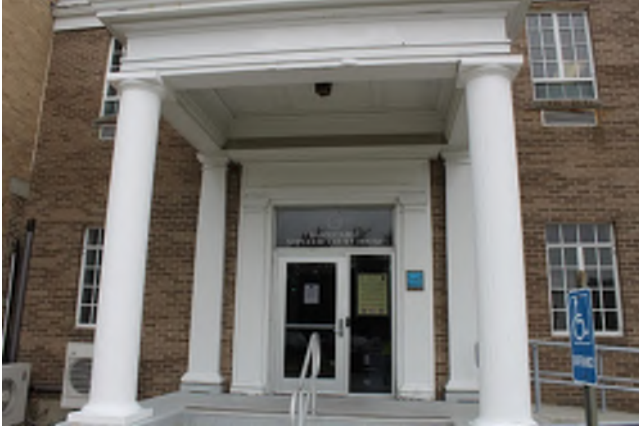
Image 129: Exterior view of Door 8 and associated portico.

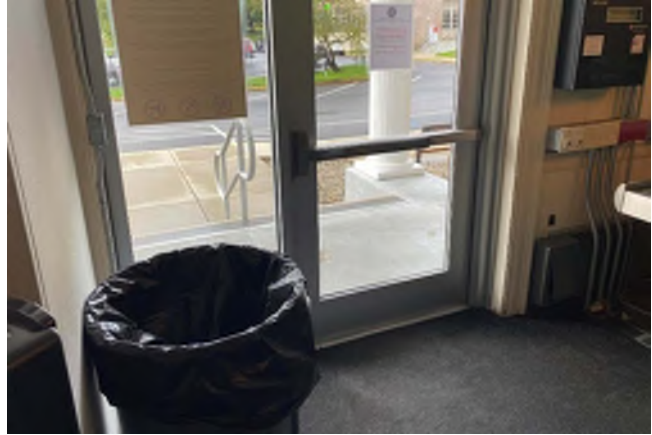
Image 130: Interior view of Door 8.

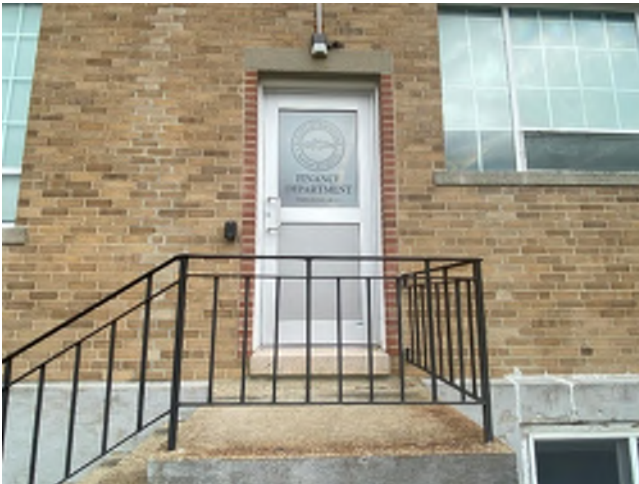
Image 131: Exterior view of Door 9 and associated portico.

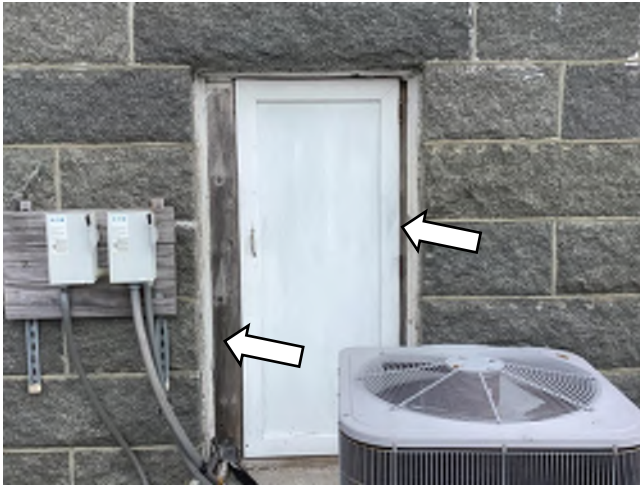
Image 133: Exterior view of Door 10 and associated portico. The arrows indicate exposed wood blocking that is exhibiting severe weathering.

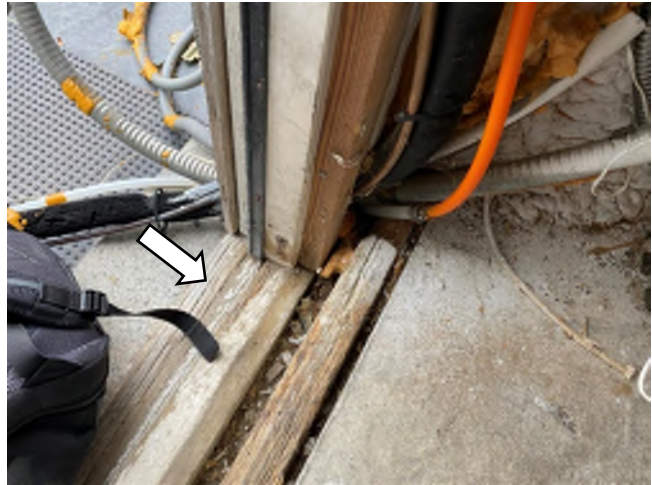
Image 134: Interior view of Door 10 and threshold. The arrow indicates the wood sill that is weatherchecked and deteriorated.

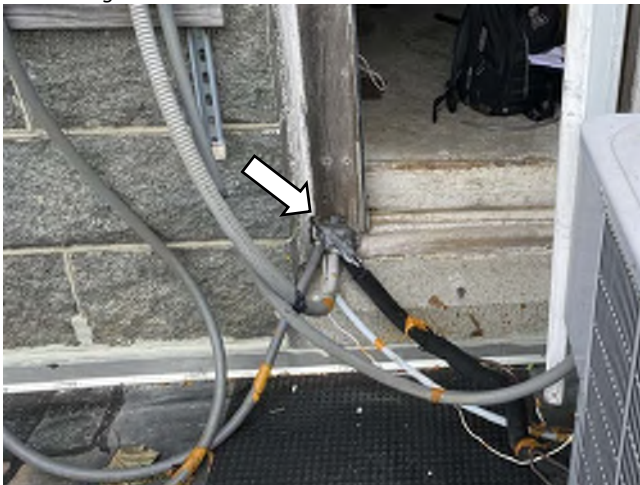
Image 135: The arrow indicates where numerous conduits penetrate through the door frame.

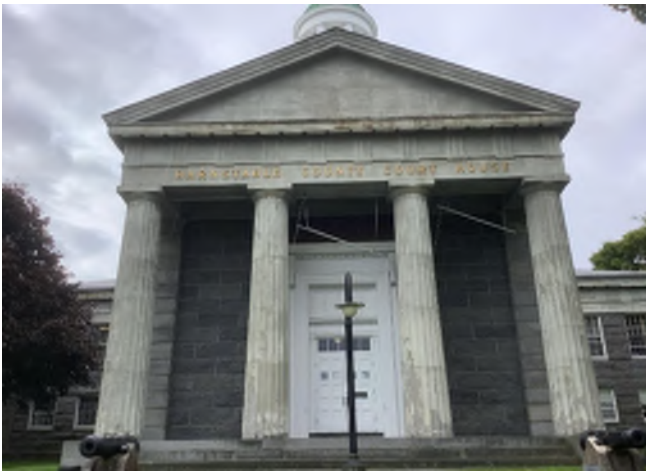
Image 137: Overall North Elevation of the 1832/33 Building.

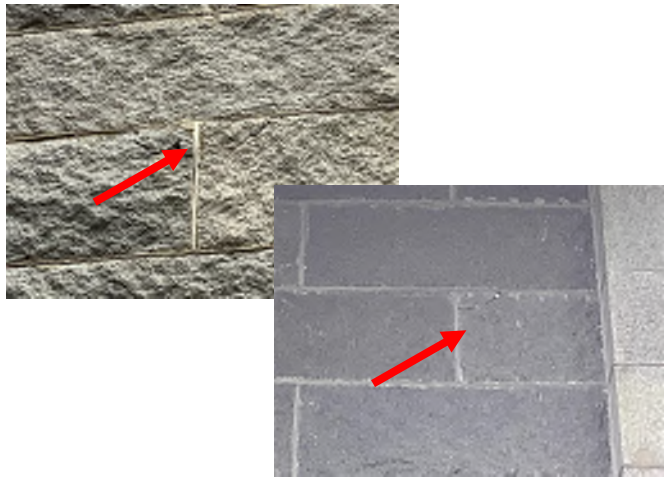
Image 140: Spalling of rock-faced granite.

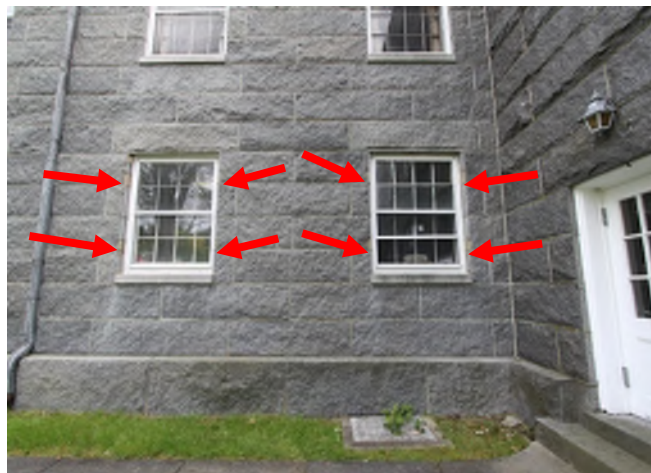
Image 141: Arrows point to locations where mortar patches were applied where iron screens had once been attached.

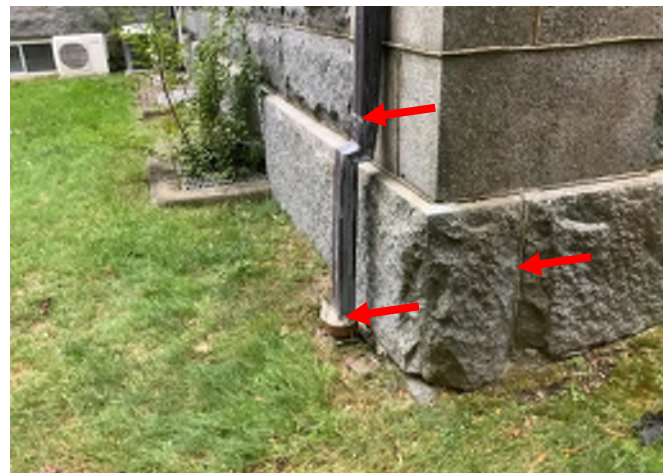
Image 142: View of deteriorated mortar joints in the granite foundation wall (arrow), cracked copper downspout at the elbow (arrow), and grout-filled ground leader (arrow) at the northeast corner of the 1893 addition.

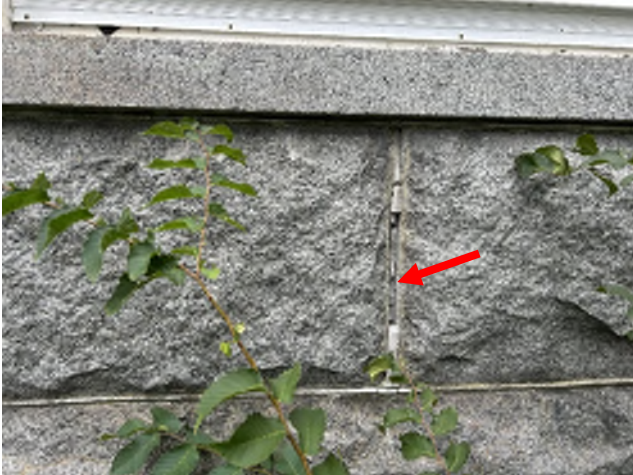
Image 143: Deteriorated/missing mortar joint.

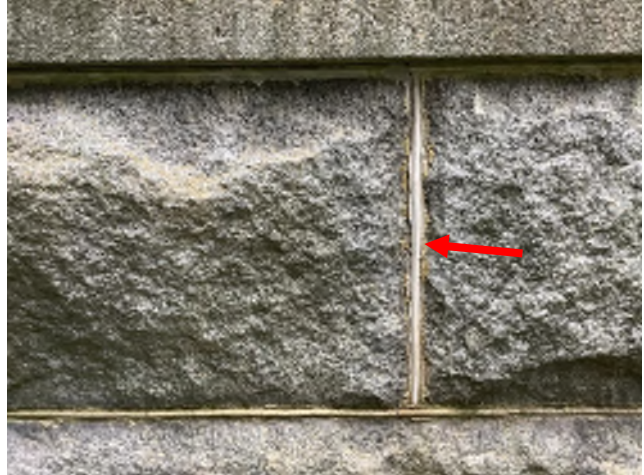
Image 144: Deteriorated/cracked mortar joint.

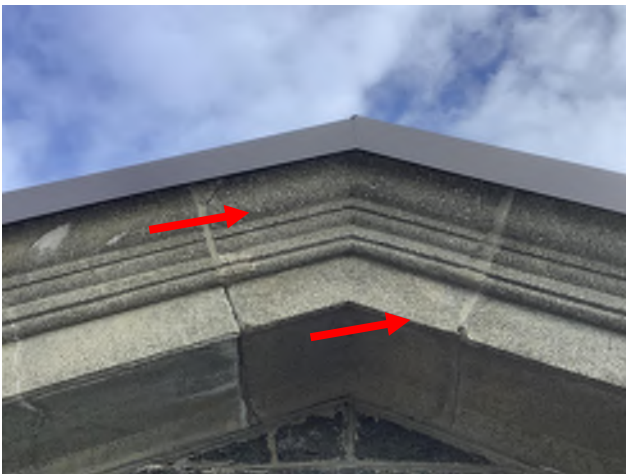
Image 145: Previously repaired, deteriorated and missing mortar on the South Elevation

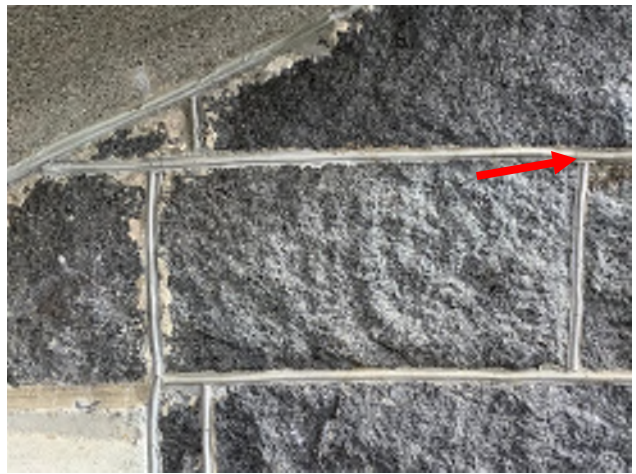
Image 146: South Elevation mortar joint repair and deterioration.

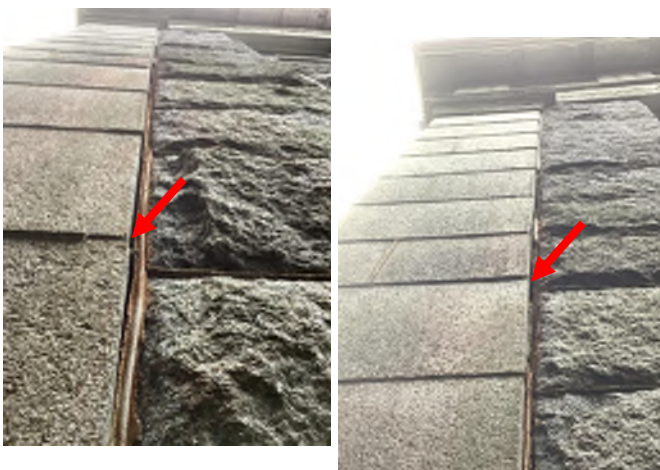
Image 147: Deteriorated and detached vertical mortar joint (arrow) between the rock-faced granite and the honed granite at the pilaster.

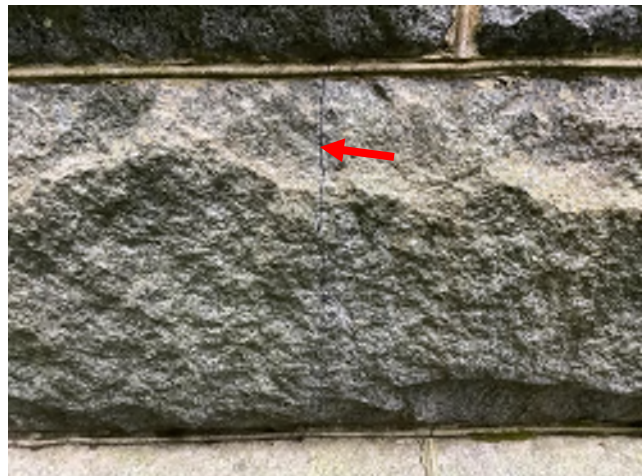
Image 148: Cracked granite element in the field of the wall.

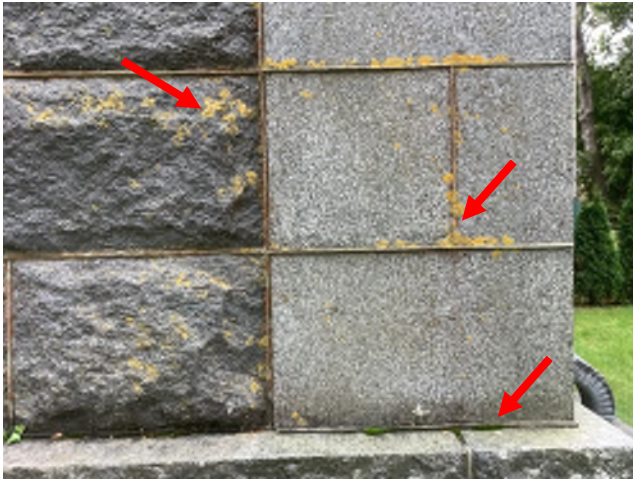
Image 149: View shows vegetative growth on the rock-faced and honed granite elements at the building corner.

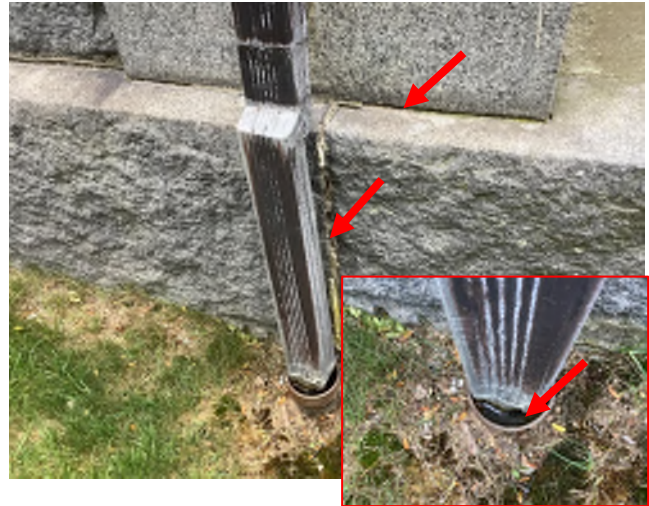
Image 150: View shows deteriorated horizontal and vertical mortar joints between granite elements (arrows), as well as water back-up in the ground leader (arrow, inset).

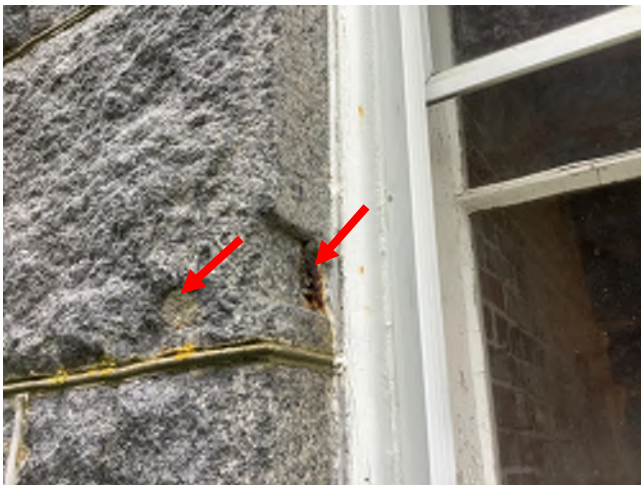
Image 151: Arrows point to a mortar-filled hole (front face) and rust stained granite where an apparent section of embedded iron remains on the jamb return.

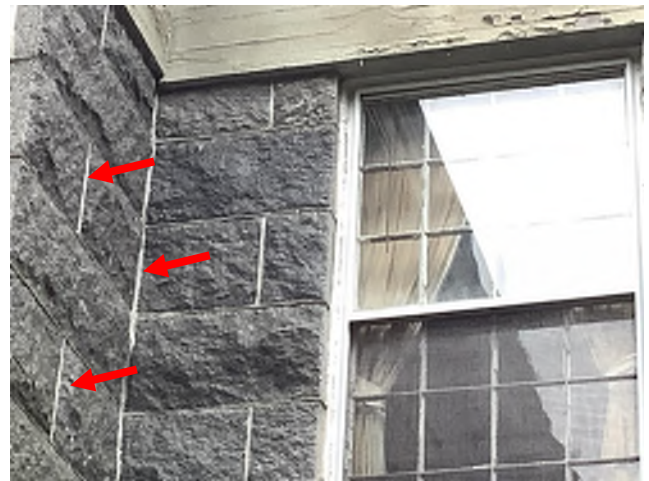
Image 152: View of sealant application over rock-faced granite mortar joints.

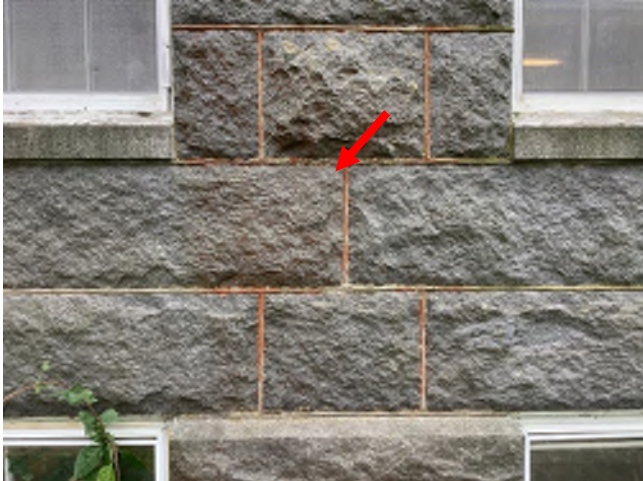
Image 153: View of red algae staining on the rock-faced granite.

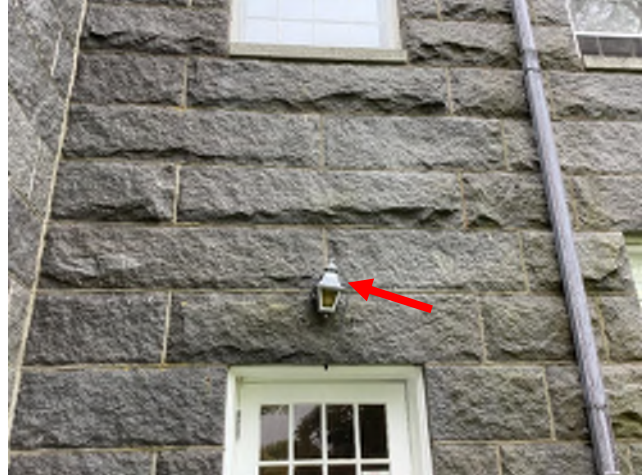
Image 154: Loose lantern observed above an entry door.

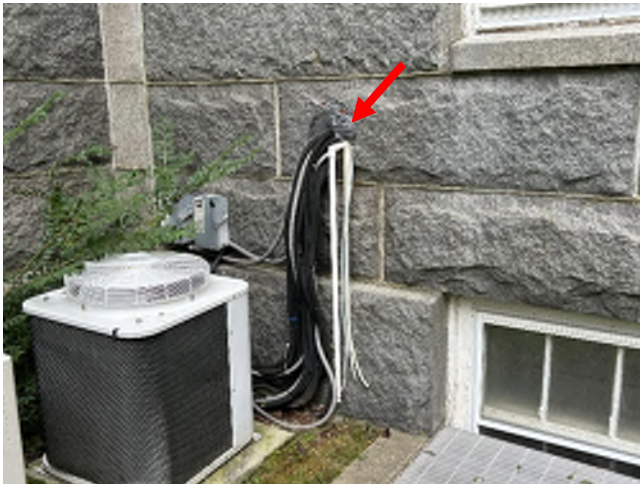
Image 155: Deteriorated spray foam applied to seal numerous conduits that penetrate the granite wall on the east elevation.

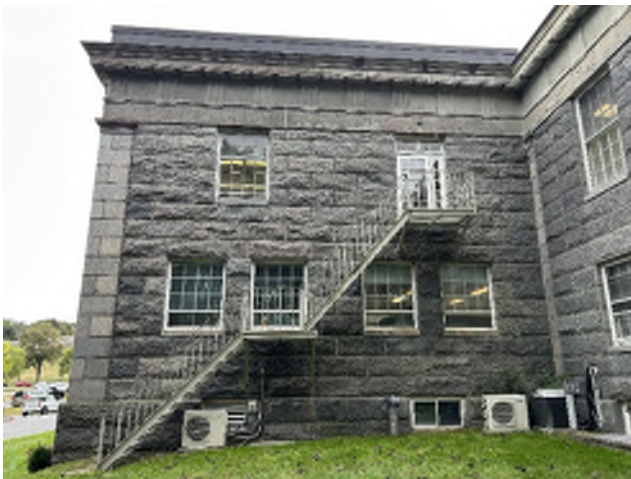
Image 156: North elevation on the east wing of the 1925/26 addition.

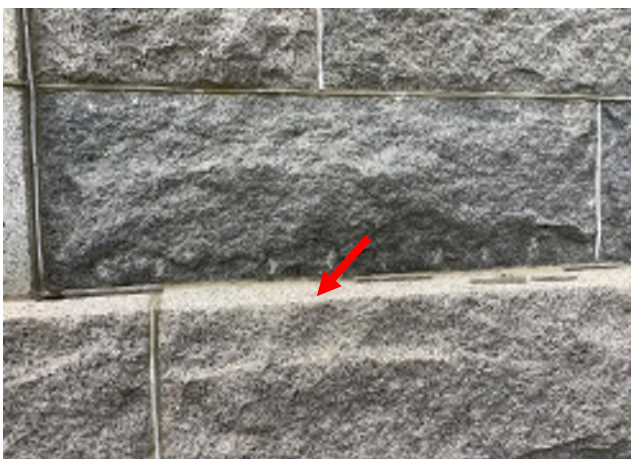
Image 158: Deteriorated and detached mortar on top of the granite foundation.

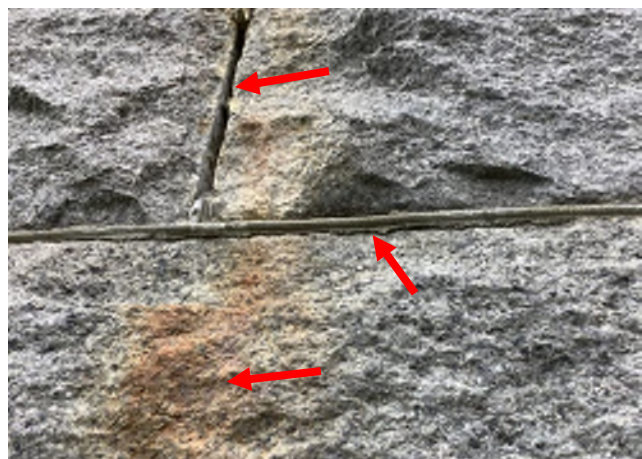
Image 159: Missing/deteriorated mortar joints. Rust staining observed on the granite masonry.

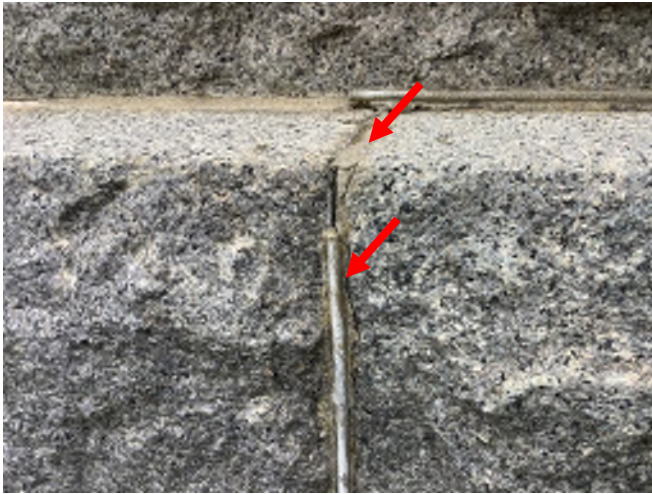
Image 160: Deteriorated and detached mortar, as well as open joints, on top of the granite foundation.

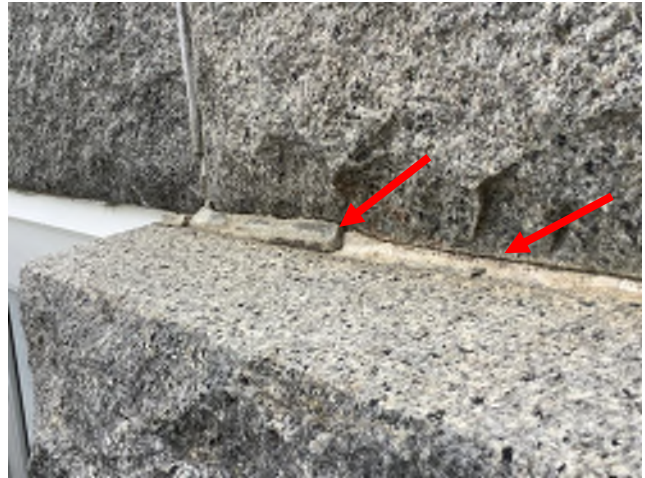
Image 161: Closer view of detached and cracked horizontal mortar between the field of the wall and the foundation.

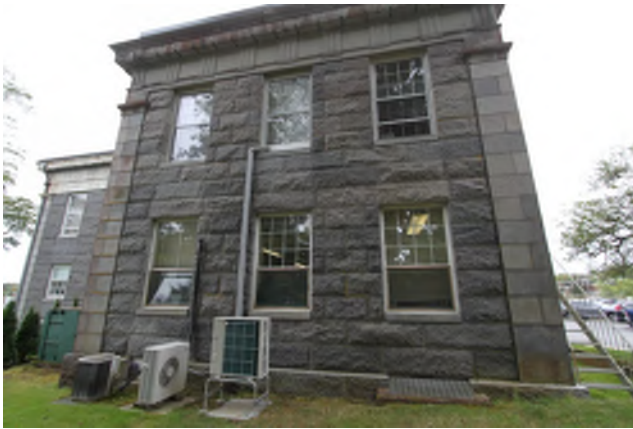
Image 162: West elevation of the 1925/26 wing.

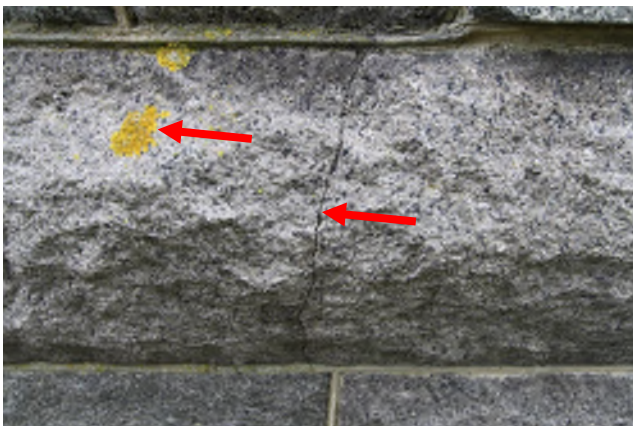
Image 164: Cracked rock-faced granite element. Note the vegetative growth on the wall.

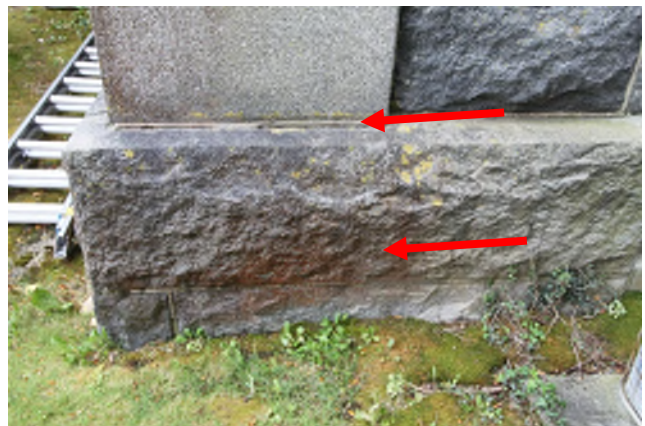
Image 165: Vegetative growth and missing/deteriorated mortar joints.

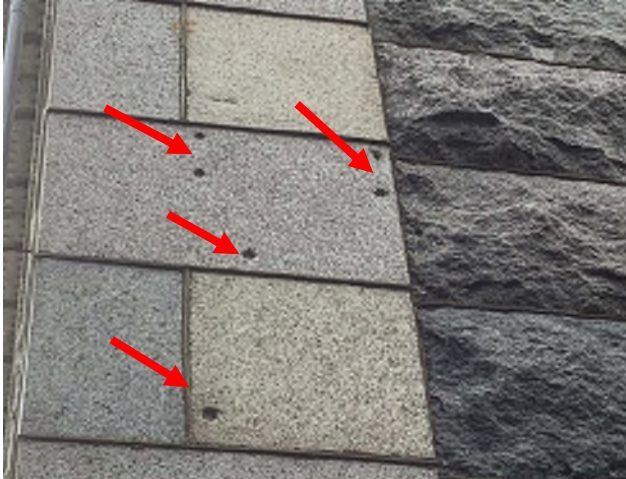
Image 166: Visible holes where embedded anchors were observed in the honed granite at the northeast corner pilaster.

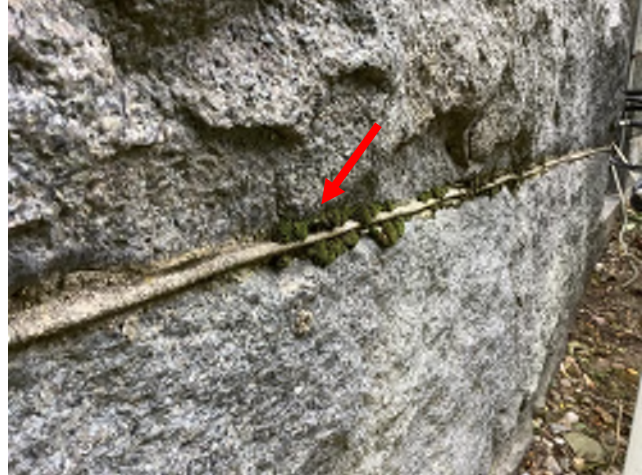
Image 167: Vegetative growth on the granite foundation wall.

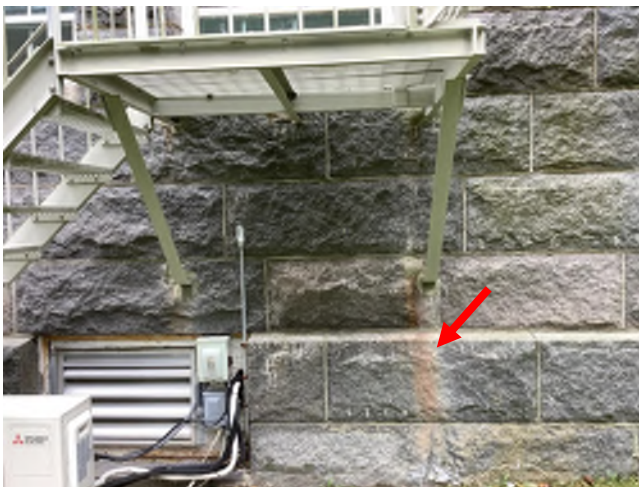
Image 168: Scattered paint and rust staining (arrow) observed below the fire escape on the north elevation of the east wing.

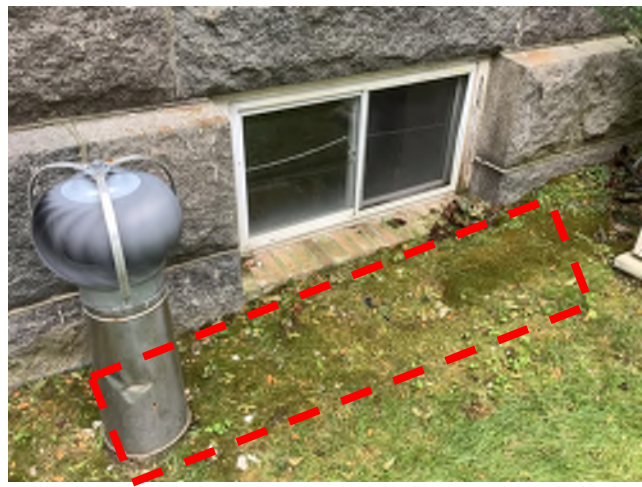
Image 169: Mortar debris had fallen to the ground.

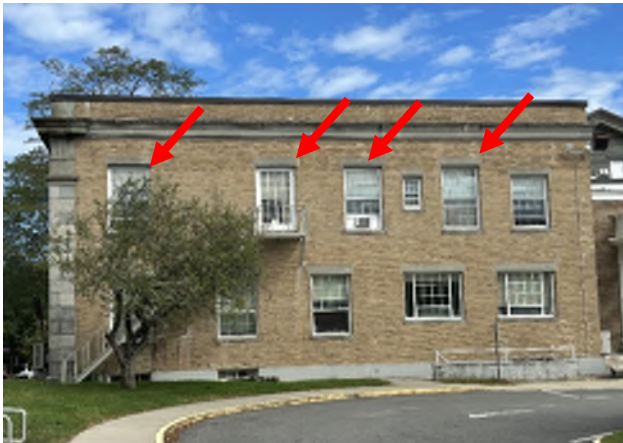
Image 170: View of the west wing of the south elevation on the 1925/26 addition. The arrows identify locations of dissimilar brick masonry units.

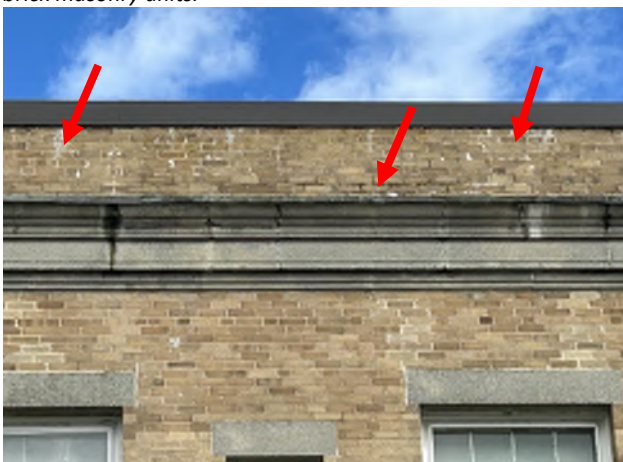
Image 172: Representative view of the parapet shows deteriorated mortar joints and efflorescence.

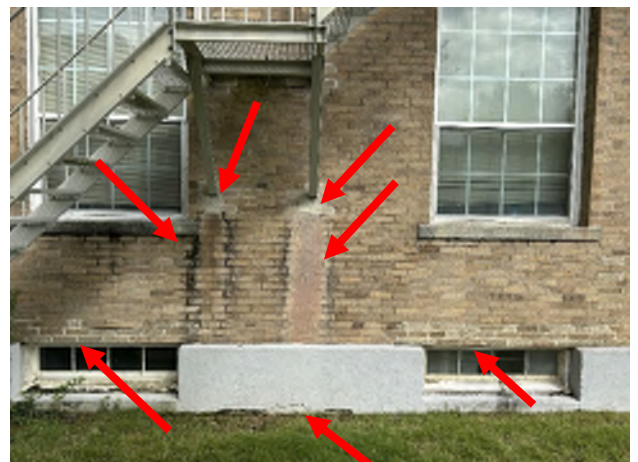
Image 173: Arrows point to black staining, replaced brick masonry units, dissimilar repair mortar and delaminated coating at the base of the wall at grade.

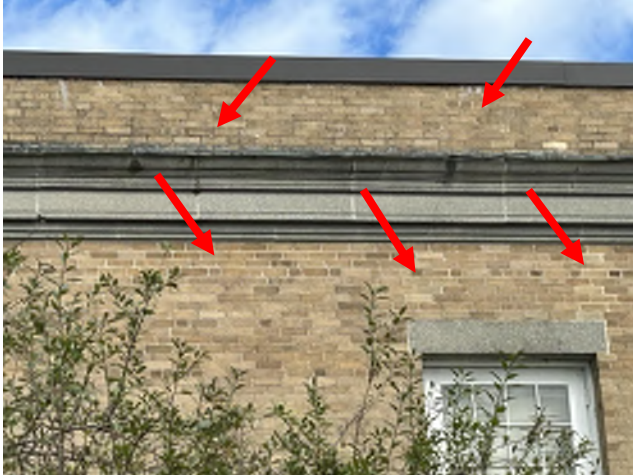
Image 174: Closer view of image above shows deteriorated mortar on the parapet wall, as well as dissimilar colors in the mortar and replacement brick masonry units.

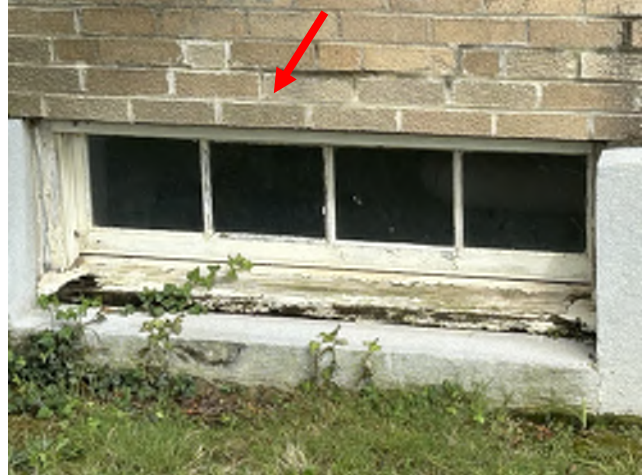
Image 175: Closer view of replacement brick masonry units that have a different color and texture than the majority of the wall.

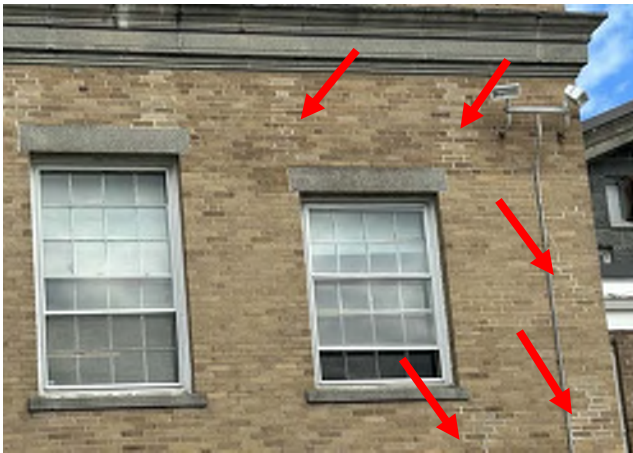
Image 176: Closer view of dissimilar mortar colors on the wall.

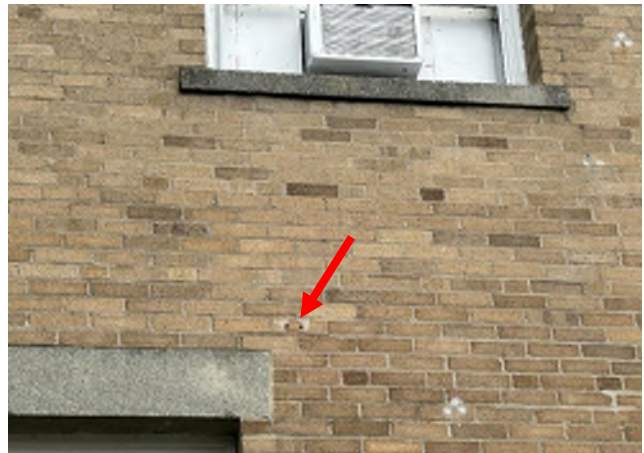
Image 177: Abandoned masonry anchors (arrow) were observed in the masonry wall.

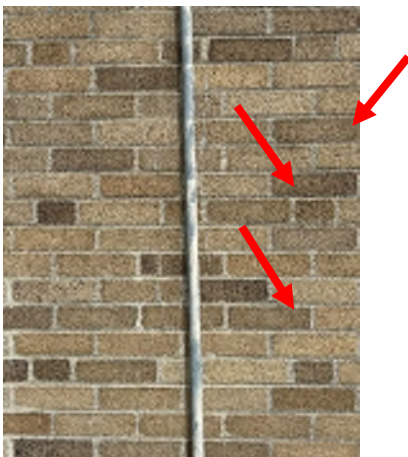
Image 178: View of vertical cracks in the brick masonry wall on both sides of the conduit.

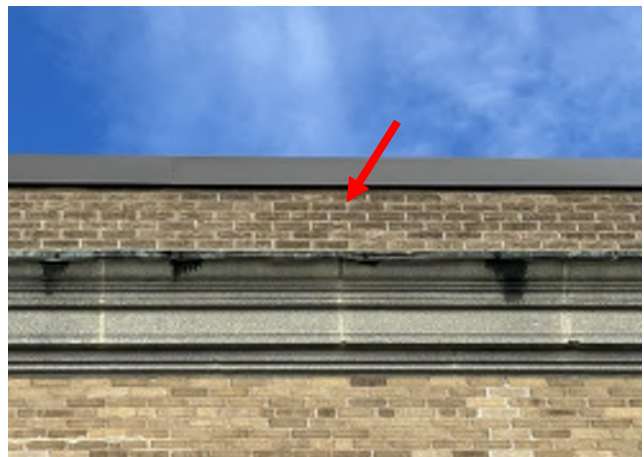
Image 179: Closer view shows textured replacement brick masonry units that had been installed on the east wing parapet. Textured bricks were observed the full length of the parapet on this elevation.
