**Restoration of the  
Barnstable County Superior  
Courthouse  
3195 Main Street  
Barnstable, MA 02630**

**Gale JN 843680  
May 9, 2025**

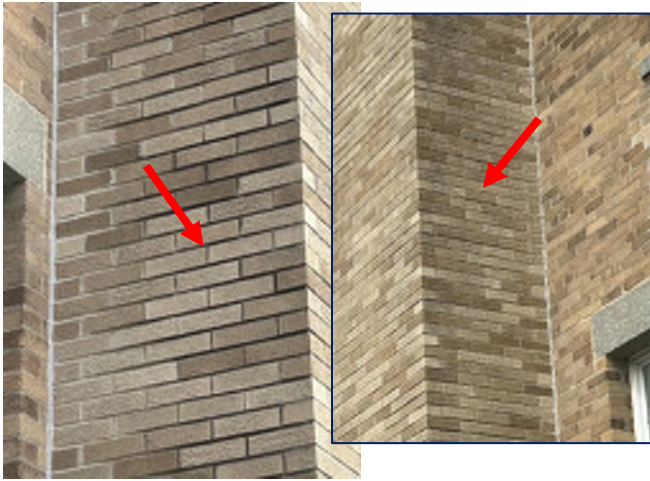
Image 180: Views of textured brick masonry units on the chimney on the south elevation of the building.

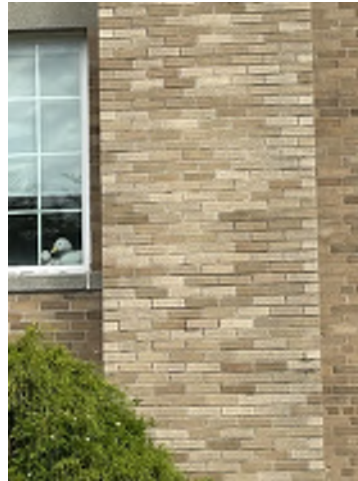
Image 181: Closer view of deteriorated mortar on the chimney.

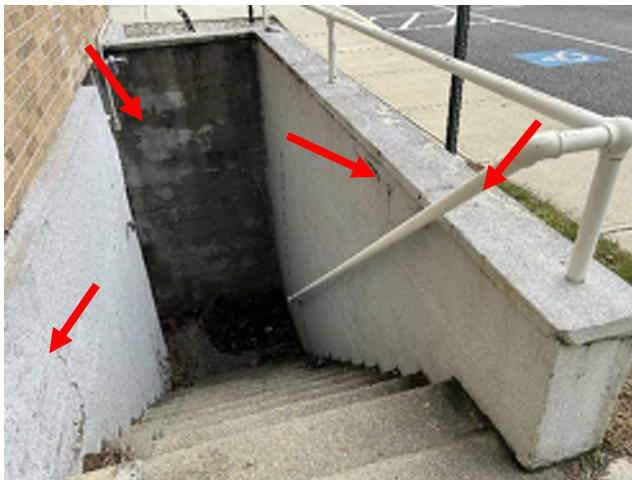
Image 182: View looking down the basement stairs shows delaminated coating on the brick masonry and concrete walls.

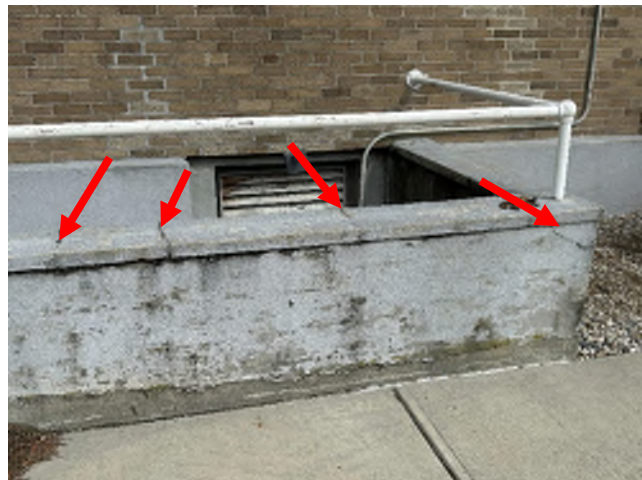
Image 183: Cracks were observed on the concrete wall and coping.

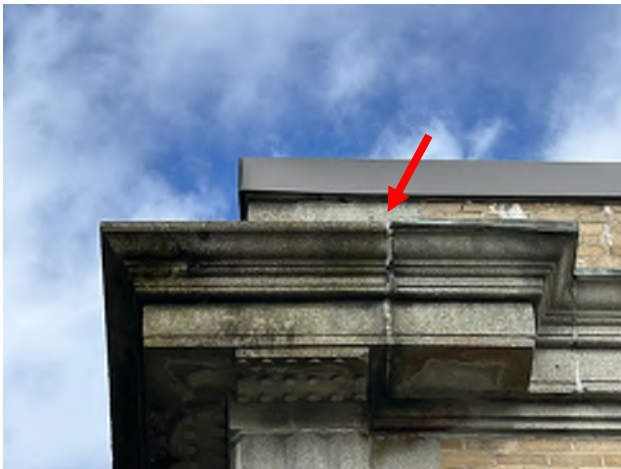
Image 184: Displacement of precast cornice at west end of the south elevation.

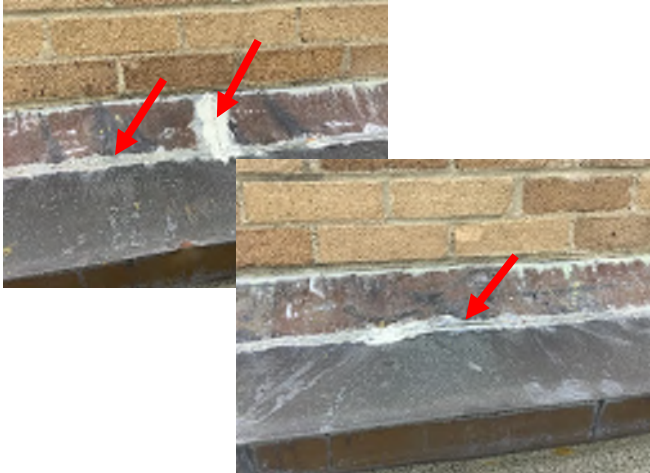
Image 186: Deteriorated solder joints (arrows) observed in the copper cornice flashing.

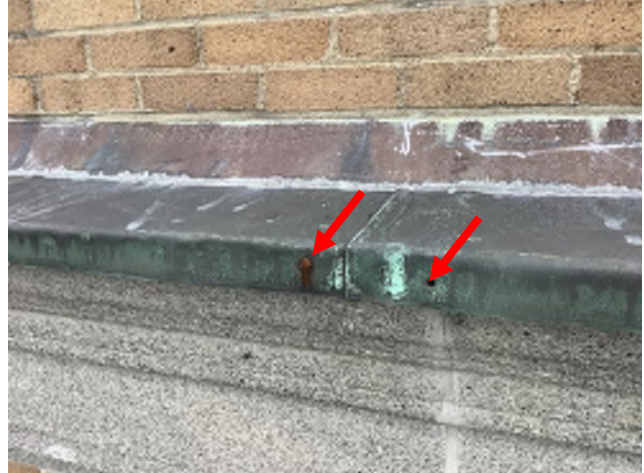
Image 187: Rusted and missing fasteners observed in the copper cornice flashing.

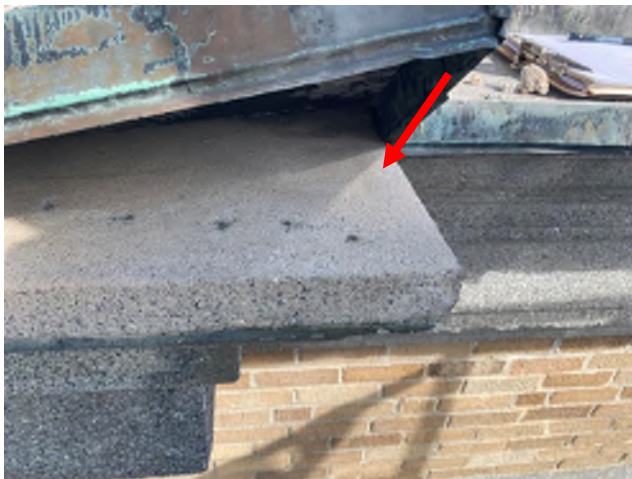
Image 188: Exposed precast cornice section due to loose / displaced copper cornice flashing

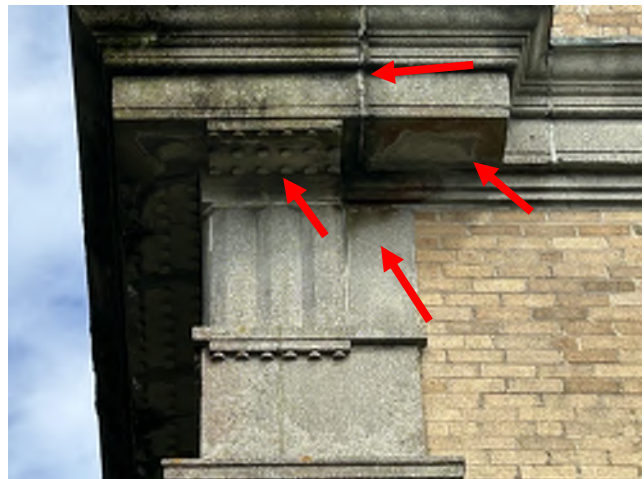
Image 189: Deteriorated mortar in precast joints, cracked and stained precast elements were observed.

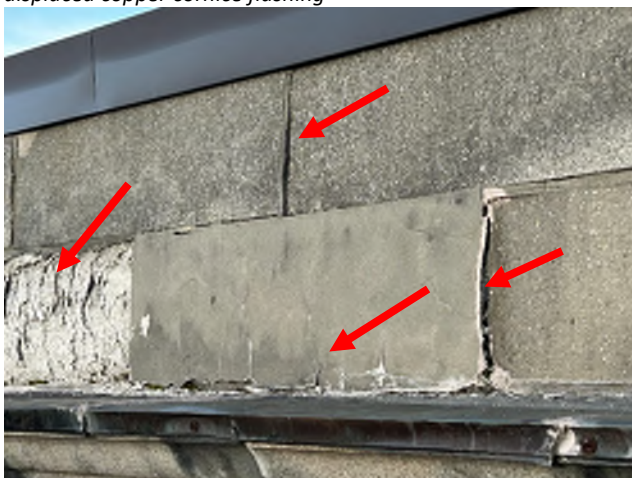
Image 190: Spalled, cracked and delaminated precast components with deteriorated mortar joints on the parapet.

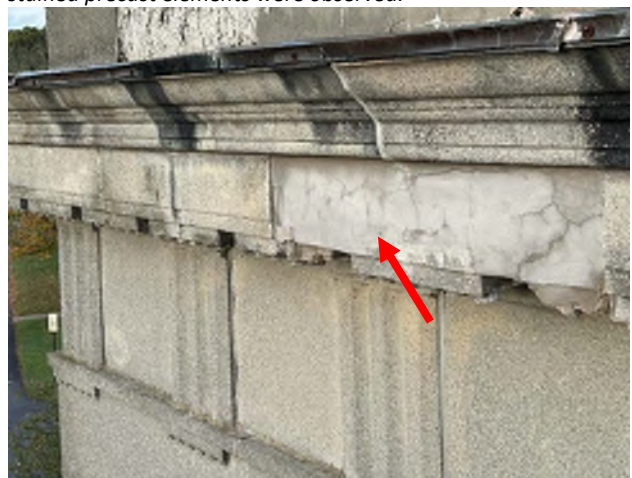
Image 191: Closer view of deteriorated precast repair on the cornice.

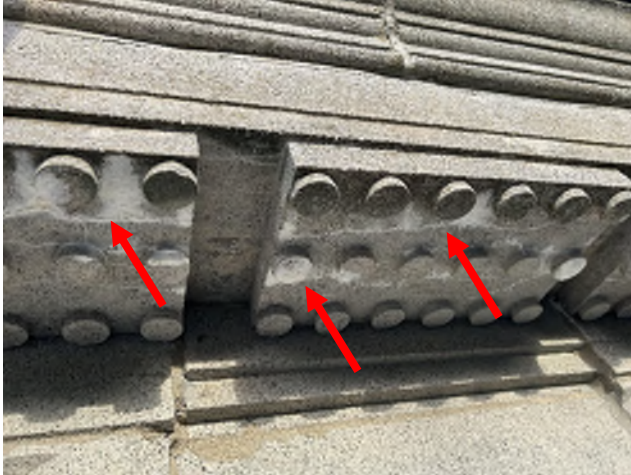
Image 192: View of cracks and efflorescent staining at decorative dentils on the underside of the cornice.

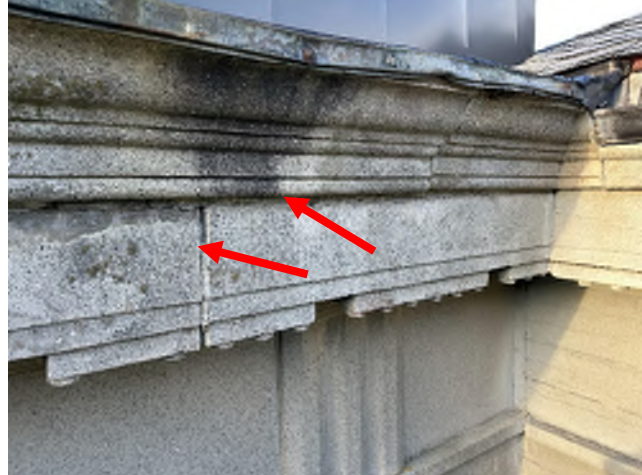
Image 193: Deteriorated mortar observed in cornice elements.

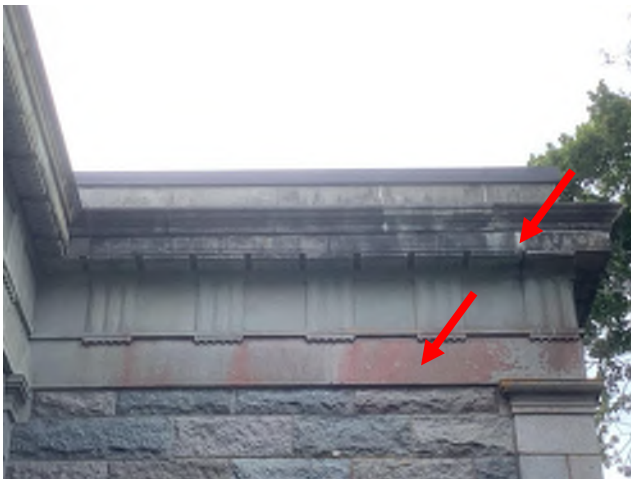
Image 194: Red algae staining and efflorescent staining observed on precast frieze and architrave elements.

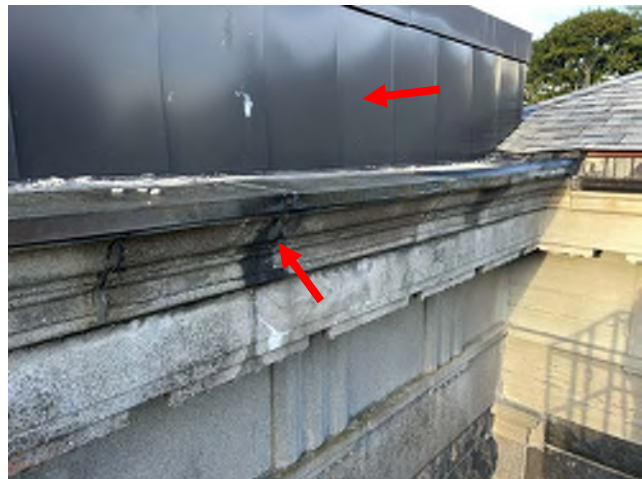
Image 195: Black staining observed on precast elements. Note the aluminum wall panels on the parapet above.

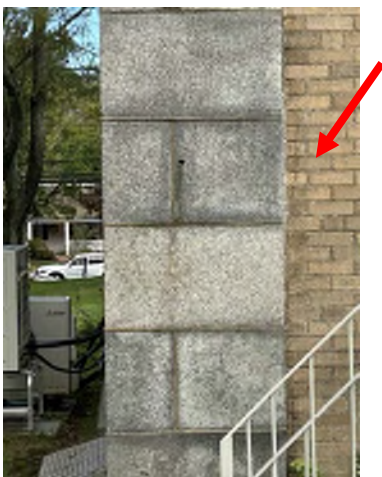
Image 196: Arrow points to abandoned hole in precast pilaster.

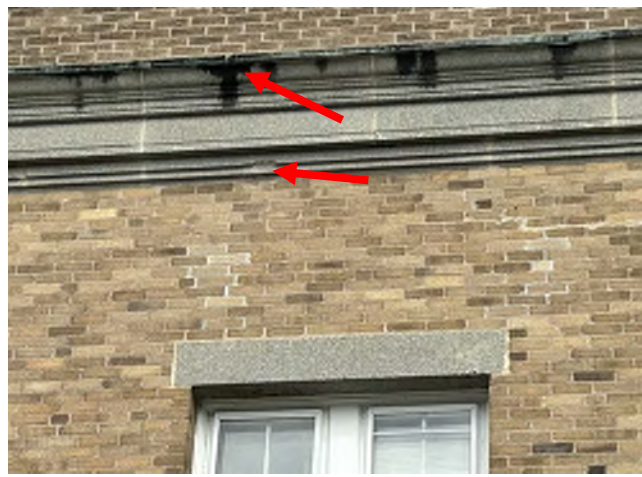
Image 197: Spalled and stained precast cornice elements (arrows) on the south elevation.

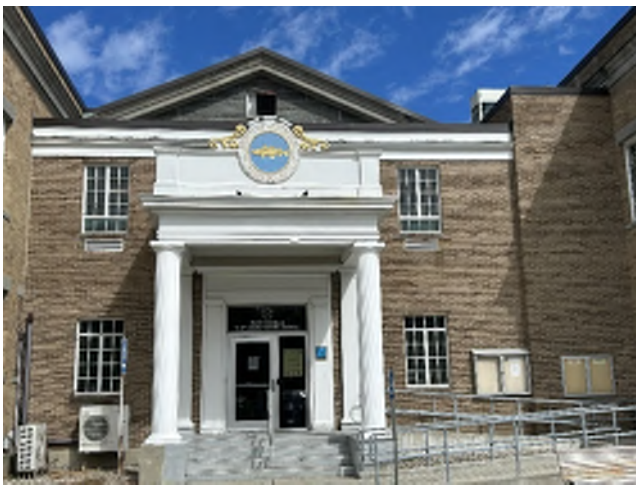
Image 198: Overall south elevation of the 1971 addition shows brick masonry and wood elements around the main entrance.

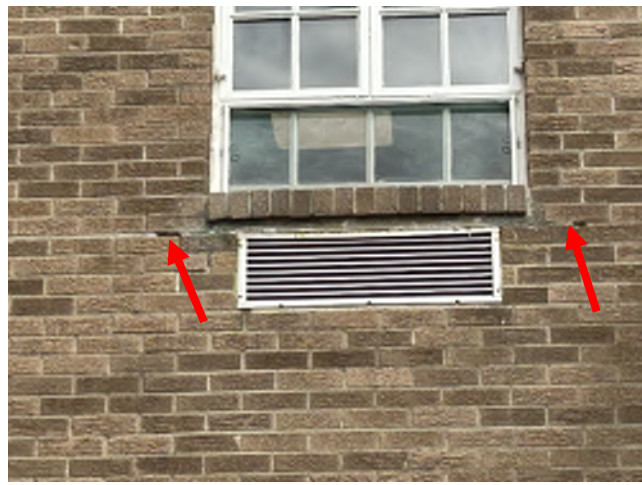
Image 199: Deteriorated mortar and apparent rusted steel lintel observed above the louver.

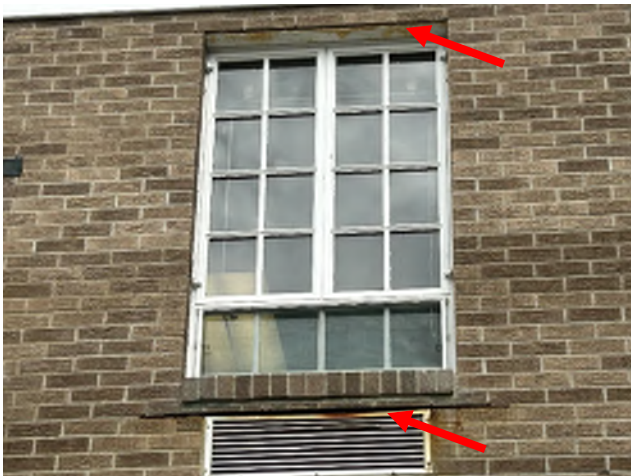
Image 200: Rusted steel lintels observed above a window and louver on the 1971 south elevation.

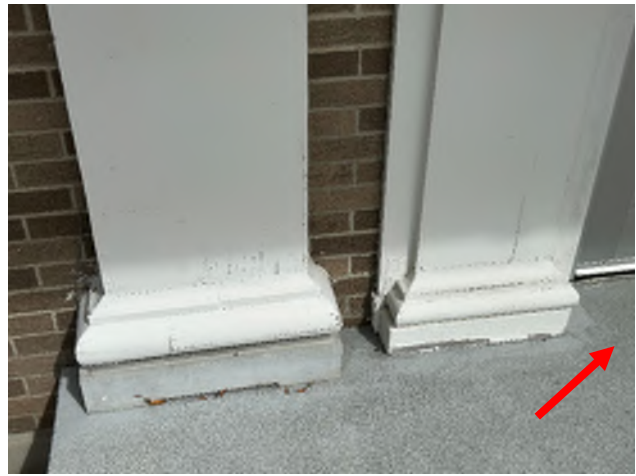
Image 201: Cracked concrete and peeled paint.

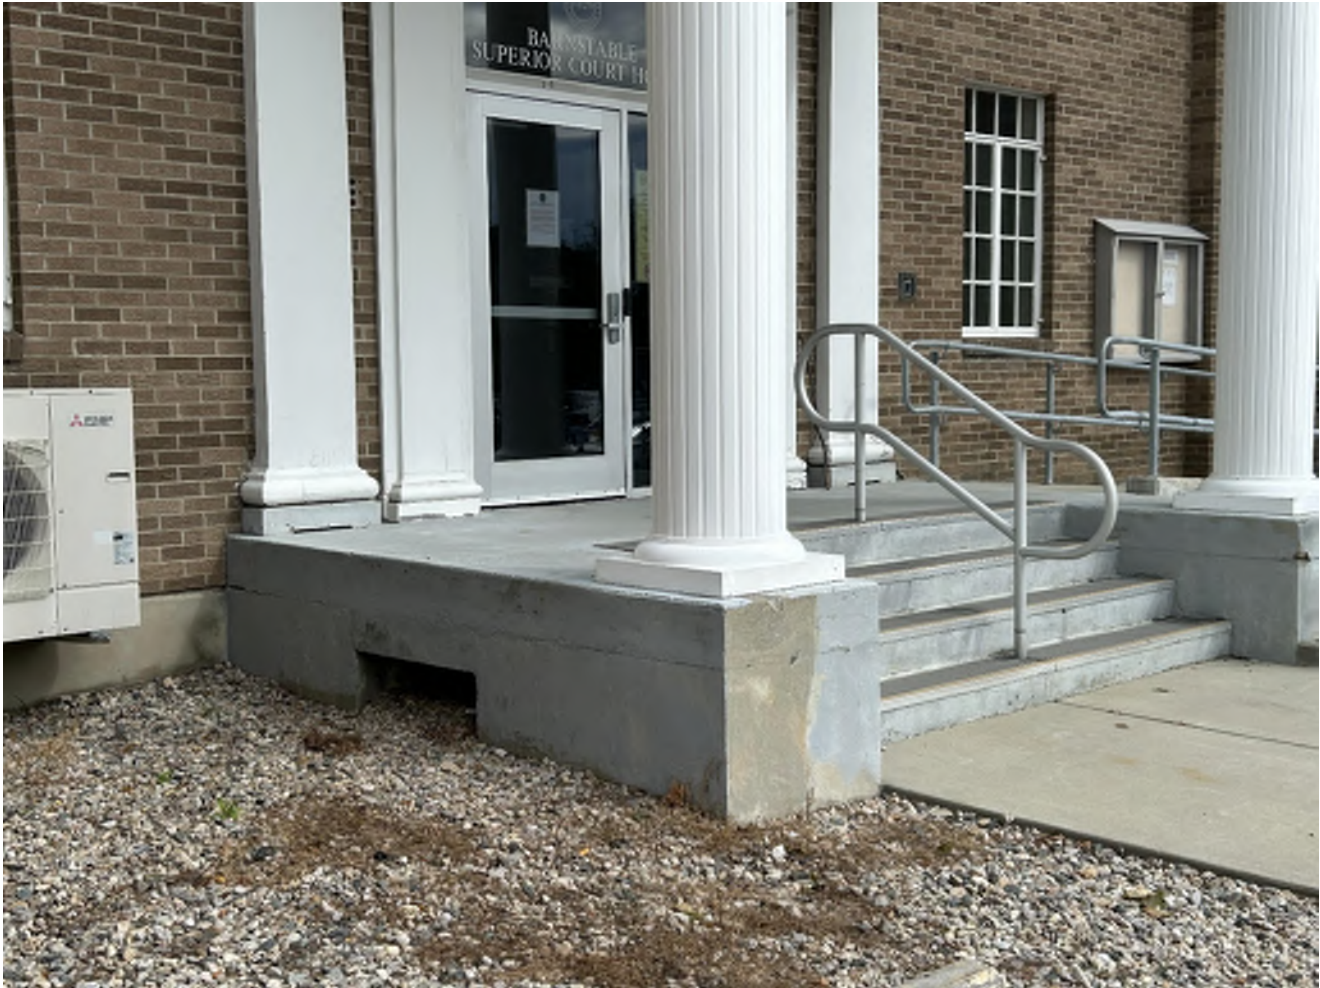
Image 202: View of open cold joint between the concrete footing and the slab at the main entry stairs.

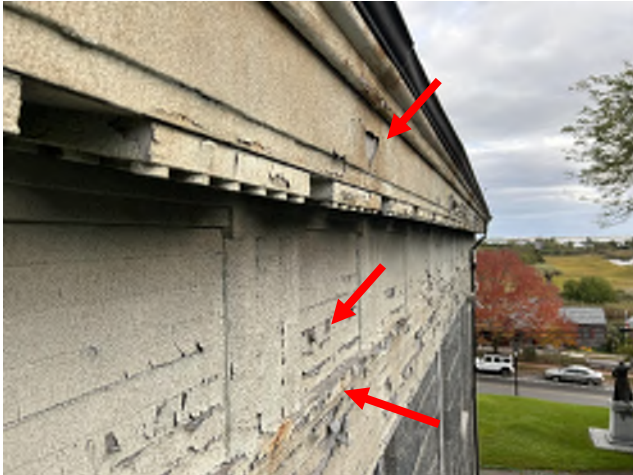
Image 203: Representative view of peeling paint on the cornice, frieze and architrave portions of the entablature.

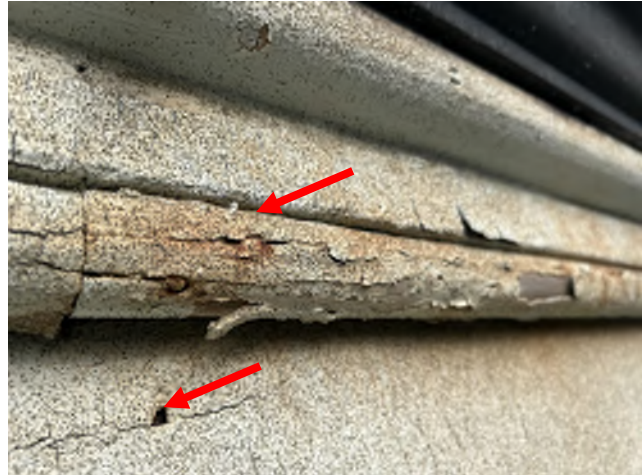
Image 204: Closer, representative view of cracked wood components on the cornice.

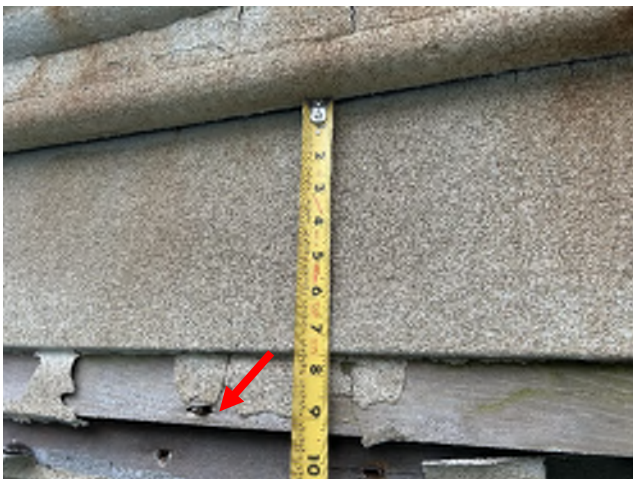
Image 205: Close-up of deteriorated wood trim on the bottom portion of the cornice.

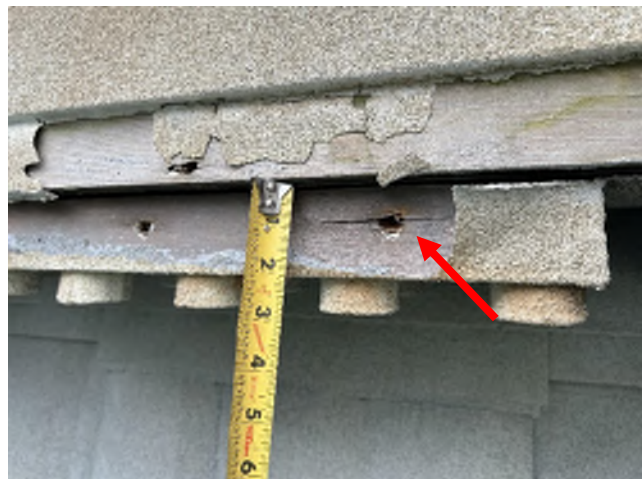
Image 206: View shows a deteriorated (split) decorative wood dentil.

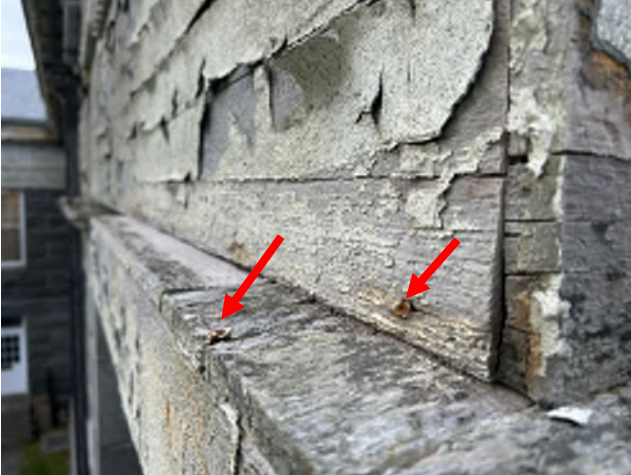
Image 207: Close-up of deteriorated wood frieze components. Note the rusted nails (arrows) that secure the wood.

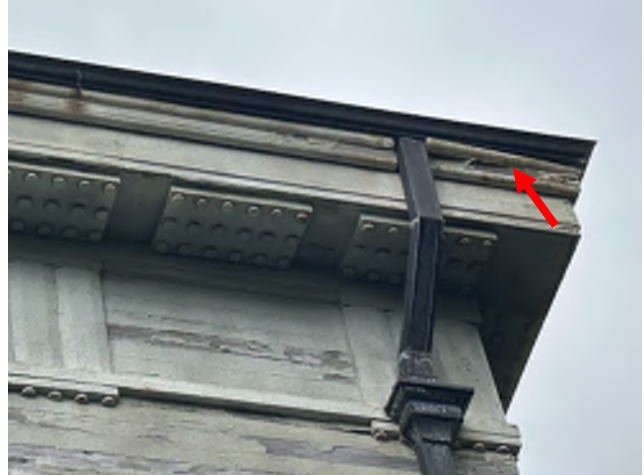
Image 208: Displaced wood trim was observed below the gutter at an isolated cornice location.

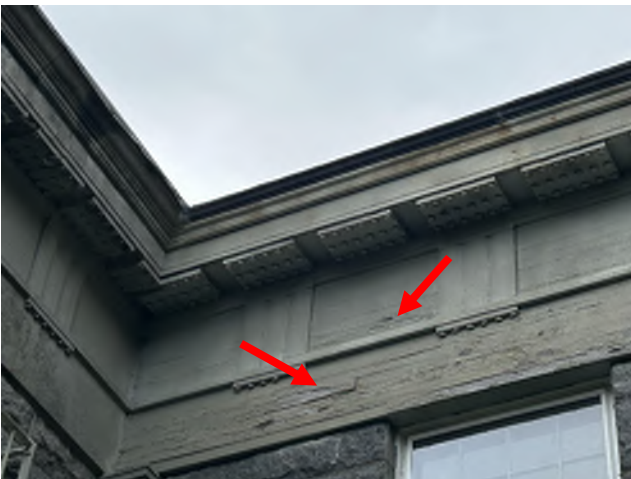
Image 209: View of a displaced wood plank in the architrave and deteriorated wood plank in the frieze portions of the entablature.

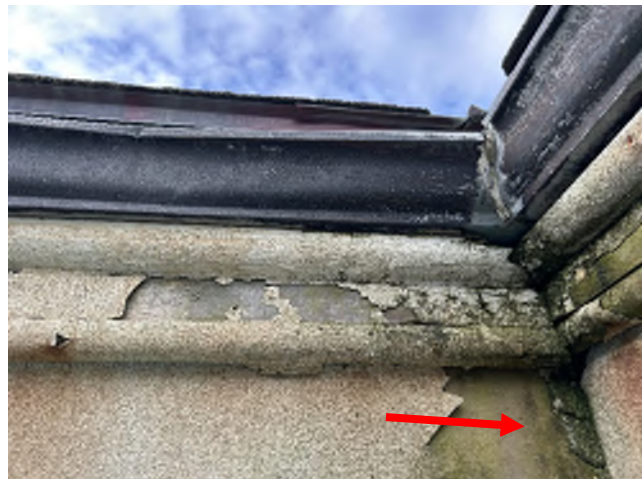
Image 210: View of peeled paint, deteriorated wood fascia board and deformed copper gutter at a cornice.

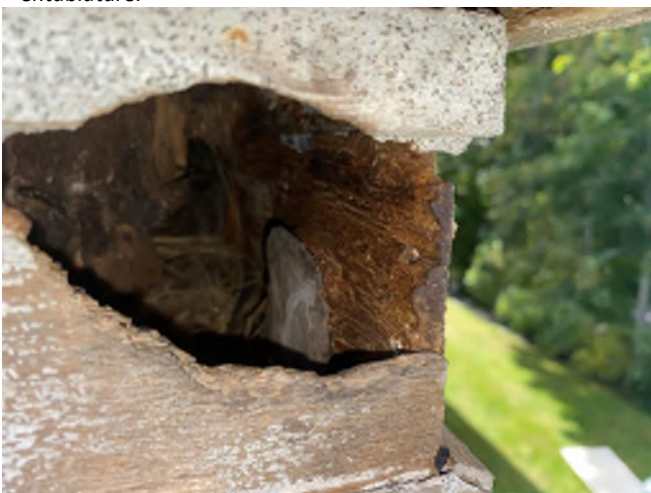
Image 211: Close-up of a missing section of wood trim on top of a pilaster.

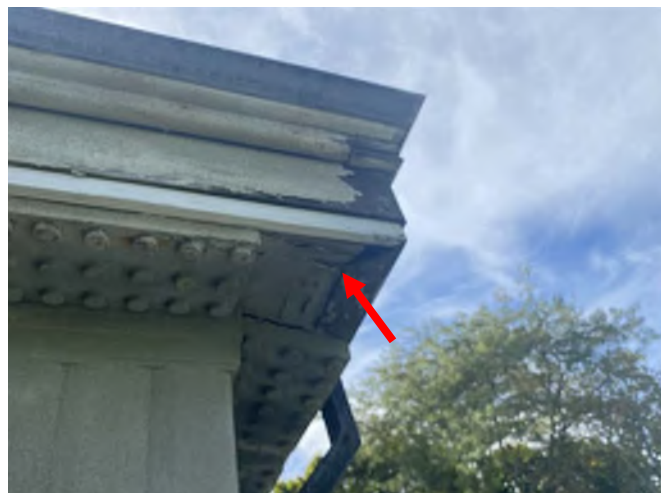
Image 212: View of deteriorated and loose soffit board below the cornice.

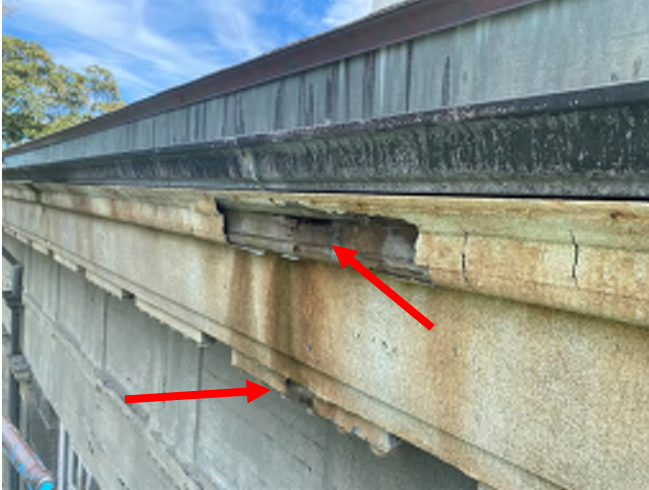
Image 213: Close-up of a missing section of wood trim on top of a pilaster.

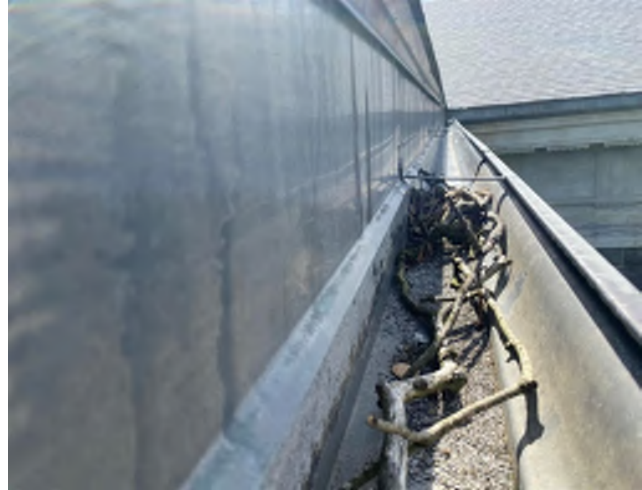
Image 214: View of debris in a copper gutter.

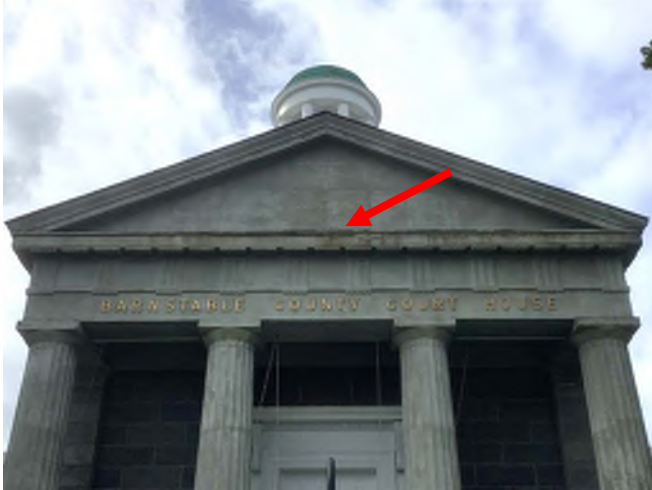
Image 215: View shows deteriorated sand-textured painted surfaces on the pediment elements at the original building's front entrance.

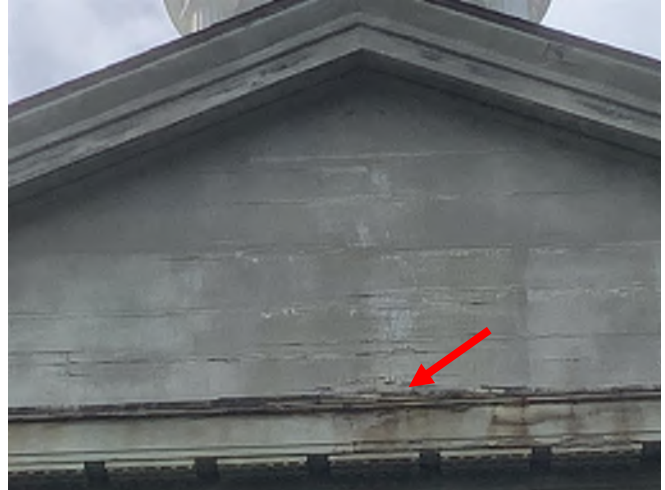
Image 216: Closer view of the previous image shows apparent deteriorated wood elements (arrow).

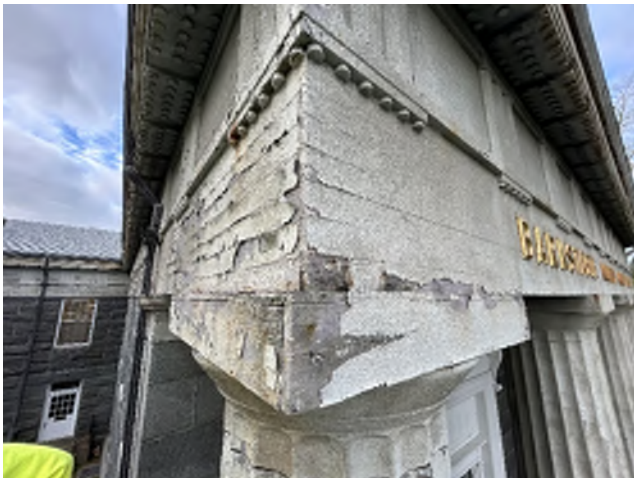
Image 217: Close-up of deteriorated wood trim above a column at the original building's front entrance.

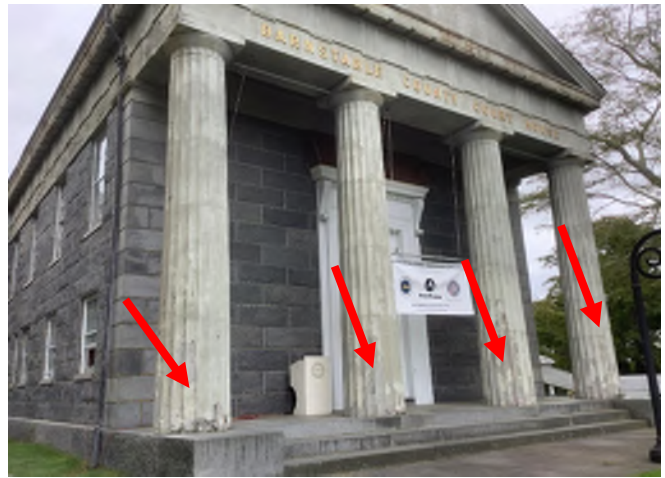
Image 218: View shows deteriorated sand-textured paint on the columns on the original building's front entrance.

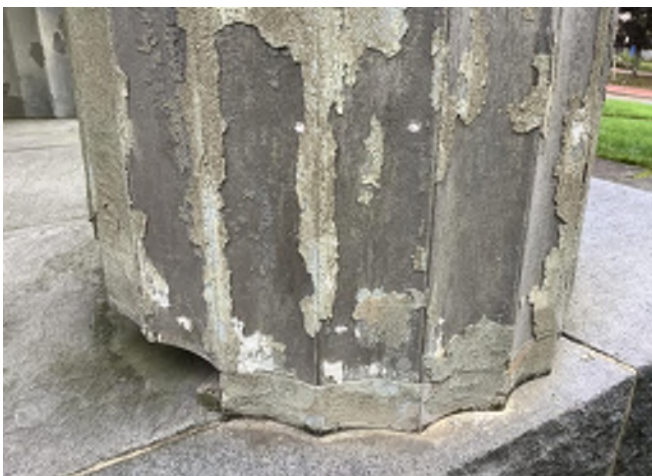
Image 219: Closer view of the previous image shows exposed and missing wood, which was observed at the column bases.

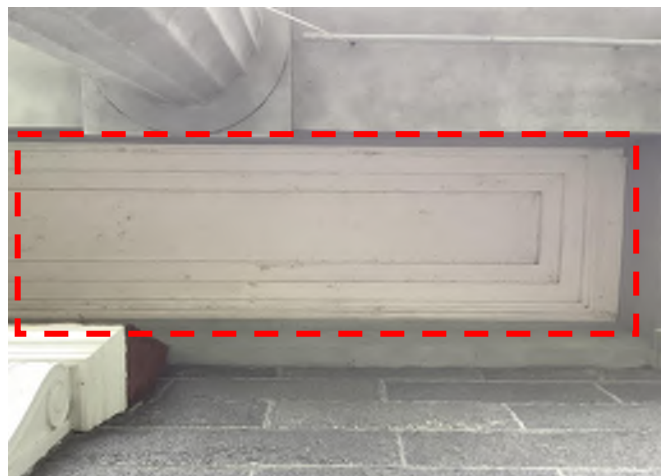
Image 220: Delaminated white paint observed on the soffit above the original building's front entrance.

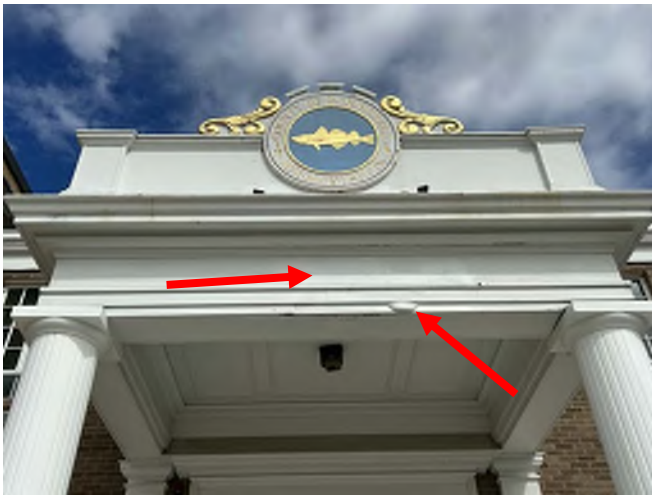
Image 221: View of blistered and faded paint (arrows) on the portico façade at the main entrance of the 1971 addition.

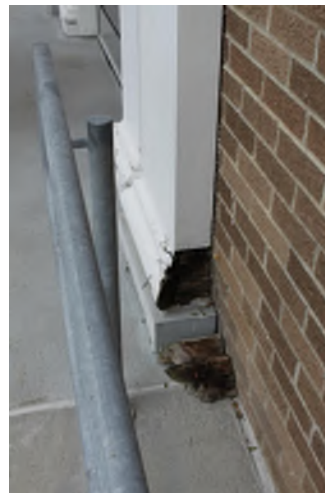
Image 224: Deteriorated and dislodged wood trim observed at the base of a piaster at the main entrance.

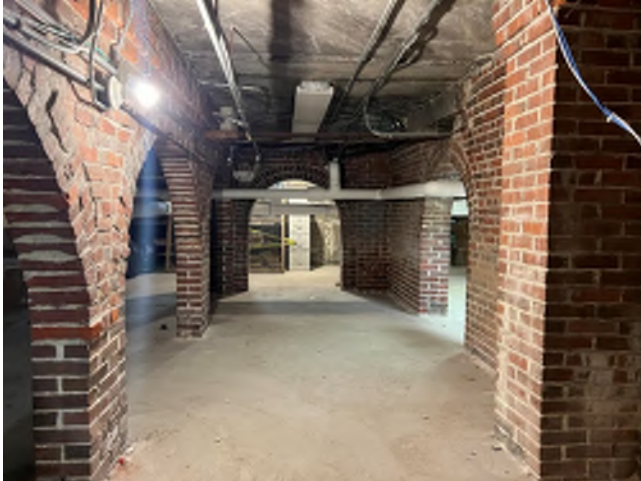
*Image 225: Partial overall view of the masonry piers in the basement of the 1831-1832 building.*

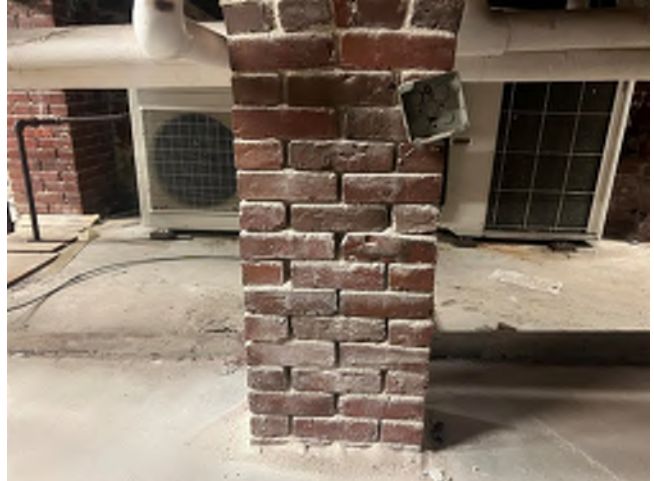
*Image 226: Typical view of the deteriorated mortar joints at the base of the masonry piers in the basement of the 1831-1832 building.*

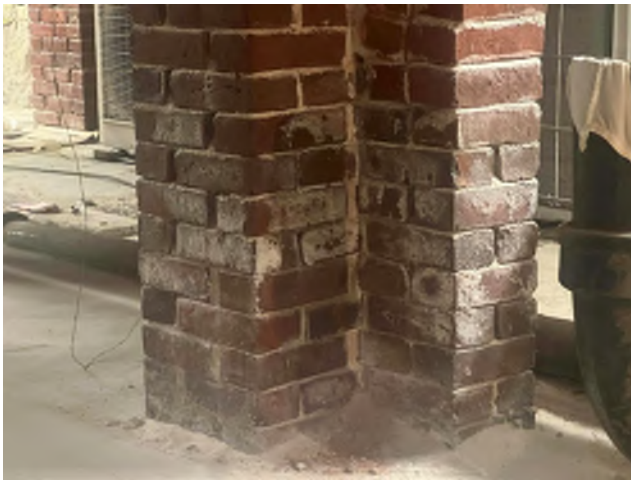
*Image 227: View of deteriorated mortar joints at the base of two (2) intersecting masonry piers.*

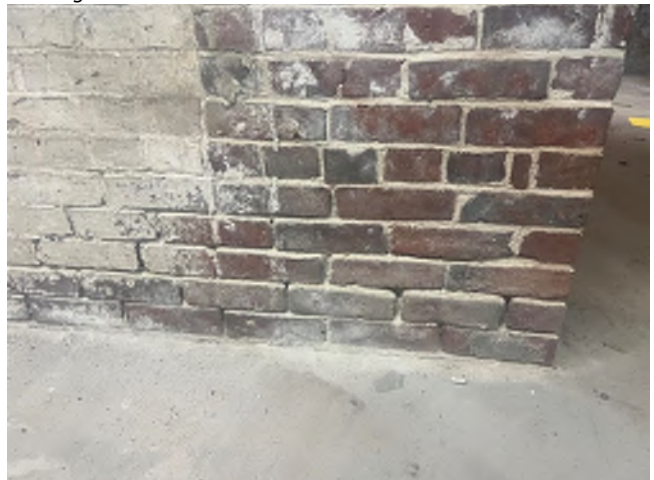
*Image 228: View of deteriorated mortar joints at the base of a masonry wall in the basement.*

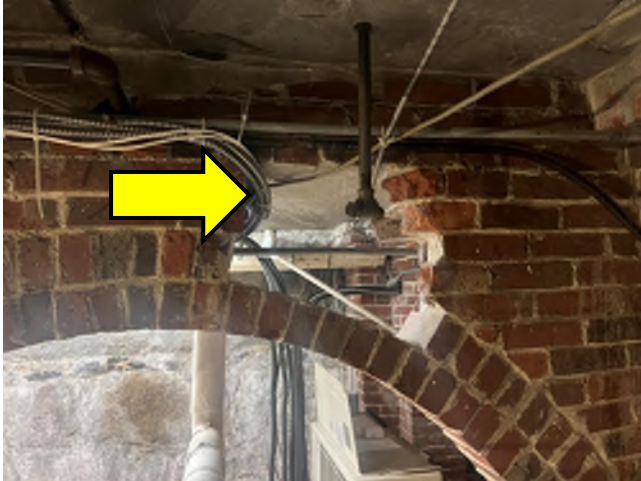
Image 229: View of a large void above a masonry arch where electrical conduits were installed.

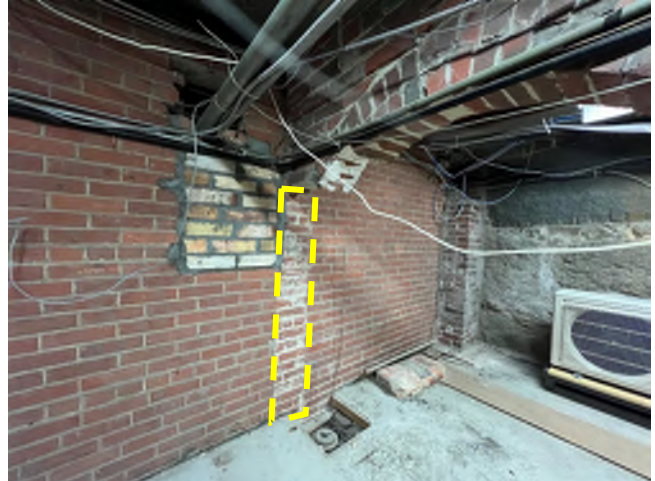
Image 234: Closer view of the missing masonry pier in the southwest corner of the 1831-1832 building that supports the masonry arch. Note: The dashed box indicates the approximate location of masonry pier.

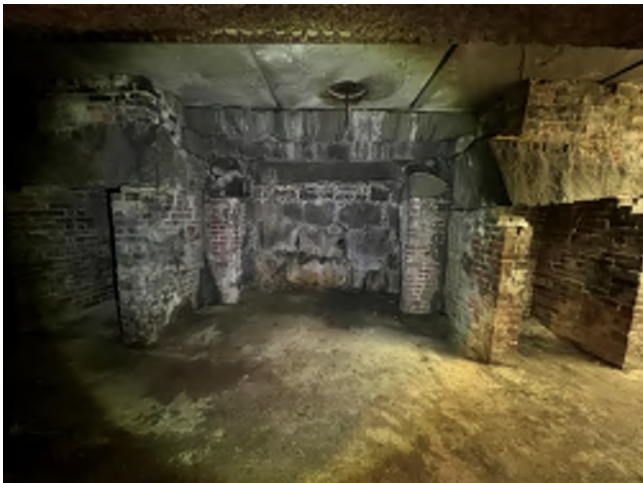
Image 235: Overall view of the north wall below the exterior granite steps.

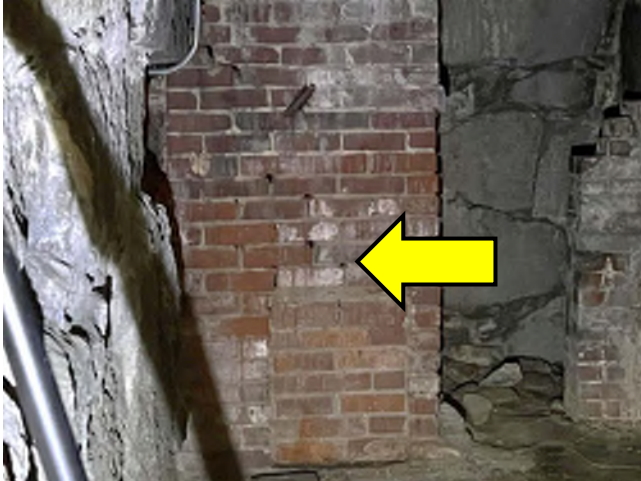
Image 237: View of a step crack and deteriorated masonry in the west masonry wall below the exterior granite steps.

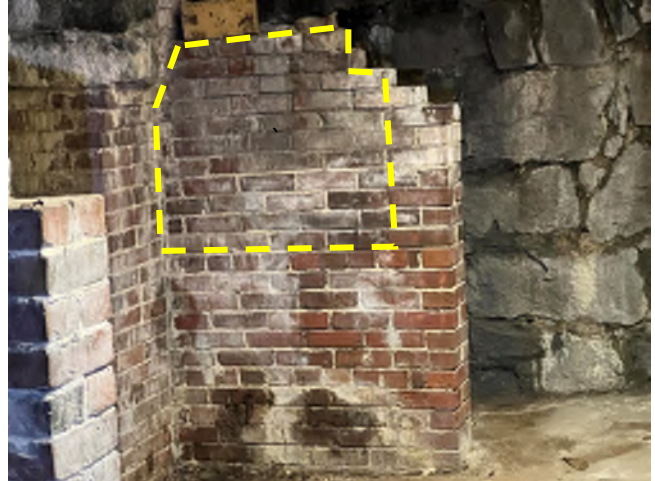
Image 238: View of an isolated location of deteriorated mortar joints in the masonry pier that supports the exterior granite steps. Note: The dashed box indicates the approximate extents of deteriorated mortar joints.

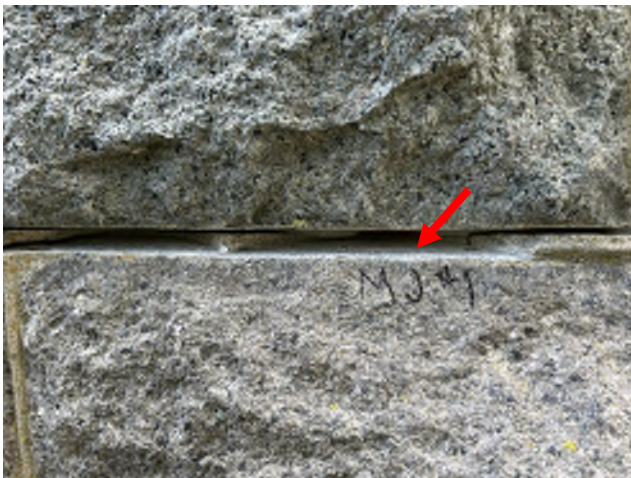
Image 241: View of granite mortar joint test cut no. 1.

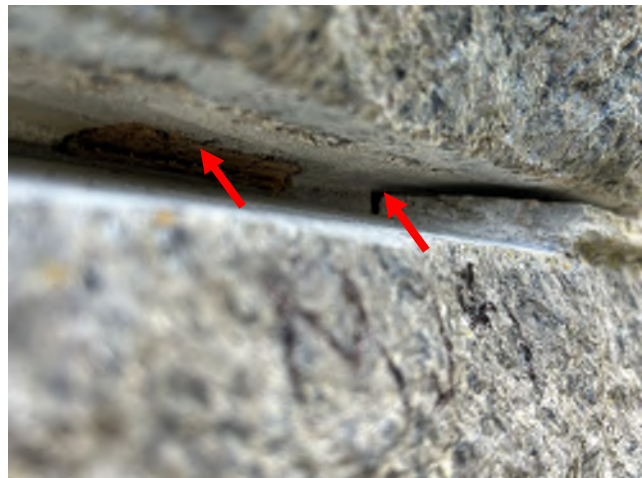
Image 242: Angled view of the previous image shows a clean break between the pointing and bedding mortar, and a metal shim in the bedding mortar at the back of the cut.

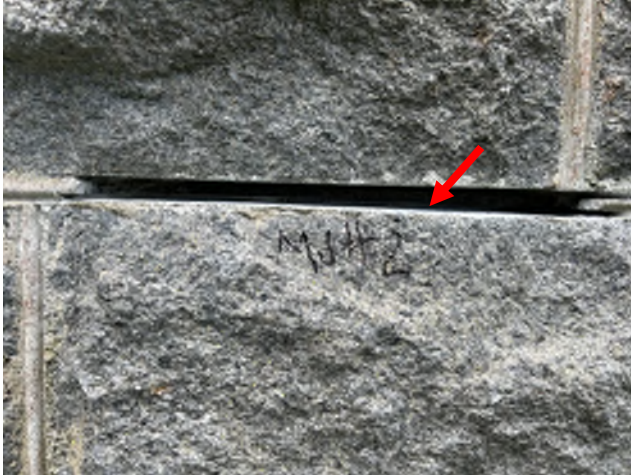
Image 243: View of granite mortar joint test cut no. 2.

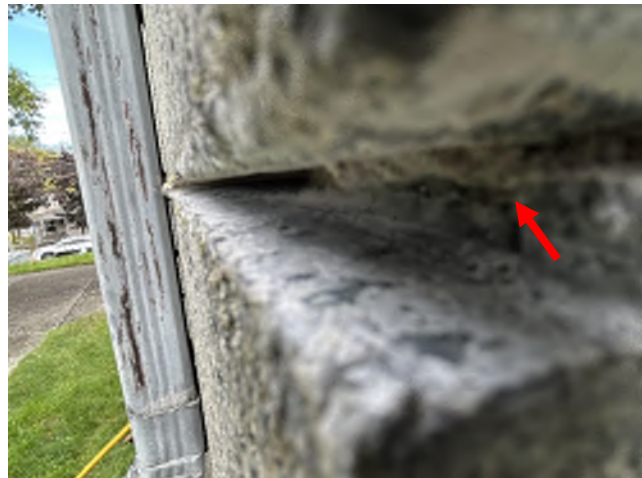
Image 246: Angled view of the previous image shows intact mortar at the back of the cut and an apparent separation between the pointing and bedding mortar.

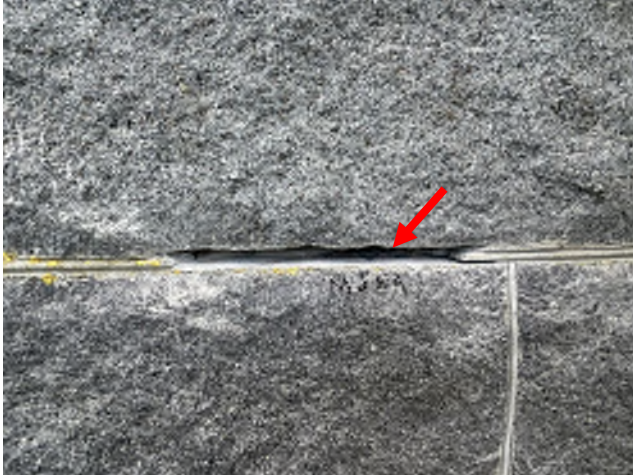
Image 247: View of granite mortar joint test cut no. 4.

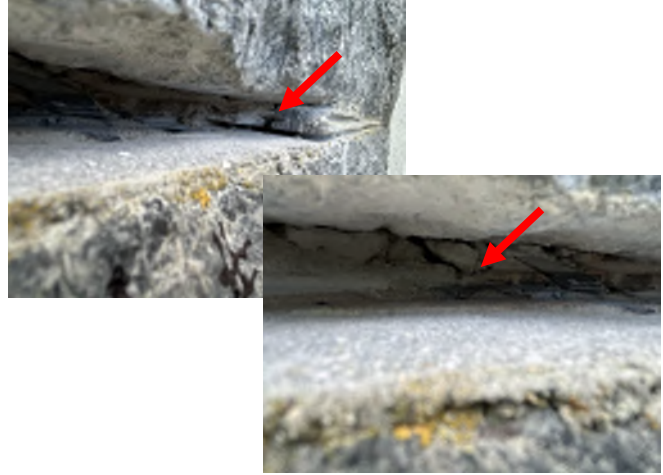
Image 248: Closer views of the previous image show a shallow pointing bead, an apparent separation between the pointing and bedding mortar, and deteriorated (crumbled) mortar in the back of the cut.

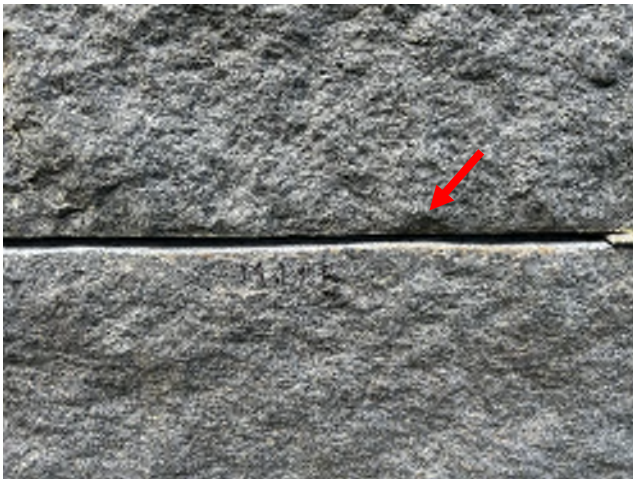
Image 249: View of granite mortar joint test cut no. 5.

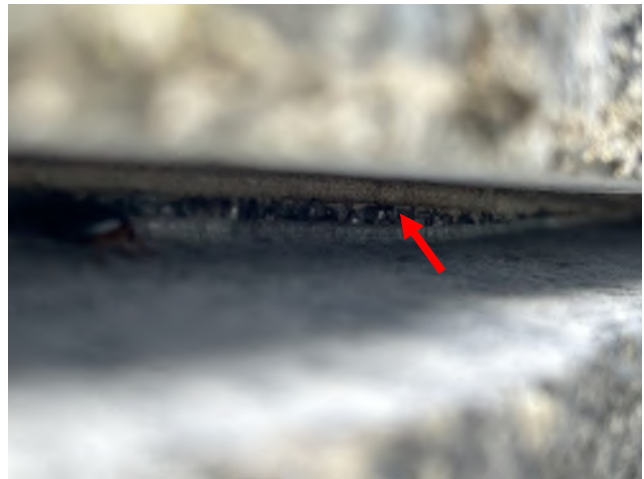
Image 250: Closer view of the previous image shows bedding mortar that appeared intact and metal, which appeared to be the spacer.

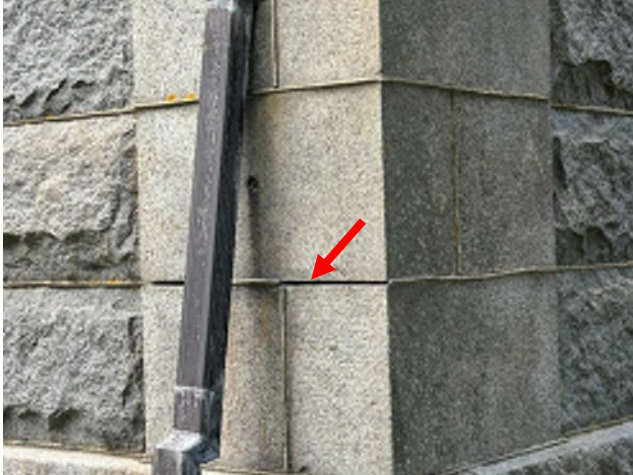
Image 251: View of granite mortar joint test cut no. 6.

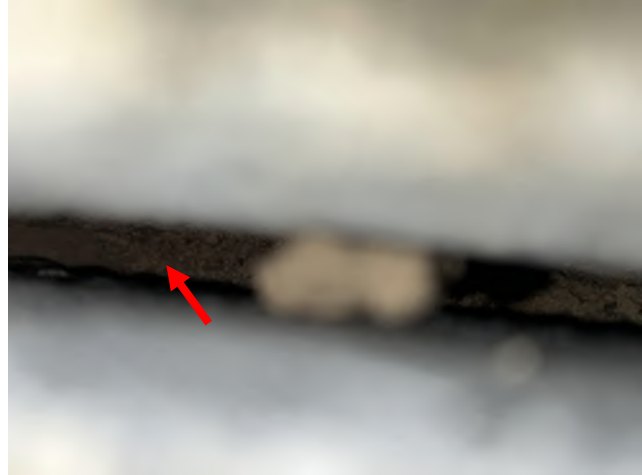
Image 252: Closer view of the previous image shows bedding mortar that appeared to be deteriorated.

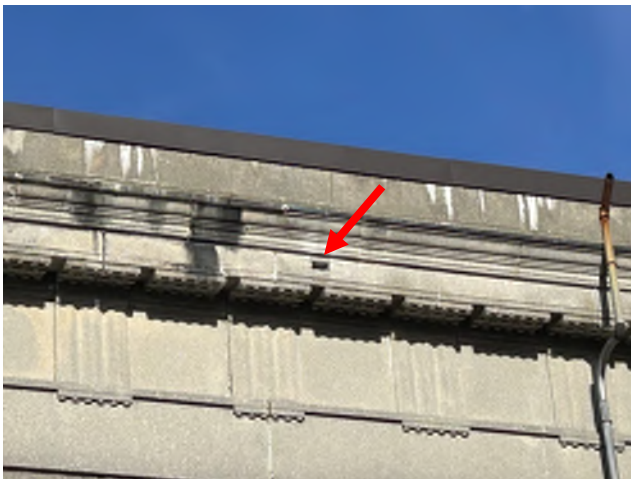
Image 255: View of precast concrete test cut no. 1.

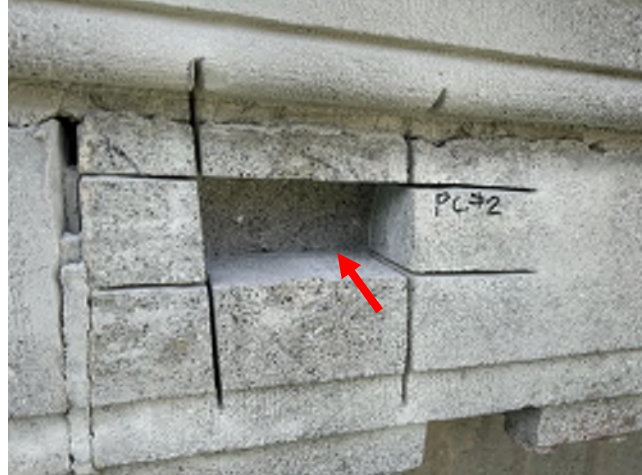
Image 258: Closer view of the previous image shows precast concrete that appeared intact.

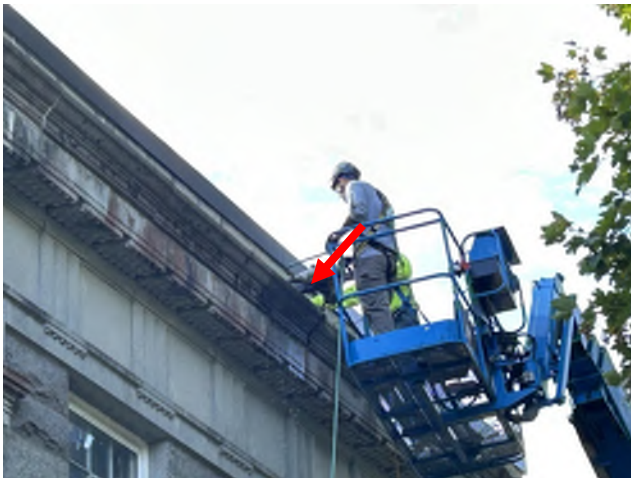
Image 259: View of precast concrete test cut no. 3

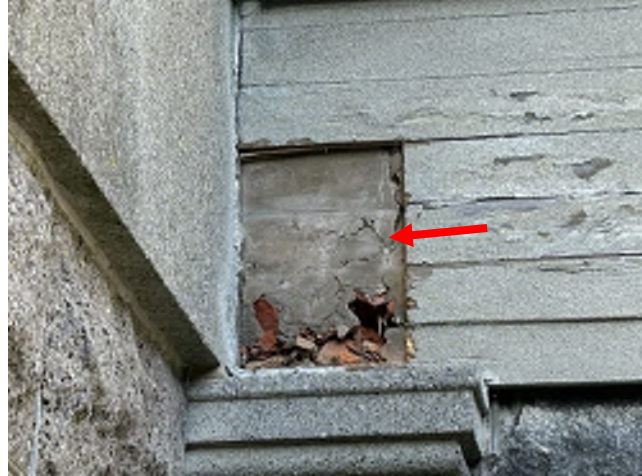
Image 262: Closer view of the previous image shows terra cotta behind painted tongue and groove wood fascia boards.

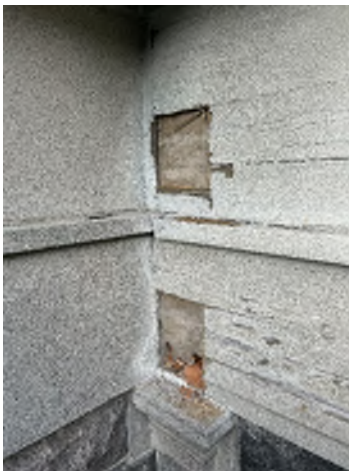
Image 263: View of wood test cut no. 2 depicted by the arrow.

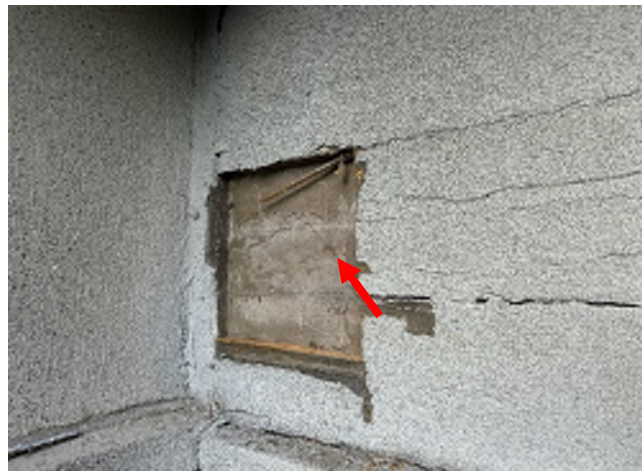
Image 264: Closer view of wood test cut no. 2 shows terra cotta backup directly behind the painted wood fascia.
