**Restoration of the  
Barnstable County Superior  
Courthouse  
3195 Main Street  
Barnstable, MA 02630**

**Gale JN 843680  
May 9, 2025**

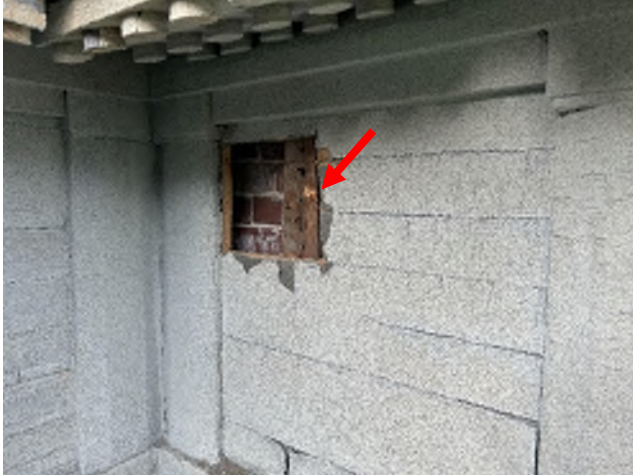
Image 265: View of wood test cut no. 3 shows painted wood fascia on wood furring against brick masonry.

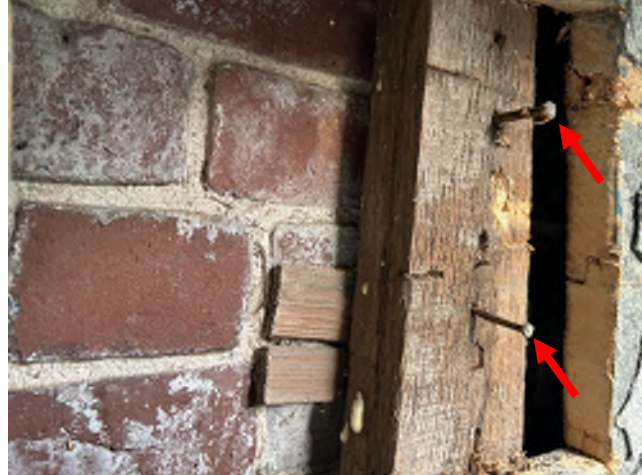
Image 266: Closer view of the previous image shows efflorescence staining and deteriorated mortar in the masonry wall, deteriorated wood furring and rusted fasteners.

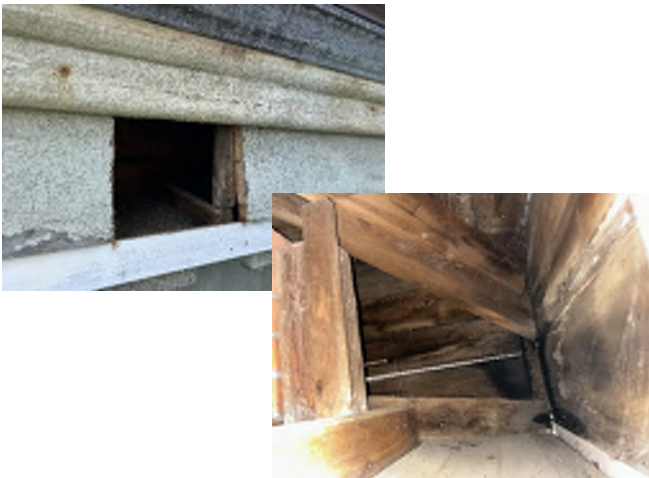
Image 267: Exterior and interior views of wood test cut no. 4. Note water and wet staining on the wood components in the cavity.

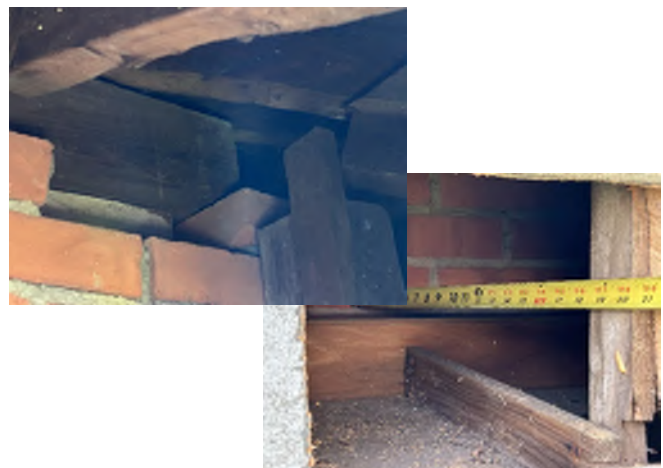
Image 268: A brick masonry wall that extends up to the underside of the roof observed in wood test cut no. 4.

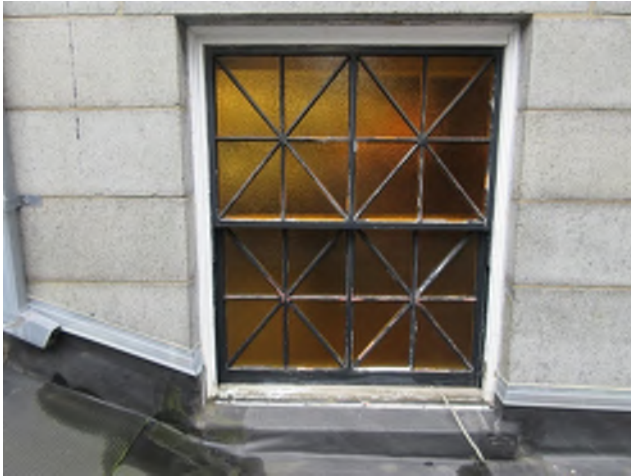
Image 269: Exterior view of a typical double-hung window at the building.

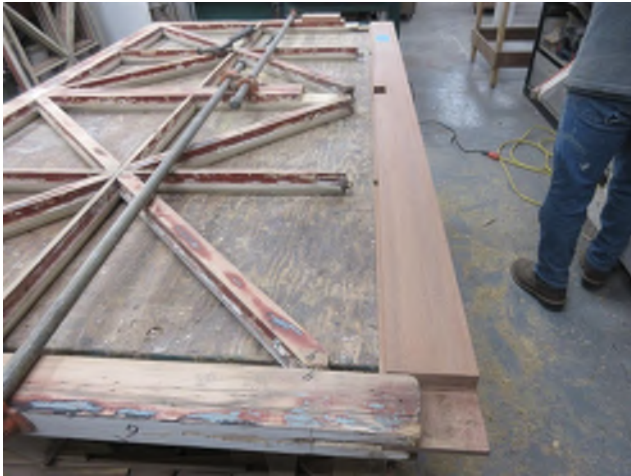
Image 271: Once paint was removed, various repairs were performed to the windows. This photo illustrates the replacement of one (1) of the sash rails with mahogany

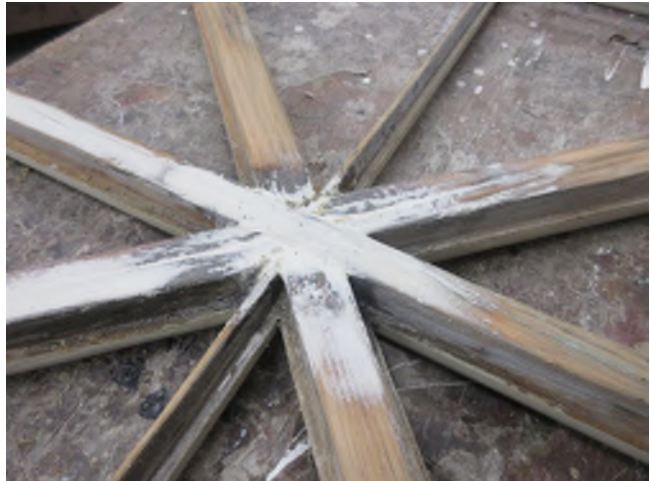
Image 272: Deterioration at sash joints was common, with joints needing to be reglued and infilled with epoxy.

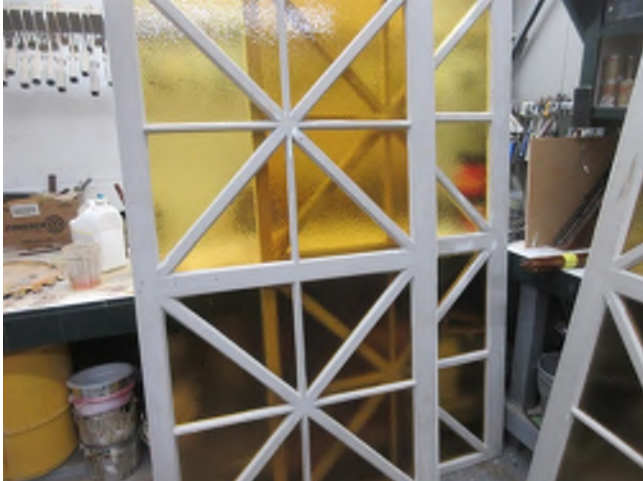
Image 273: Once repaired, the windows were primed and re-glazed.

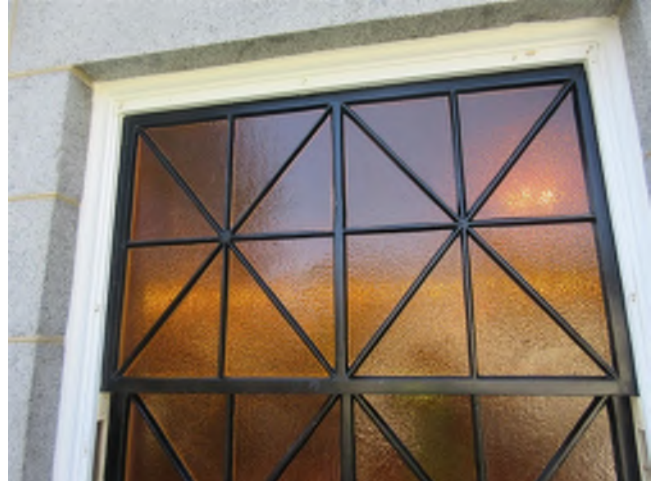
Image 274: Eventually the windows received finish paint and were reinstalled.

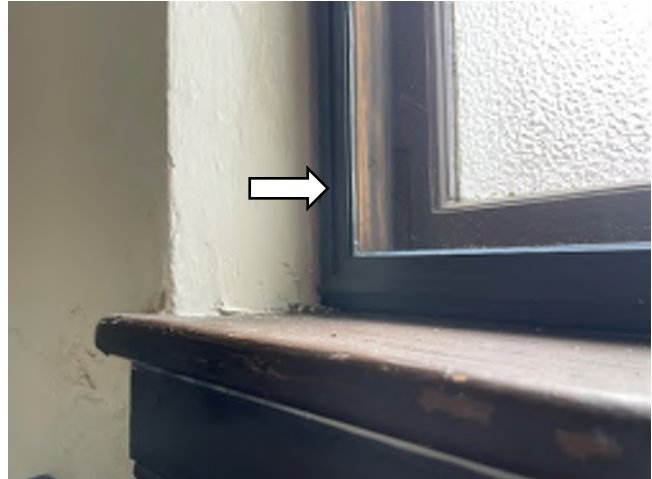
Image 276: The arrow indicates the storm window frame.

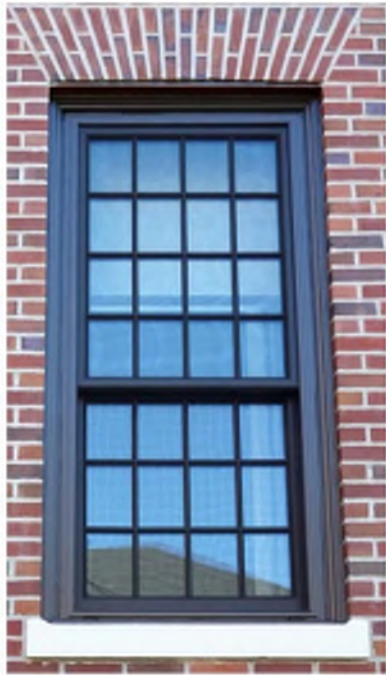
Image 277: Exterior image of St. Cloud SCW5000 aluminum hung window (U-0.4) (image taken from St. Cloud Window website).

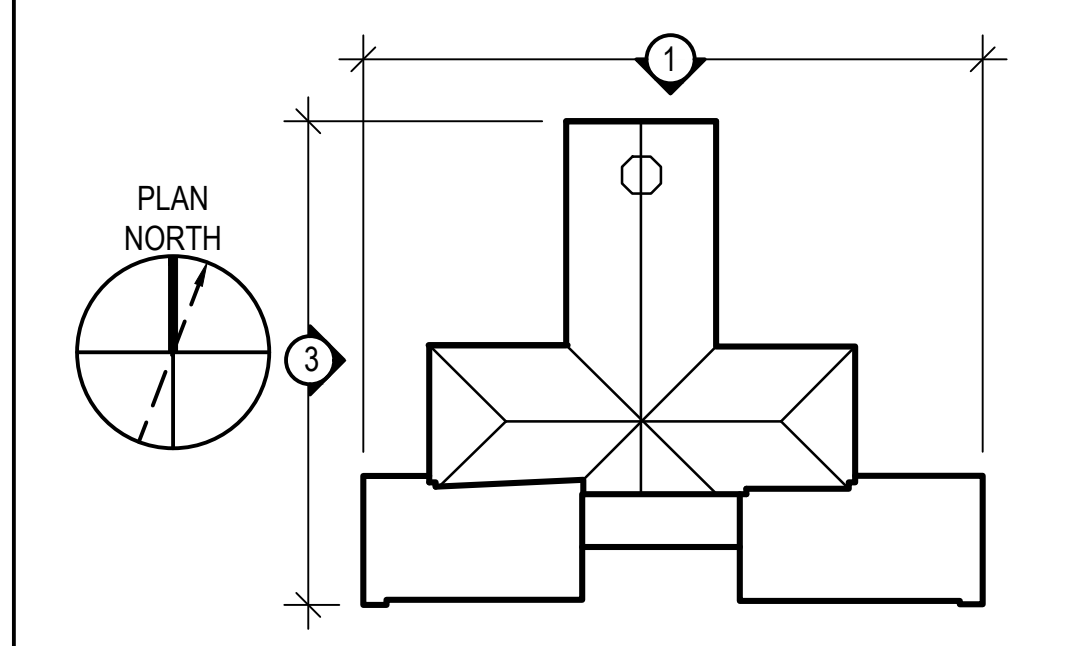
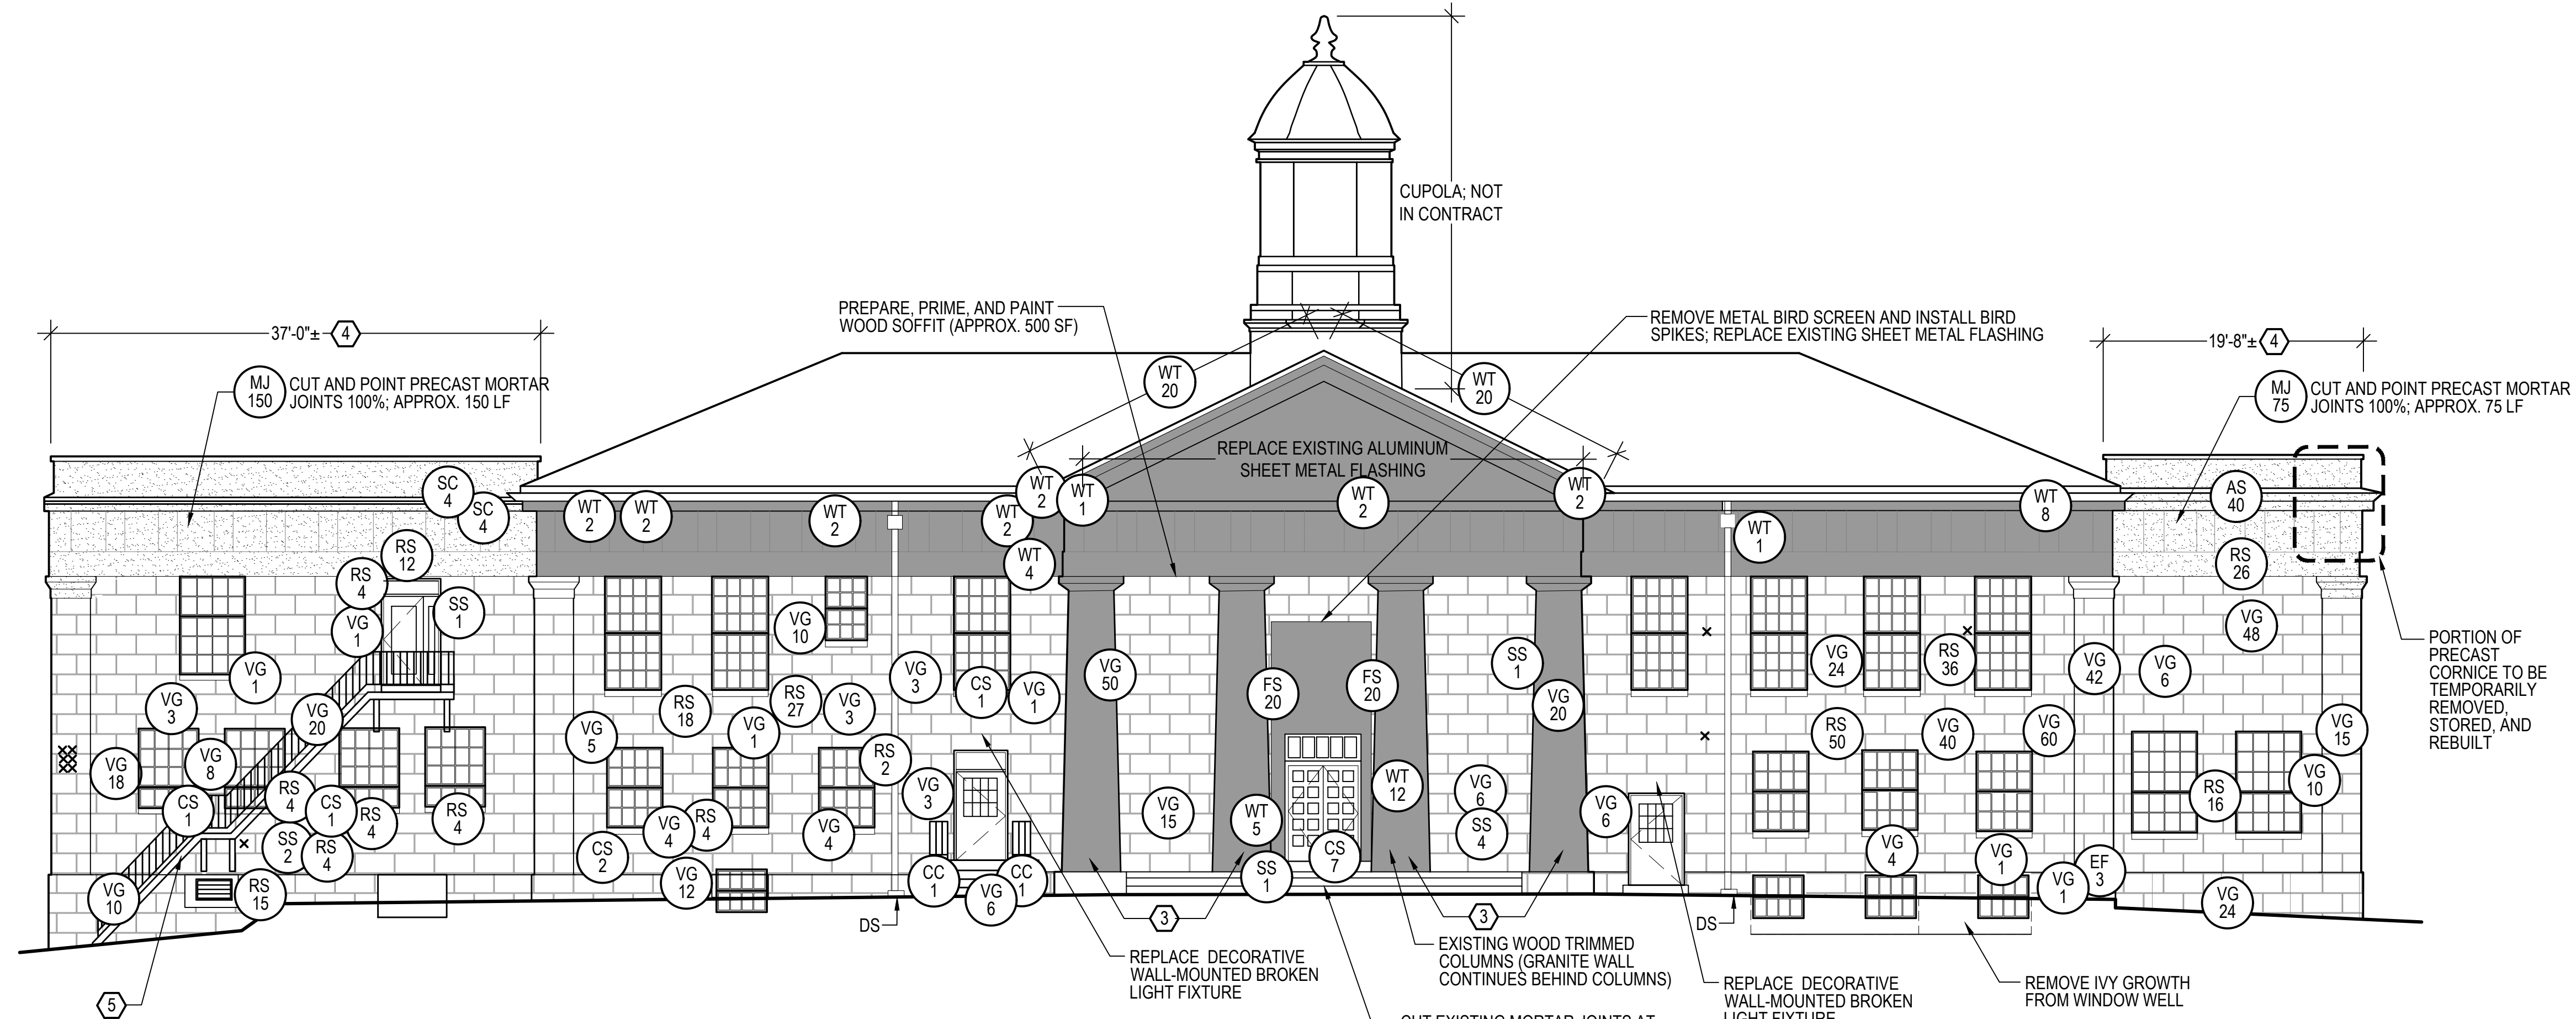
**1**  
 WALL REPAIR SCOPE  
 NORTH ELEVATION  
 A201 SCALE: 1/8"=1'-0"

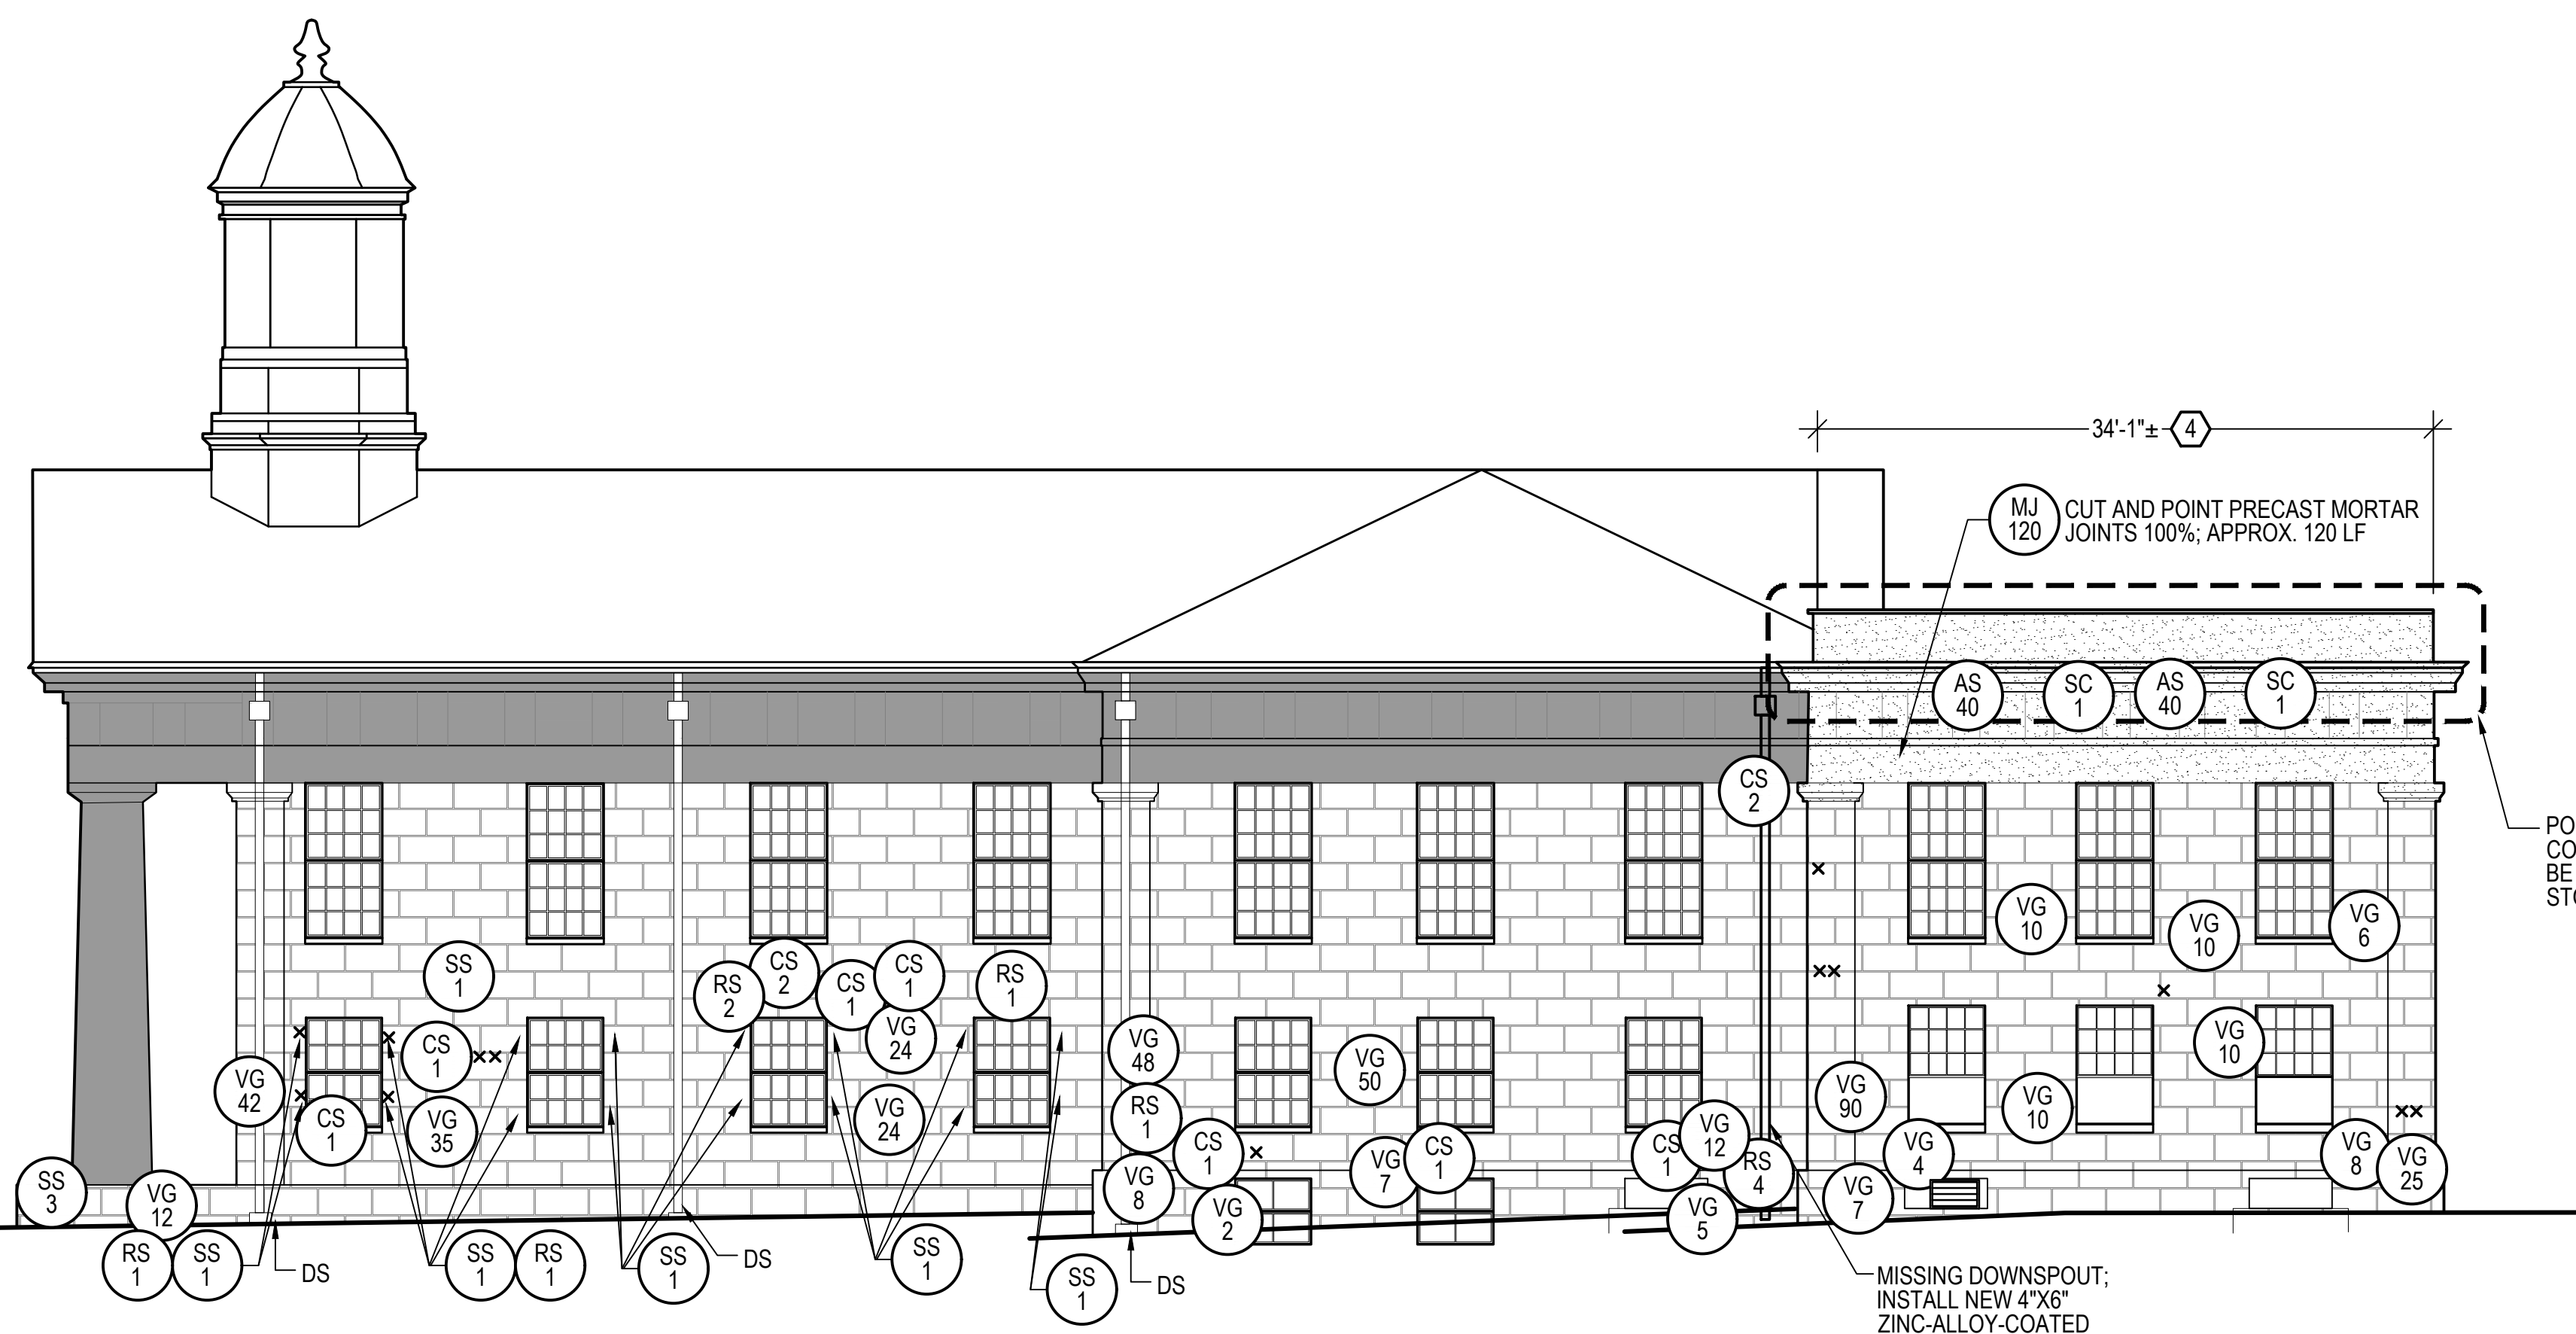
**2**  
 WALL REPAIR SCOPE  
 WEST ELEVATION  
 A201 SCALE: 1/8"=1'-0"

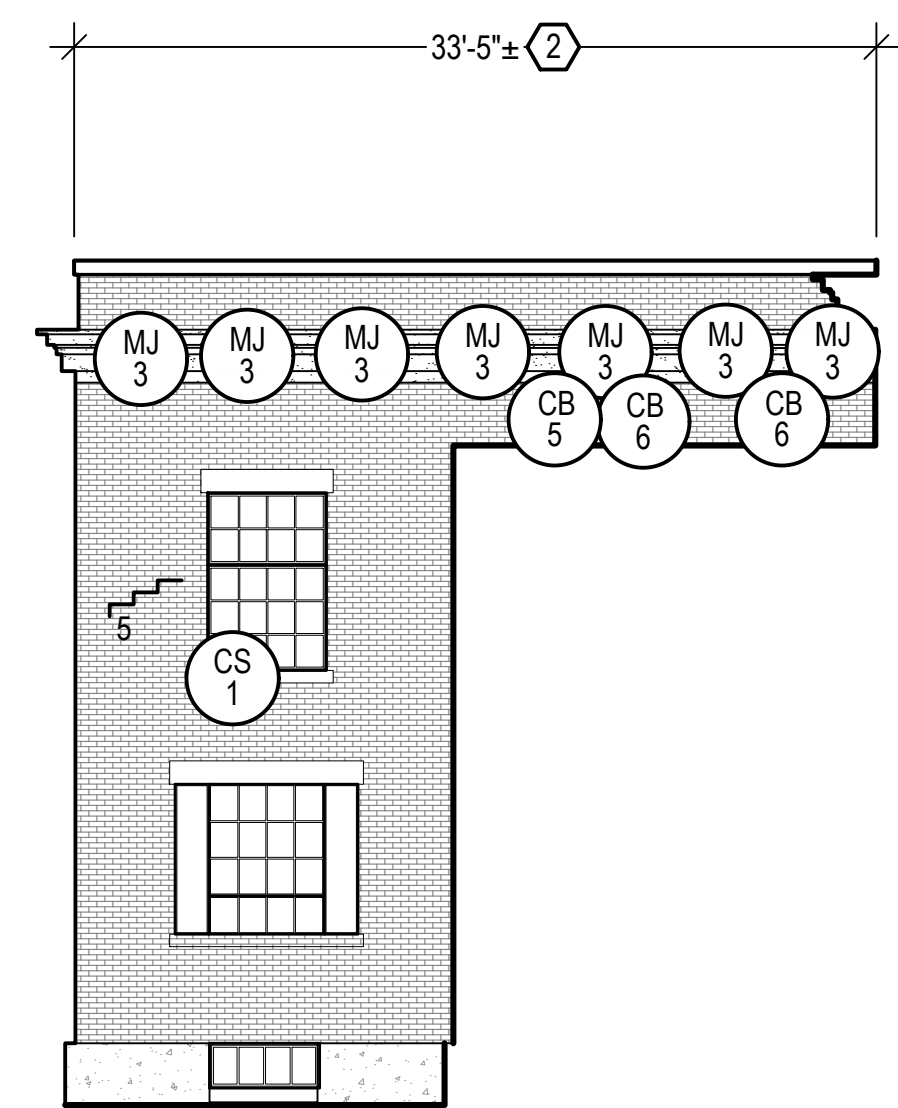
**WALL REPAIR SCOPE HIDDEN WEST ELEVATION**  
 5 A202 SCALE: 1/8"=1'-0"

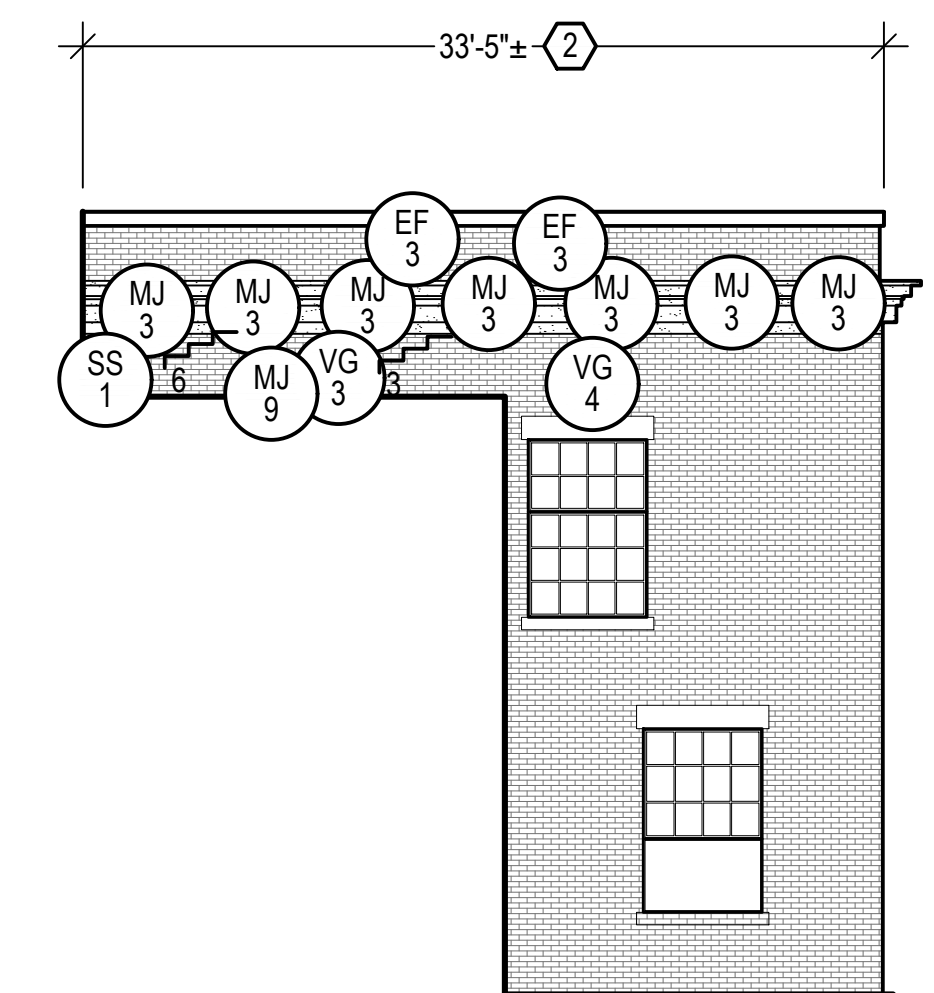
**WALL REPAIR SCOPE HIDDEN EAST ELEVATION**  
 6 A202 SCALE: 1/8"=1'-0"

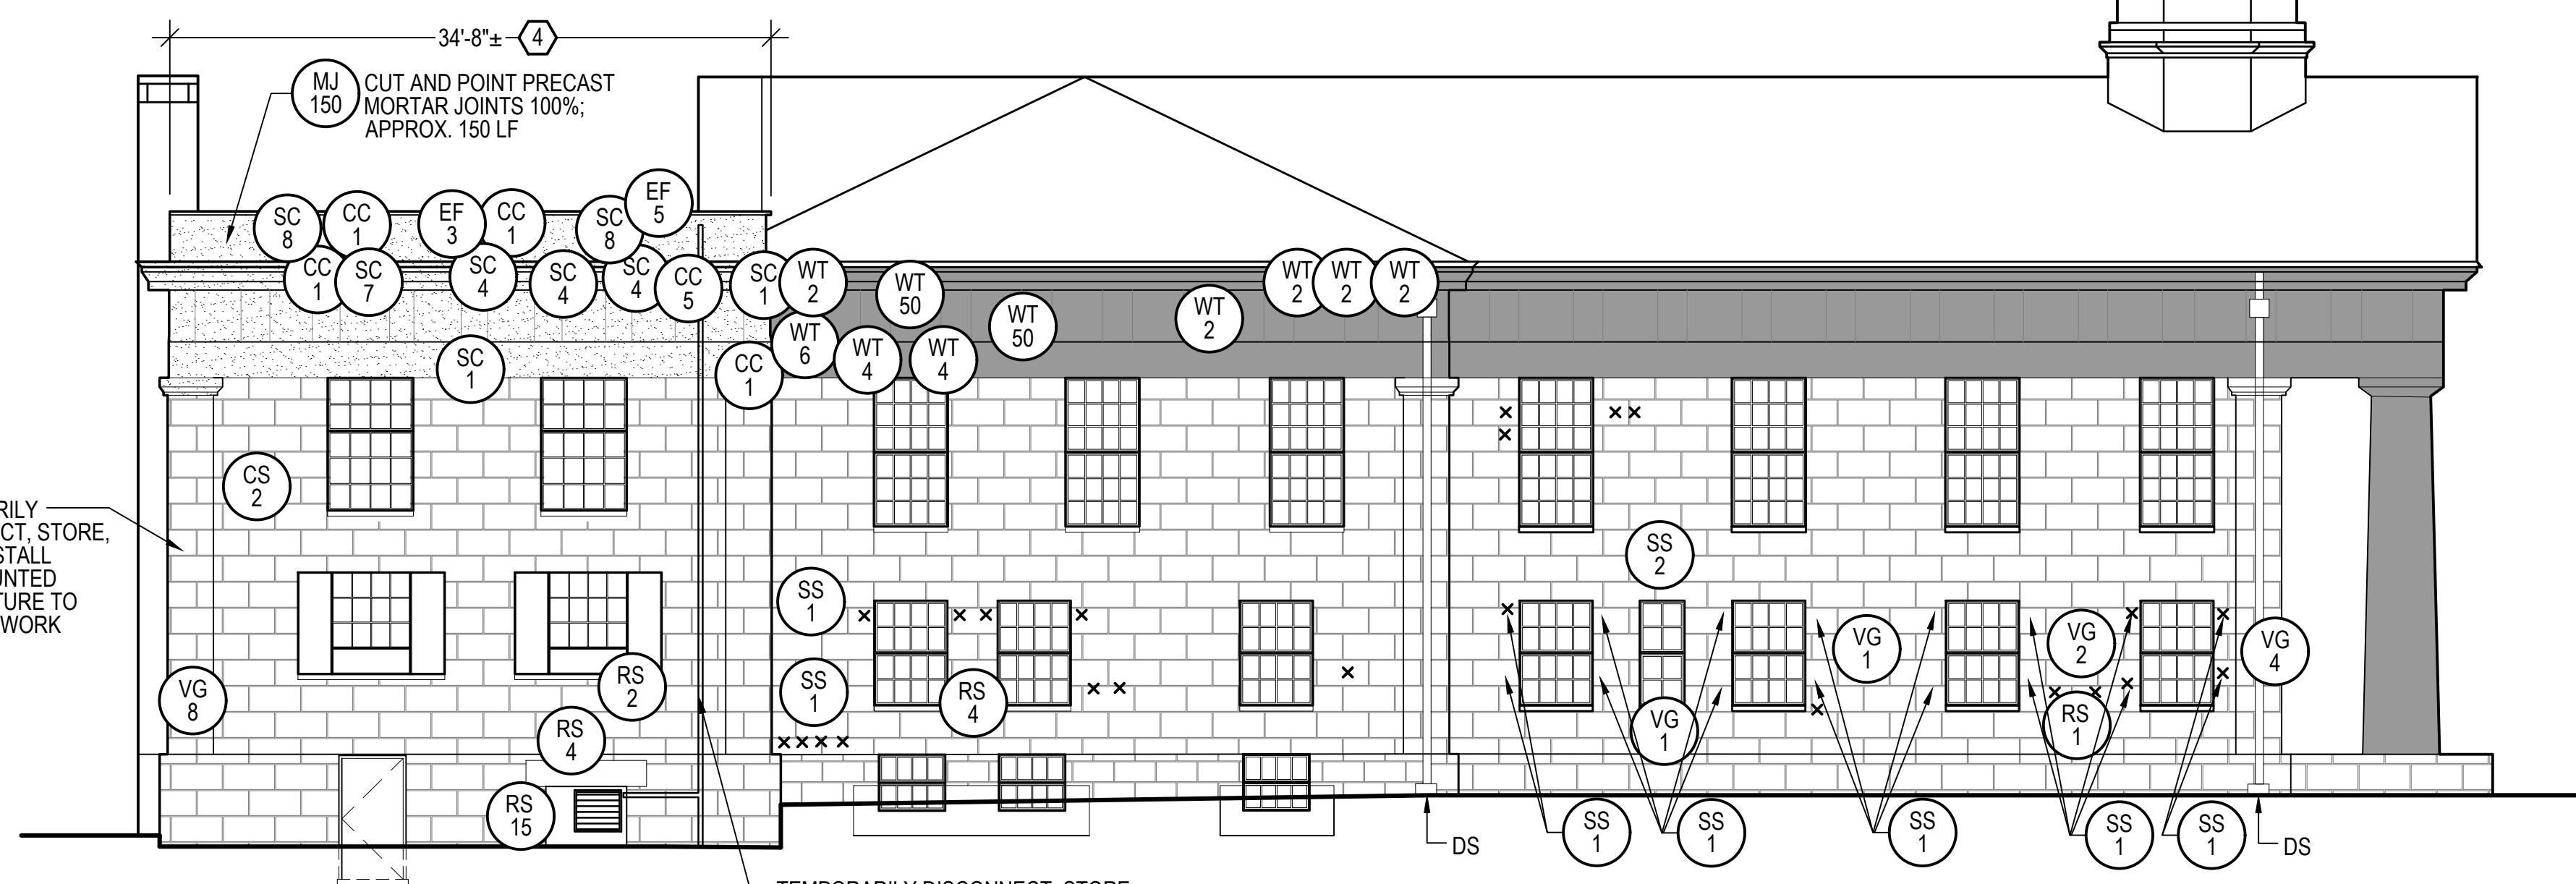
**WALL REPAIR SCOPE EAST ELEVATION**  
 4 A202 SCALE: 1/8"=1'-0"

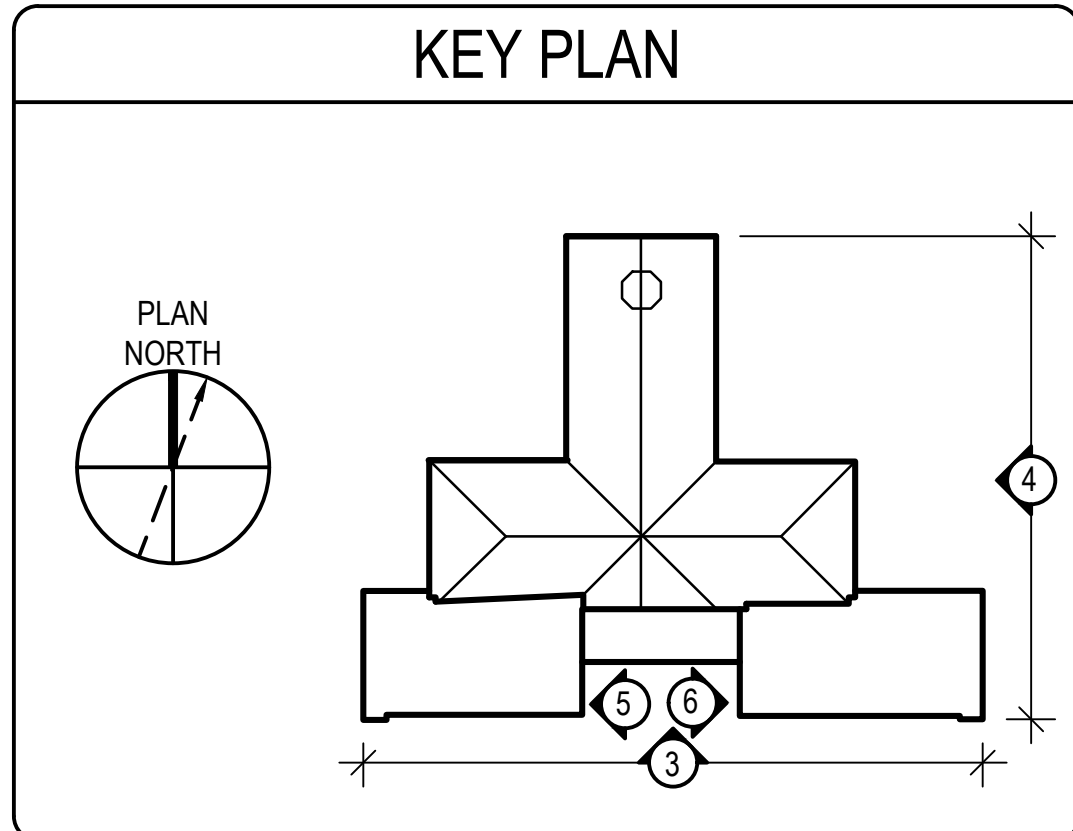
**GALE**  
 Gale Associates, Inc.  
 Engineers and Planners  
 300 LEDGEWOOD PL | ROCKLAND, MA 02370  
 P 781.335.6465 F 781.335.6467  
 www.galeinc.com  
 Boston Baltimore Orlando Hartford  
 Manchester Portland

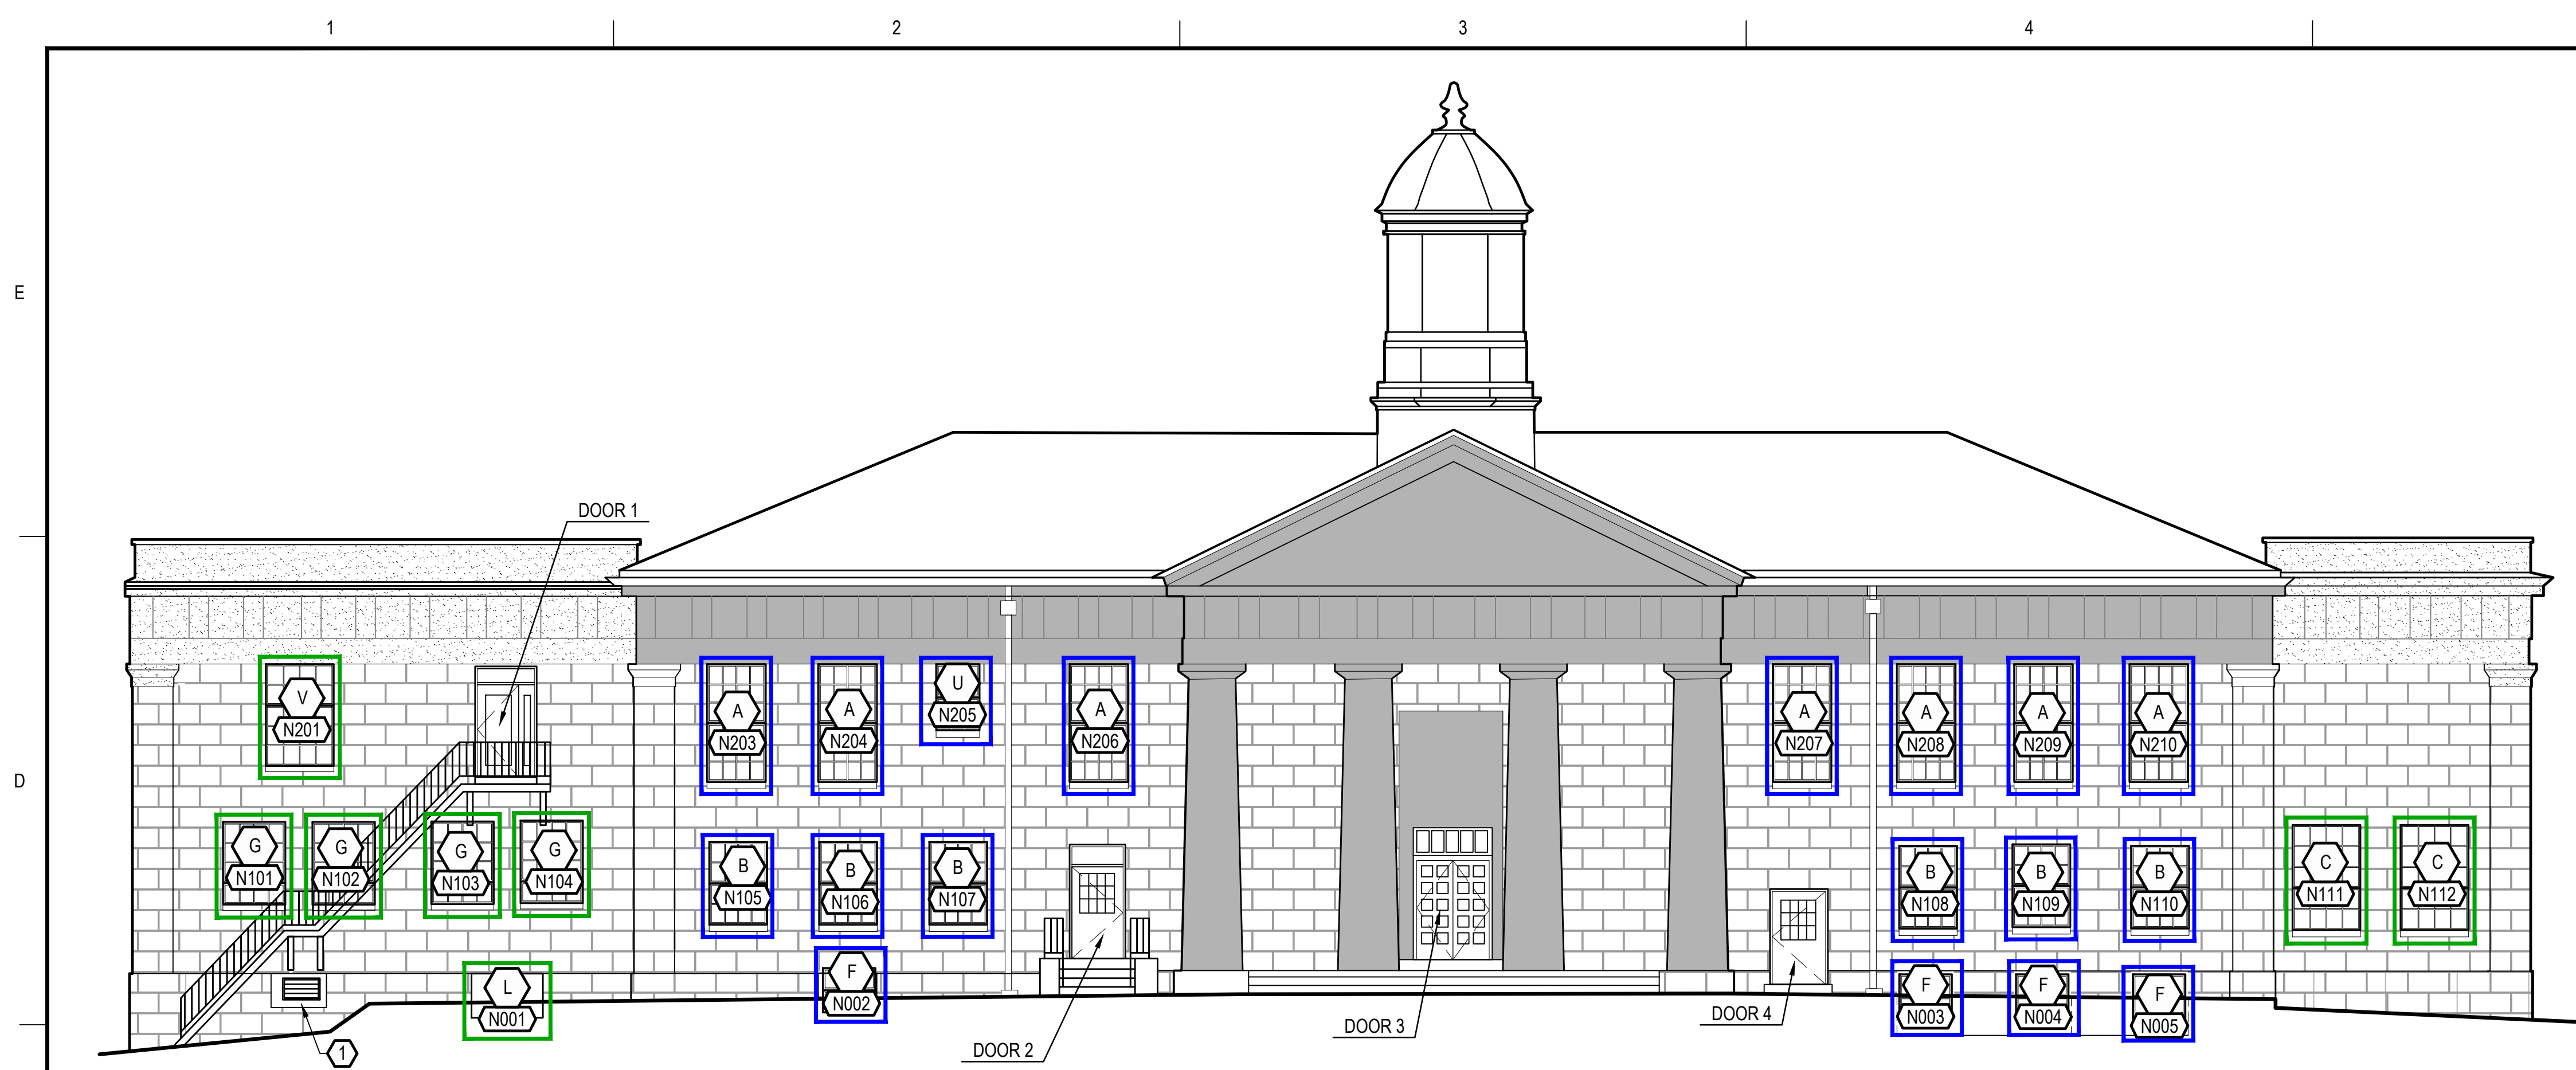
2  
A203  
FENESTRATION SCOPE  
NORTH ELEVATION  
SCALE: 1/8"=1'-0"

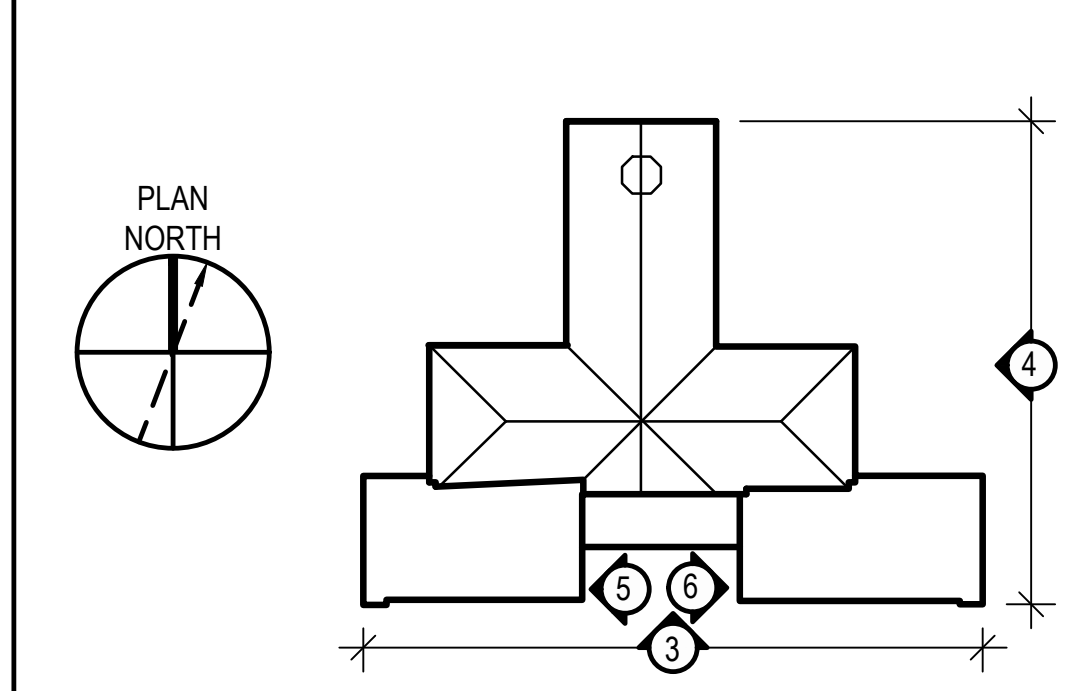
**Gale Associates, Inc.**  
Engineers and Planners  
300 LEDGEWOOD PL | ROCKLAND, MA 02370  
P 781.335.6465 F 781.335.6467  
www.galinc.com  
Boston Baltimore Orlando Hartford  
Manchester Portland

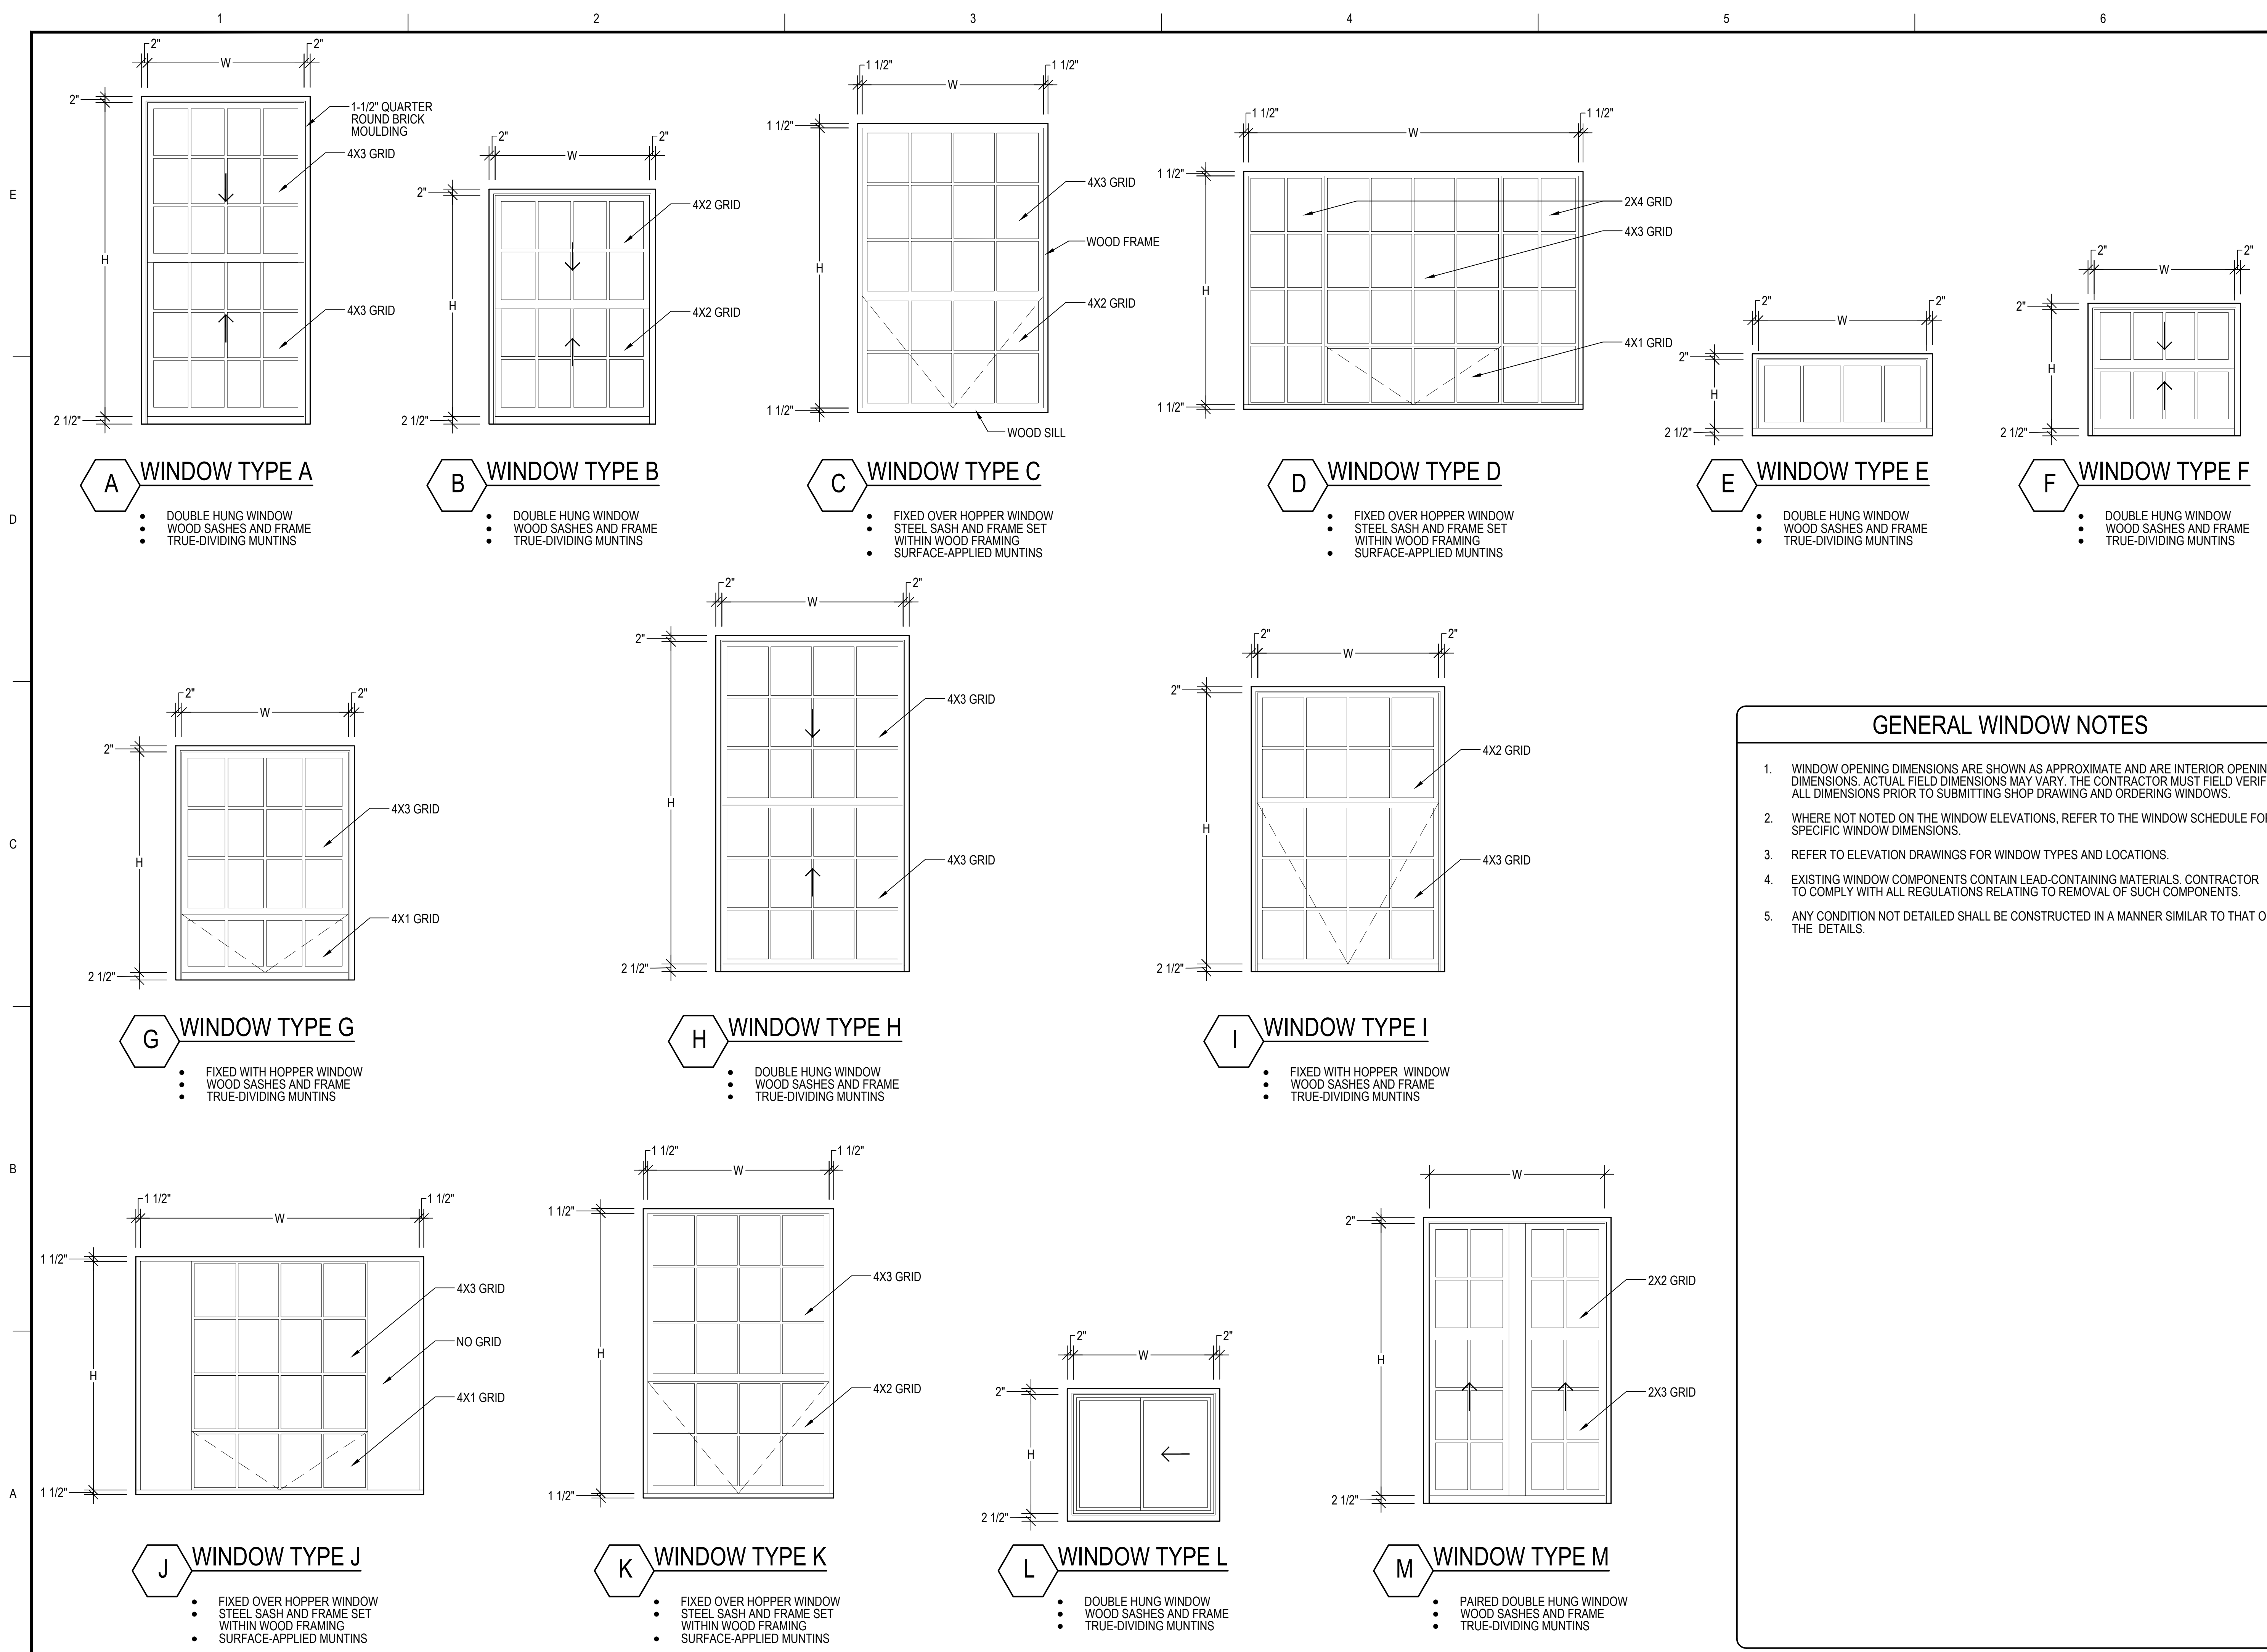
**GENERAL WINDOW NOTES**

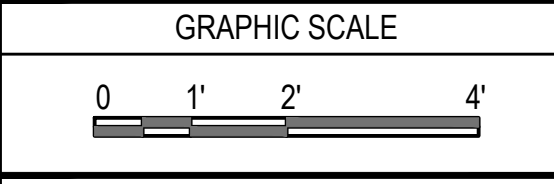
NO.	DATE	DESCRIPTION	BY
PROJECT NO.			
CADD FILE		843680 A200s	
DESIGNED BY		SWWW/RFM	
DRAWN BY		SWWW/JEN	
CHECKED BY		BHN	
DATE		12/20/24	
DRAWING SCALE		1/2"=1'-0"
