**Restoration of the  
Barnstable County Superior  
Courthouse  
3195 Main Street  
Barnstable, MA 02630**

**Gale JN 843680  
May 9, 2025**

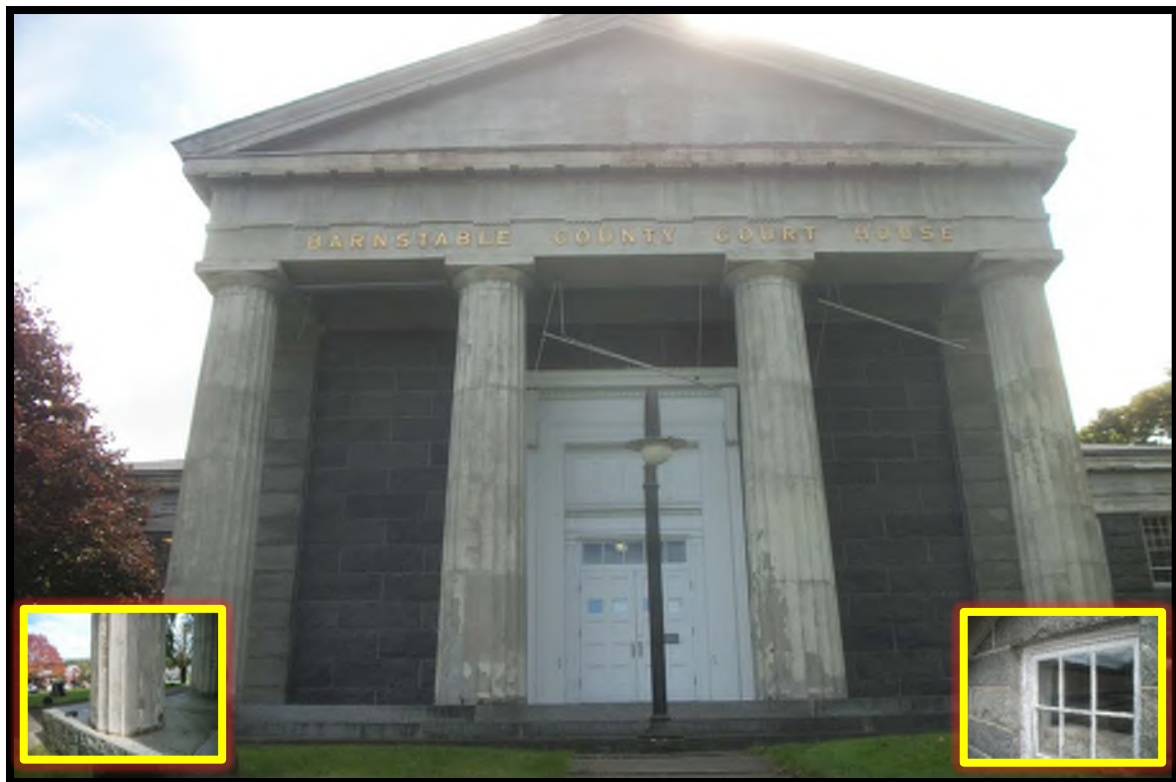
**LIMITED HAZARDOUS BUILDING MATERIALS INSPECTION**  
**BARNSTABLE SUPERIOR COURT BUILDING**  
**3195 MAIN STREET**  
**BARNSTABLE, BARNSTABLE COUNTY, MASSACHUSETTS**

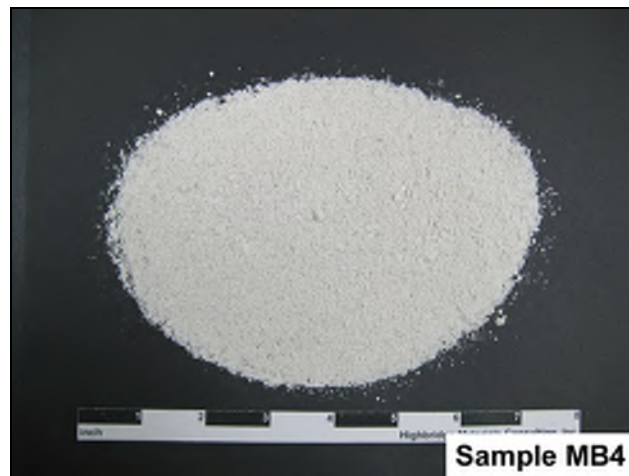
**Figure 1:** Photographs of the lime mortar (Sample MB4) provided to Highbridge for analysis. The sample consists entirely of loose granules and powdered debris. It has a nearly white color overall.

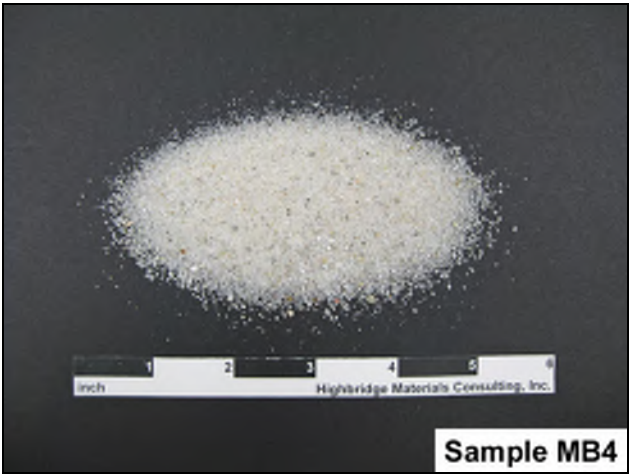
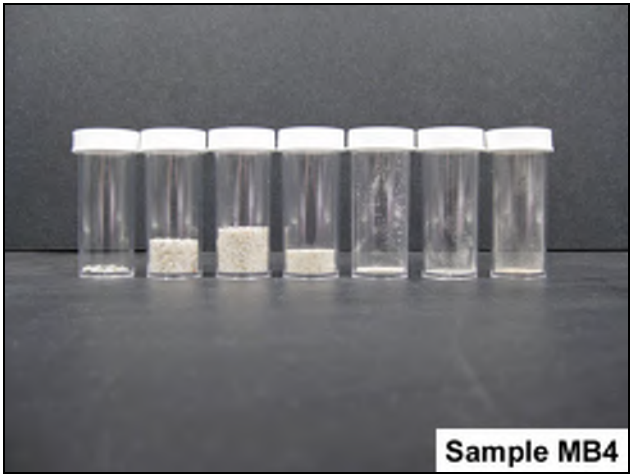
**Figure 2:** Photographs illustrating the sand sample extracted from Sample MB4 through acid digestion. The total extraction is shown at left. The sand is uniform and semi-translucent with a light gray color. At right, the sand is shown after gradation through a standard sieve stack. The gradation is broad and the sand is medium-grained. The vial at right contains minor unwashed silt and clay.

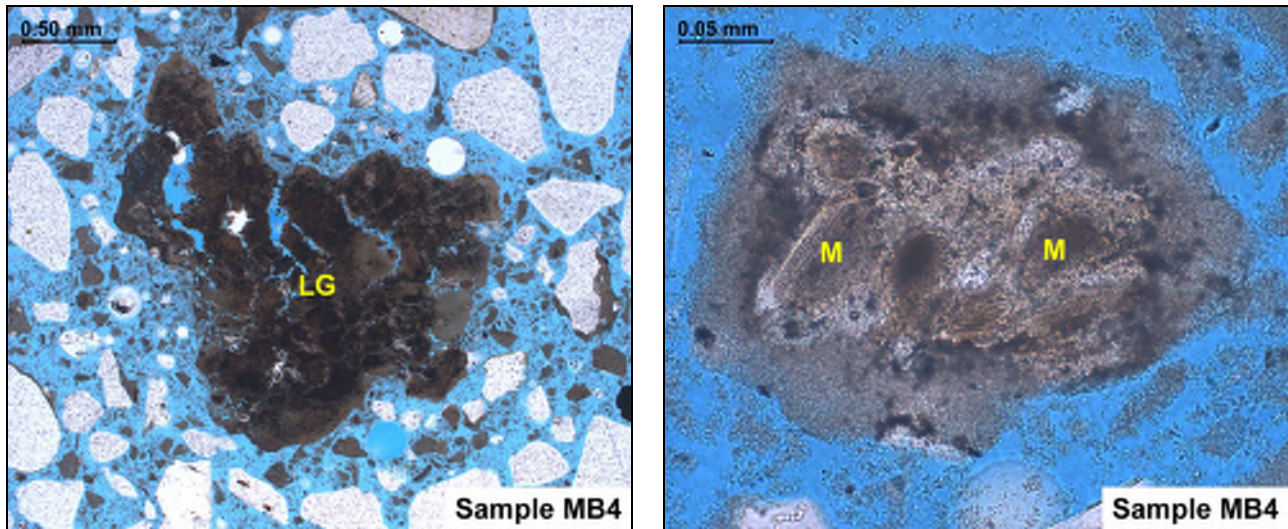
**Figure 4:** PPL photomicrographs illustrating mineralogical and microtextural features of the lime in Sample MB4. (Left image) An undispersed lime grains is shown. (Right image) A cluster of fired mica (M) is shown within a fragment of lime paste. This suggests that the lime was burned from a marble source.

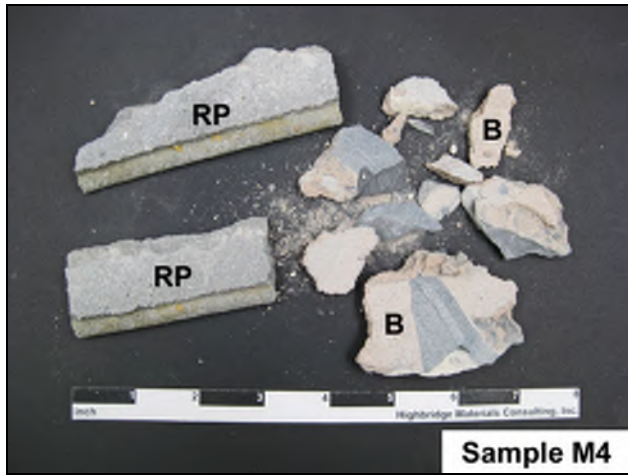
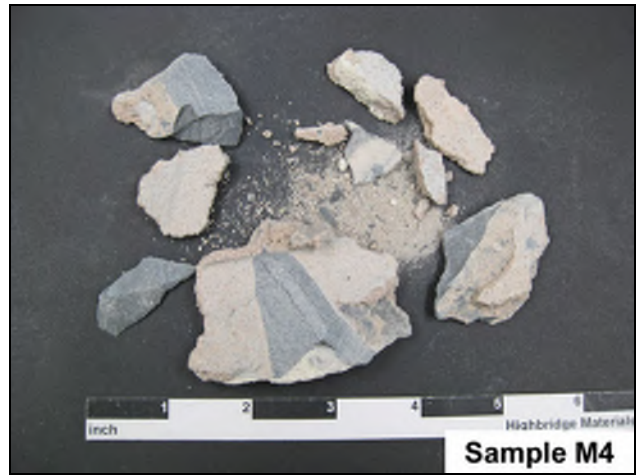
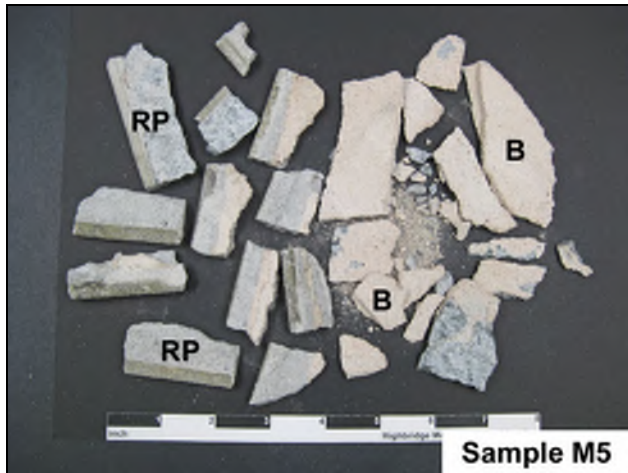
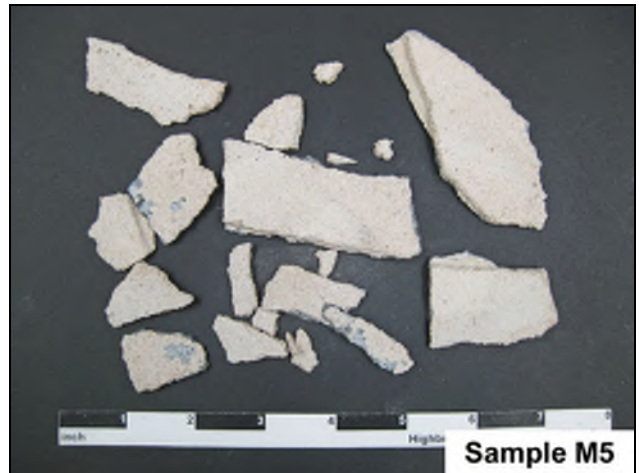
**Figure 5:** Photographs of the natural cement mortars (Samples M4 and M5) provided to Highbridge for analysis. (Left images) Each sample contains some gray repointing mortar (RP) in addition to the pale pink bedding mortar (B) that is the focus of the analysis. (Right images) The examined, pale pink mortars are cohesive yet relatively soft and moderately permeable.

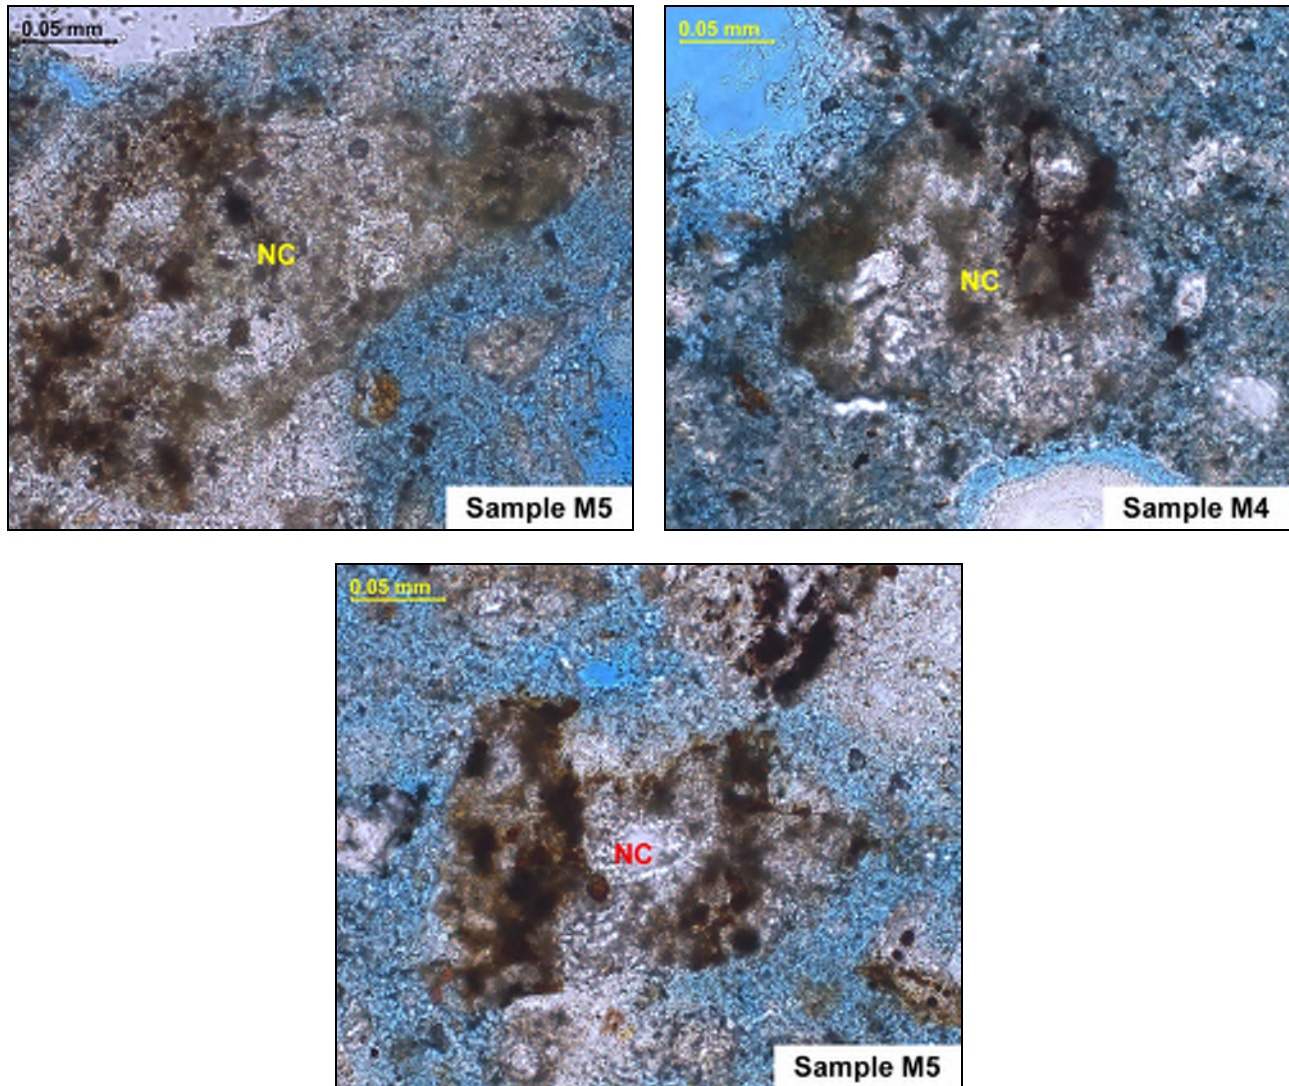
**Figure 9:** PPL photomicrographs illustrating mineralogical and microtextural features of the natural cement in Samples M4 and M5. The natural cement particles (NC) are found to a maximum size of 0.2 millimeters. These exhibit complex microtextures consistent with an argillaceous limestone that has been fired at a low temperature.

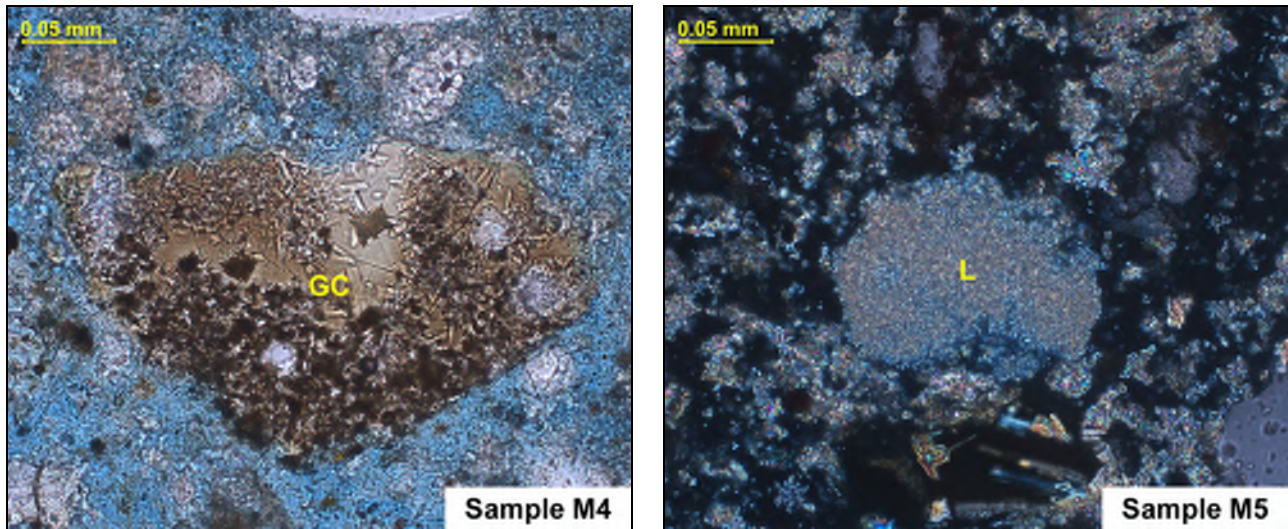
**Figure 10:** Photomicrographs illustrating other particles associated with the natural cement binder in Samples M4 and M5. (Left PPL image) There is a low abundance of glassy clinker particles (GC). (Right XPL image) There are also some lime-rich grains, but these could represent parts of the natural cement rather than signifying the presence of a separate lime addition.

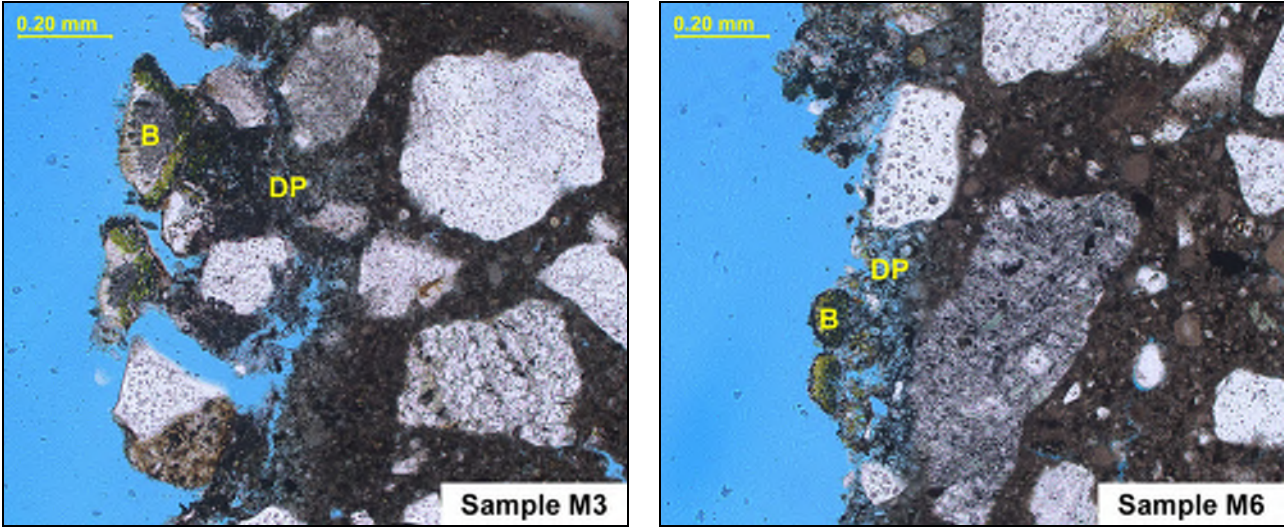
**Figure 21:** PPL photomicrograph illustrating the weathered joint faces in Samples M3 and M6. Both mortars exhibit some normal surface weathering in which there is a thin veneer of degraded paste (DP) with some biological growth (B).

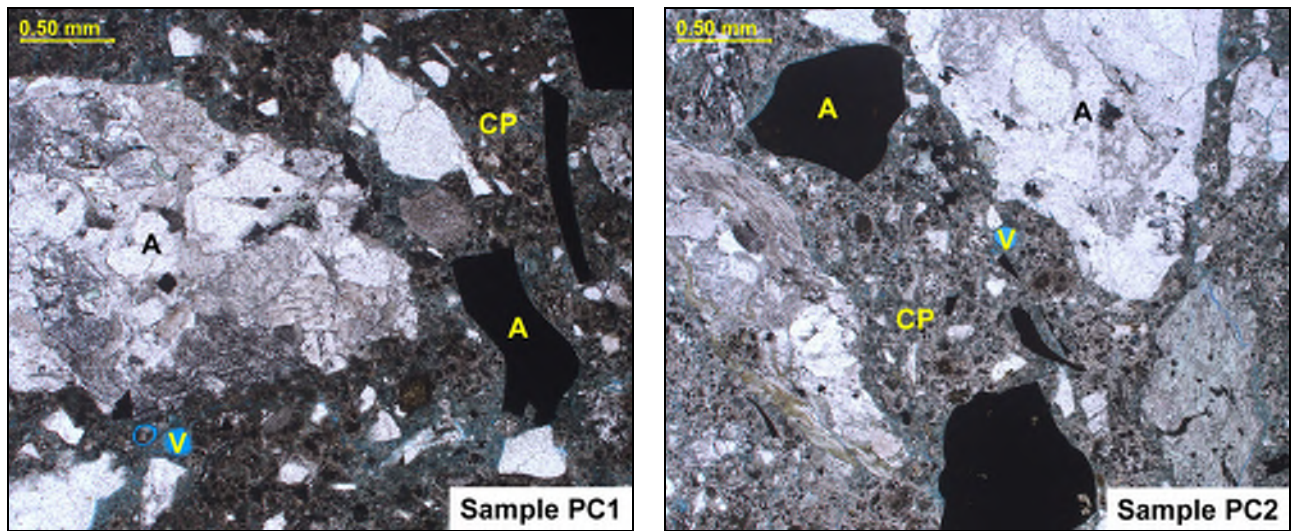
**Figure 4:** PPL photomicrographs illustrating the overall microstructure of the cast stone. The cement paste (CP) is mostly uniformly developed. The degree of absorption of blue-dyed epoxy used in the sample preparation indicates a moderate to moderately high capillary porosity. Aggregate (A) are sharp-textured, well-distributed, and thoroughly coated with hardened cement paste. Air-voids are not especially abundant.

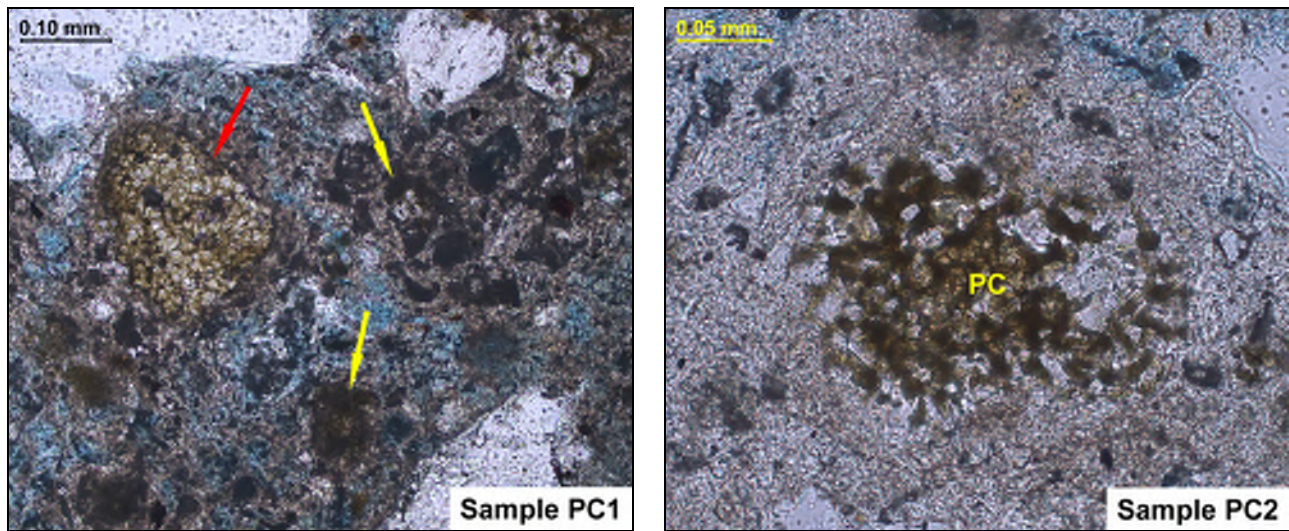
**Figure 5:** Photomicrographs illustrating the portland cement residuals in the cast stone. (Left) The red arrow indicates an unhydrated belite agglomerate with interstitial ferrite. The yellow arrows indicate hydrated cement reliefs that have been filled with cementitious product. (Right) A hydrated portland cement agglomerate (PC) is shown in which only the ferrite remains. The mineralogy and microtextures are consistent with gray portland cement manufactured in the early twentieth century.

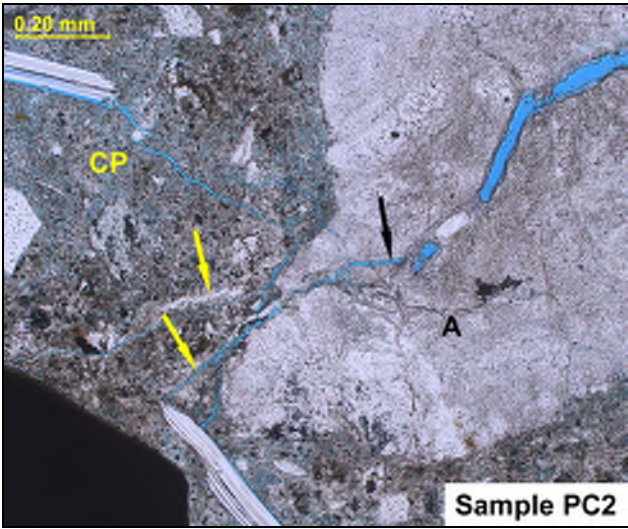
**Figure 6:** PPL photomicrograph illustrating the very minor occurrence of alkali-aggregate reaction in Sample PC2. The arrows indicate a microcrack through coarse aggregate (CA) that extends into adjacent cement paste (CP). There is some non-porous gel within this particular crack. The occurrence of these features is trace, and there is no pervasive distress in the cast stone.

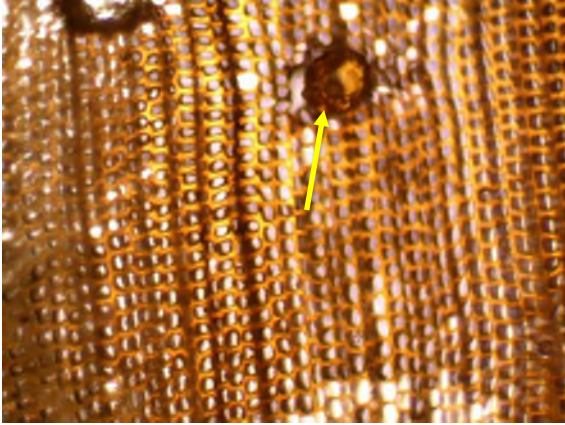
Photo 1 - Longitudinal resin canal observed in sample W2.

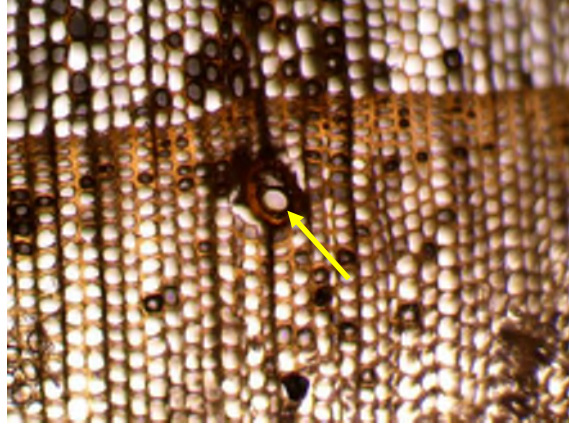
Photo 2 - Longitudinal resin canal observed in sample W3.

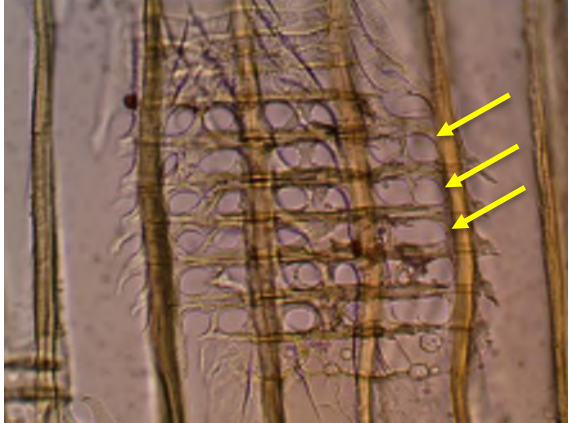
W2	Eastern White Pine
