IMMEDIATE RESPONSE ACTION PLAN MODIFICATION

Barnstable County Fire and Rescue Training Academy
155 South Flint Rock Road
Barnstable, Massachusetts
MassDEP Release Tracking No. 4-26179
Project File 6206

August 2019

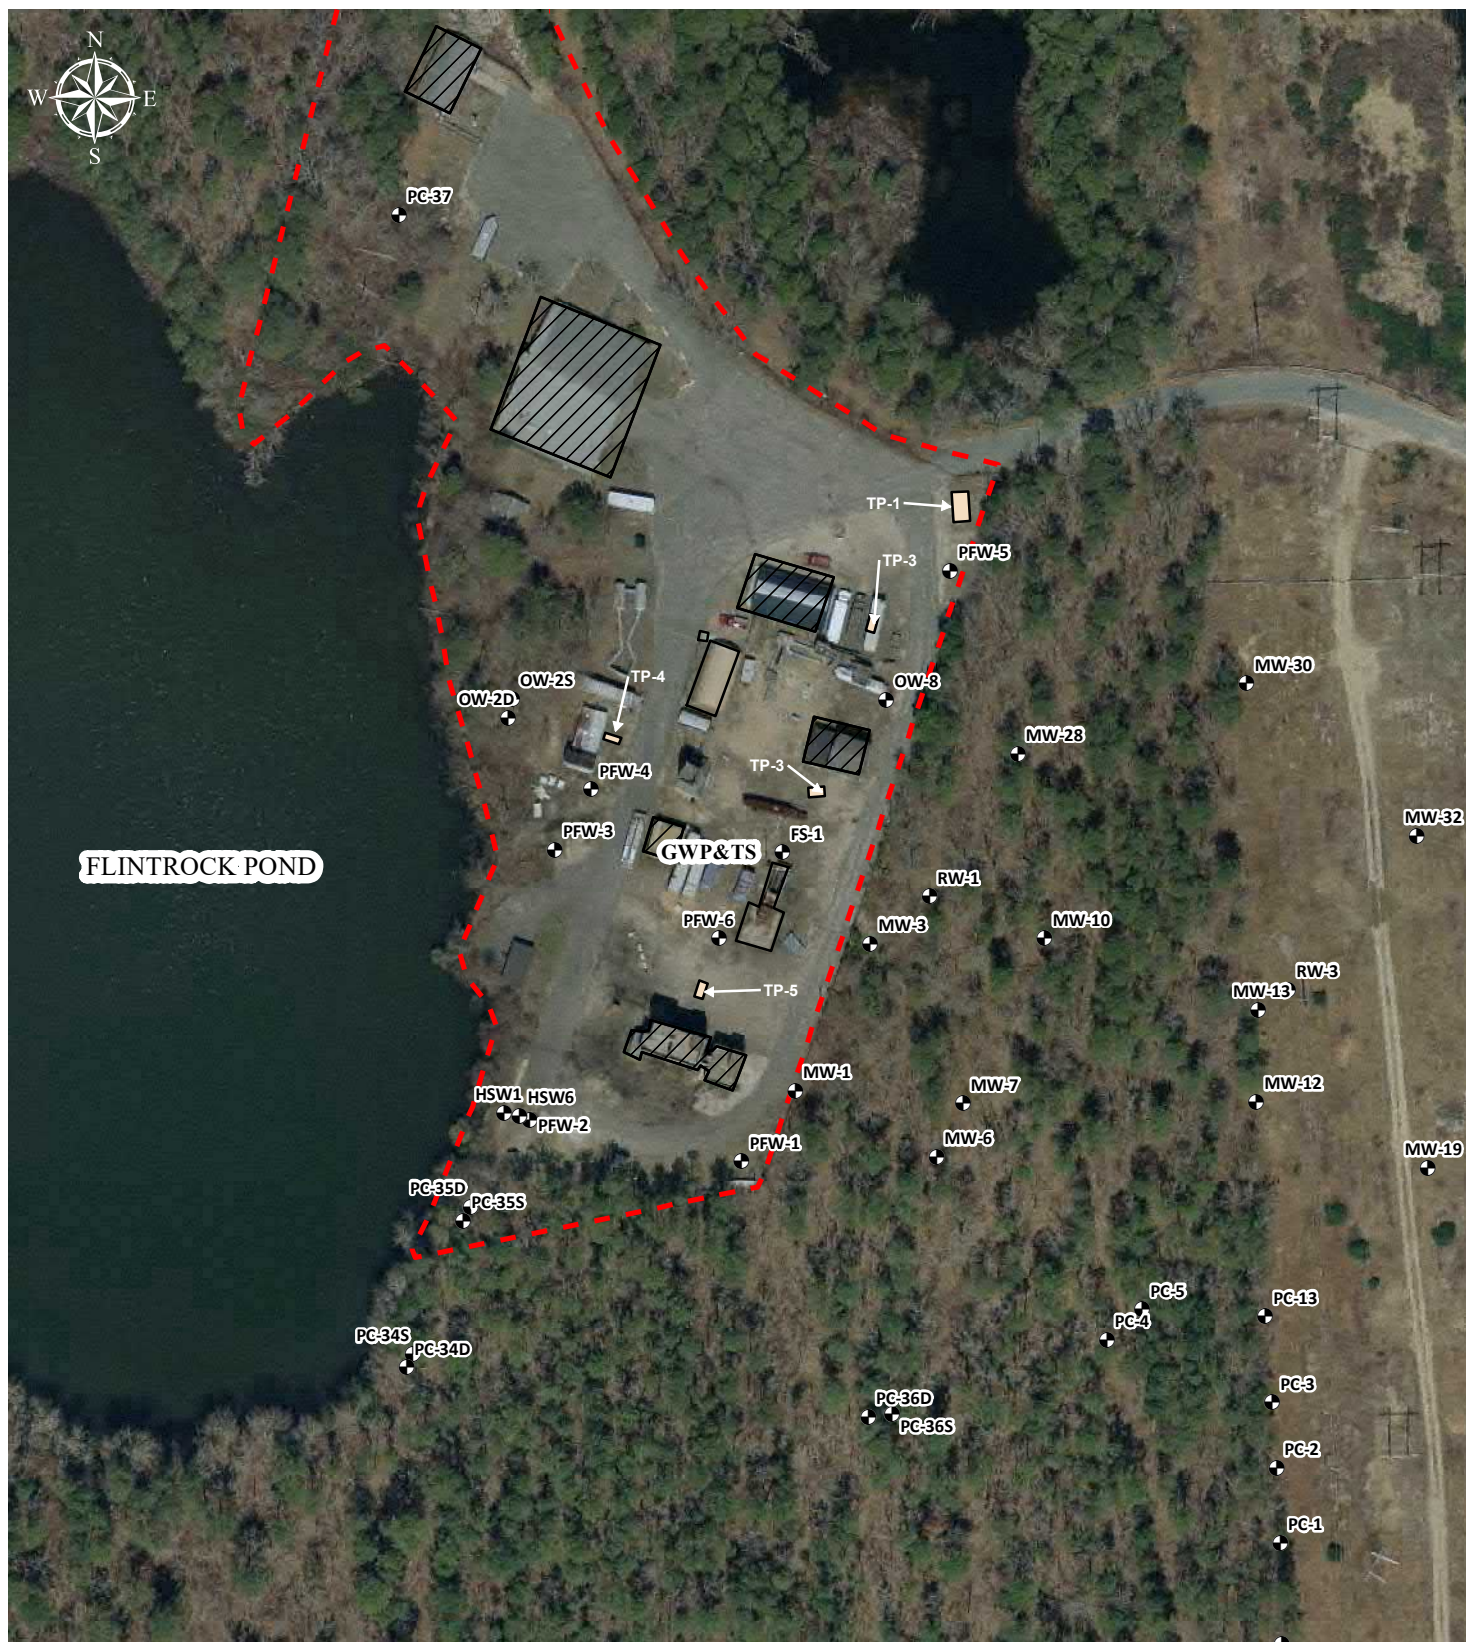
**155 South Flint Rock Road,
Barnstable, MA**

- Monitoring Wells
- Approximate Facility Boundary
- Test Pit -2019
- Major Facility Structures

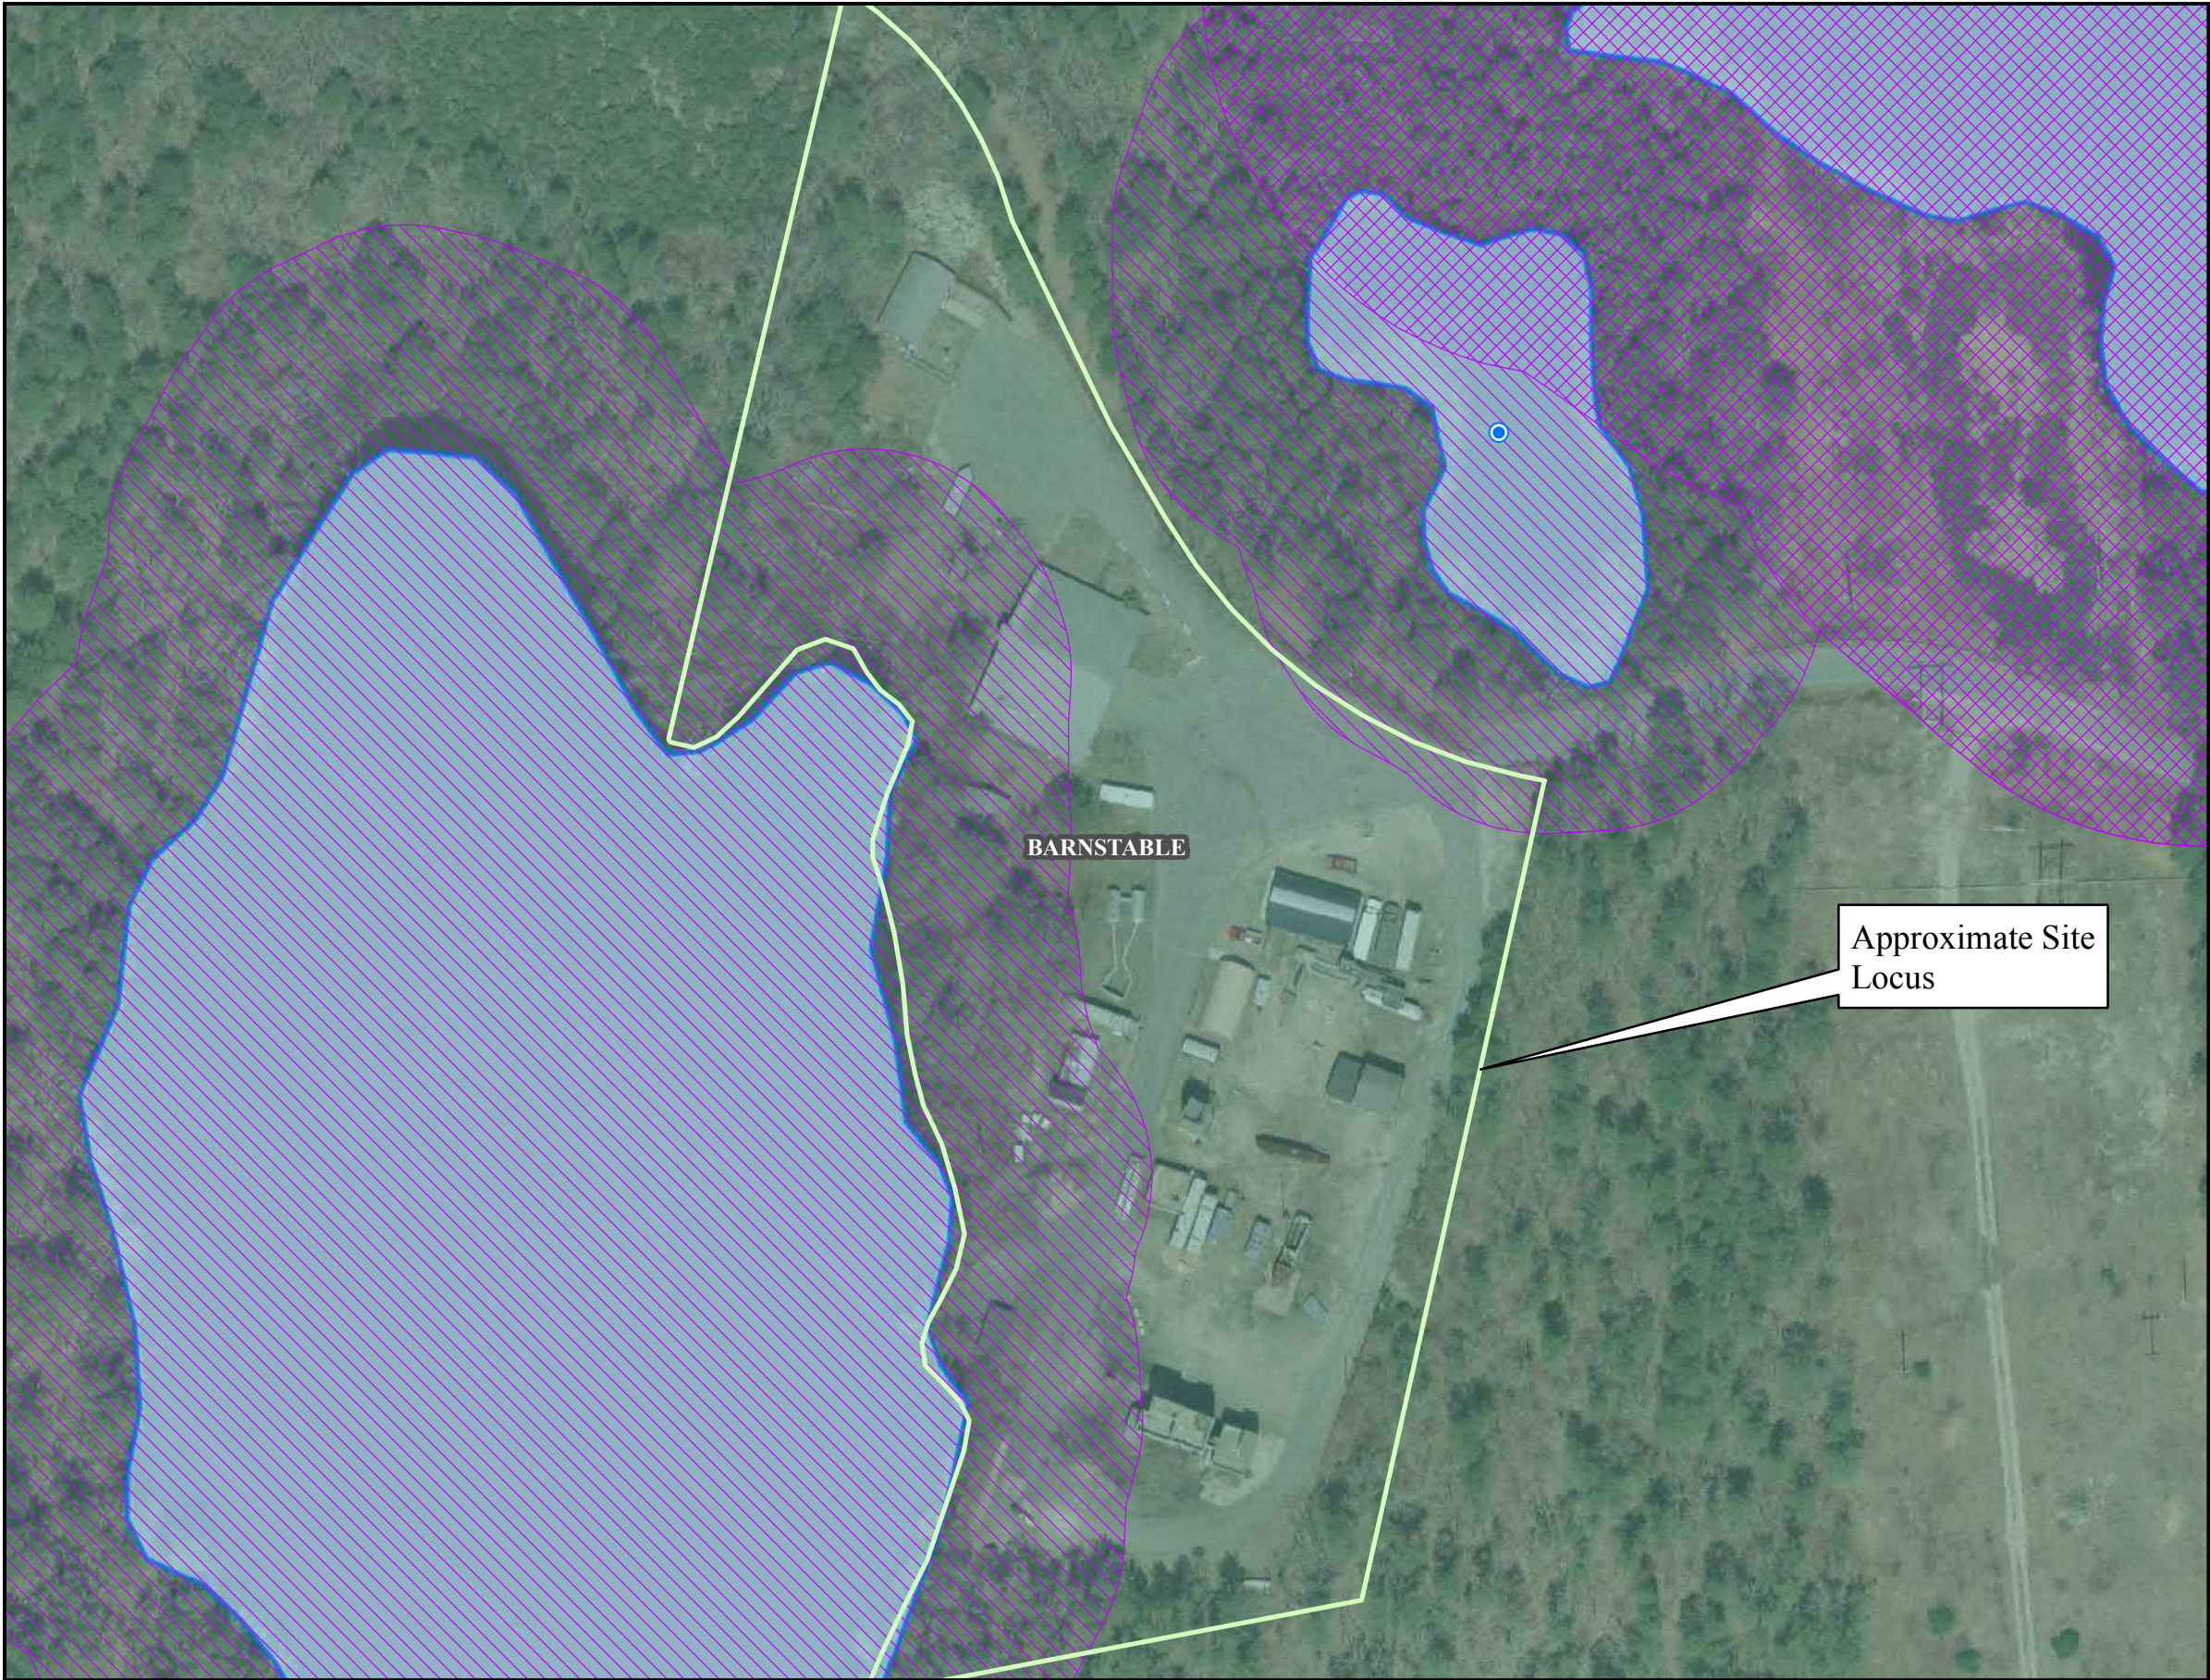
Figure 2
Environmental Resources Map
155 South Flint Rock Road
Barnstable, MA

- Approximate Site Locus
- MassDEP Hydrologic Feature
- Marsh/Bog
- Wooded marsh
- Open Water
- NHESP Potential Vernal Pool
- NHESP Certified Vernal Pool
- NHESP Priority Habitats of Rare Species
- NHESP Estimated Habitats of Rare Wildlife

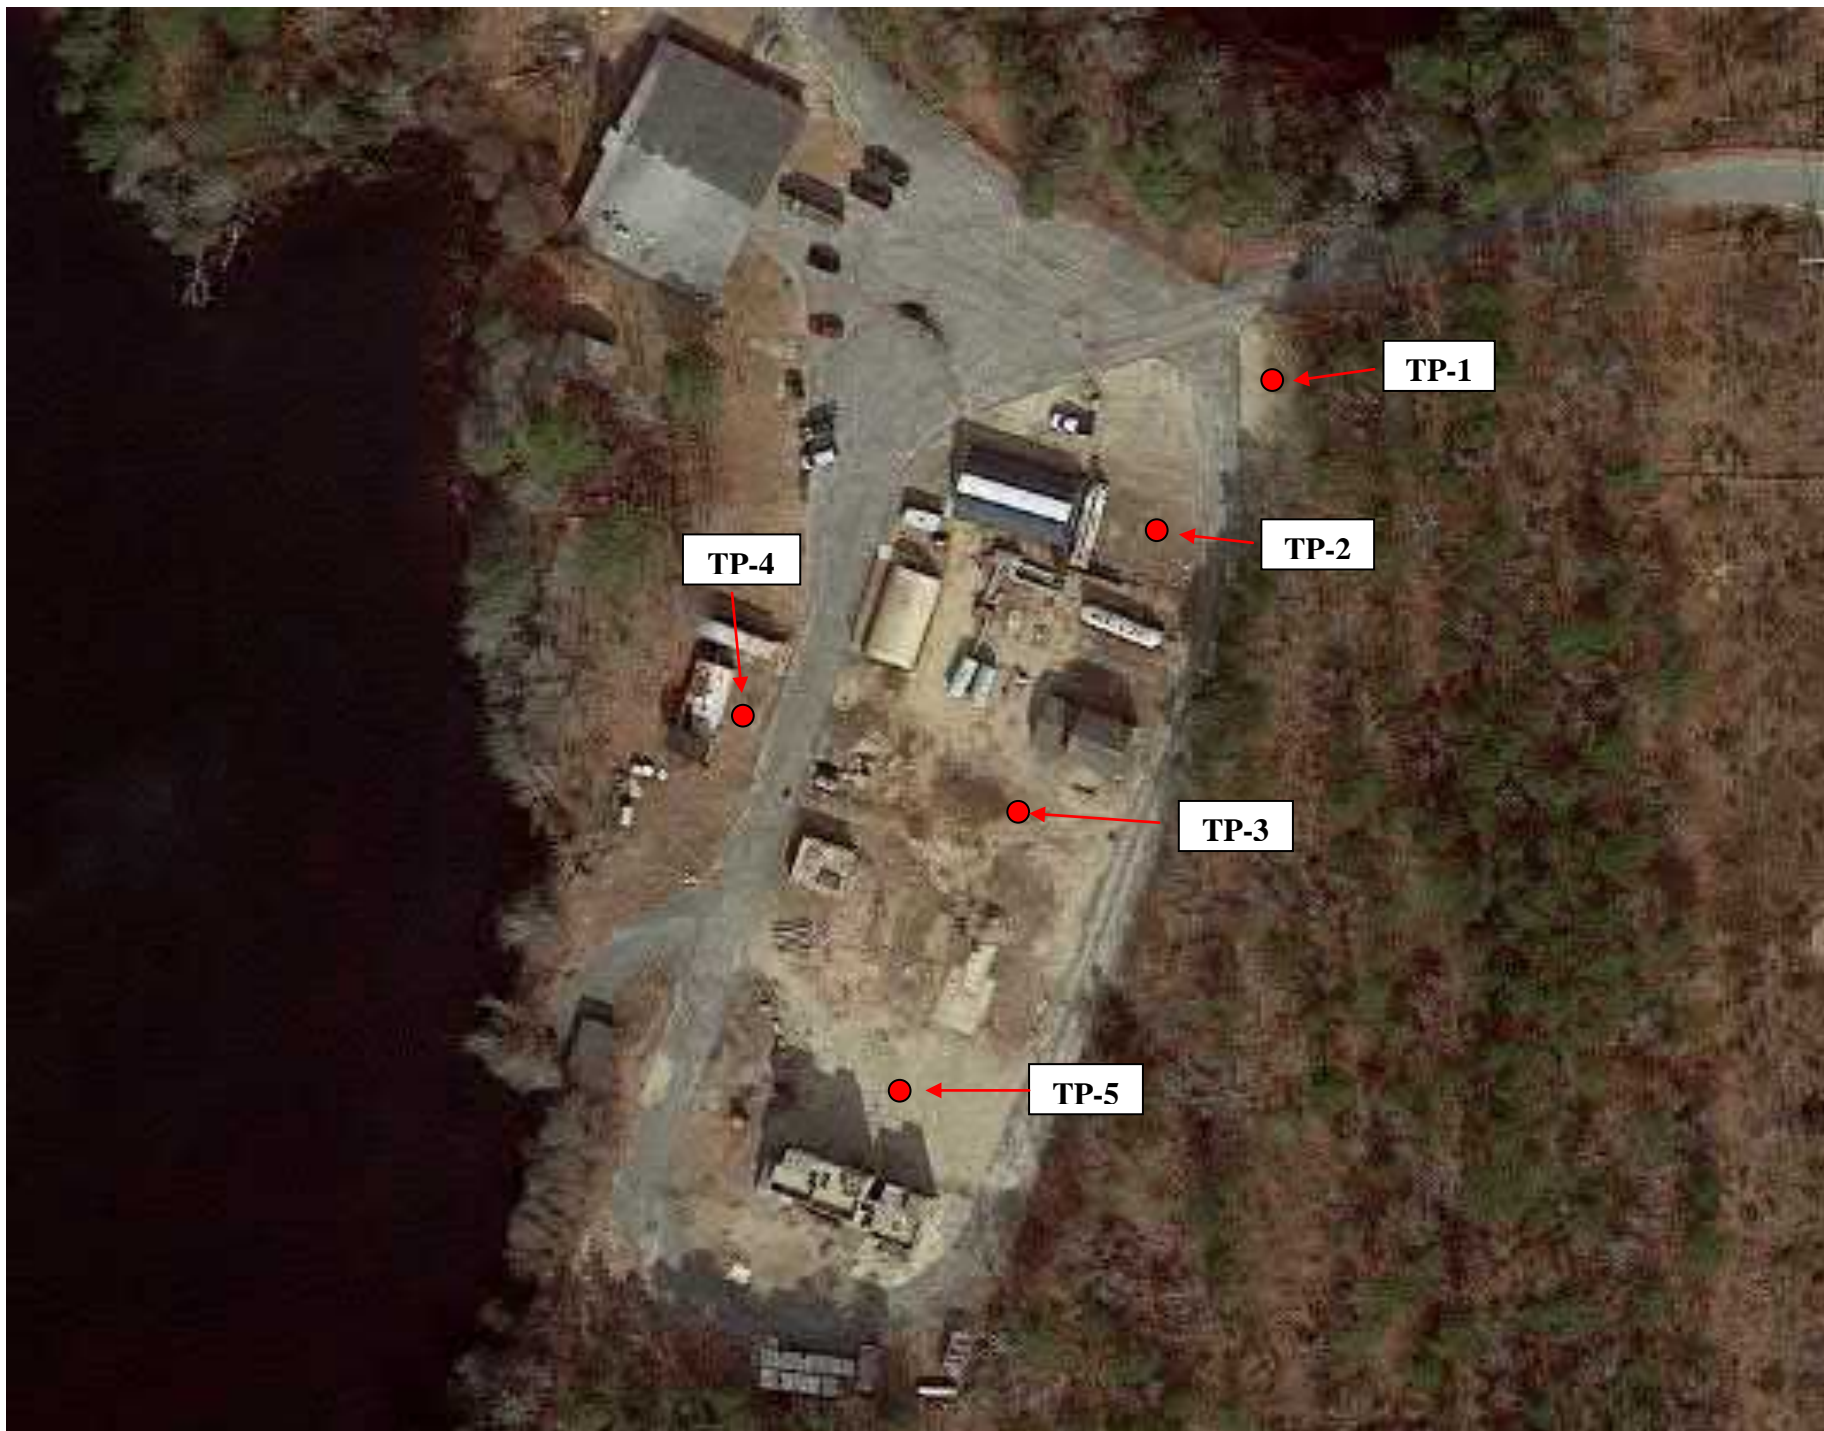
Figure 5

TEST PIT LOCATIONS

As depicted in Figure No. 4, many of the underlying soils within the project area belong to HSG A, meaning that the project area likely has a high infiltration rate with a low potential for runoff. This is supported by soil evaluations completed at five test pit locations on the site (Figure 5).
